QUALITY ASSURANCE -- NON-CONFORMANCE REPORT

Report No: NCR-000313

Reference Description: Missed UT Indication by QC, Weld SB002-012-004, Segment 1BW

Job Name: SAS Superstructure

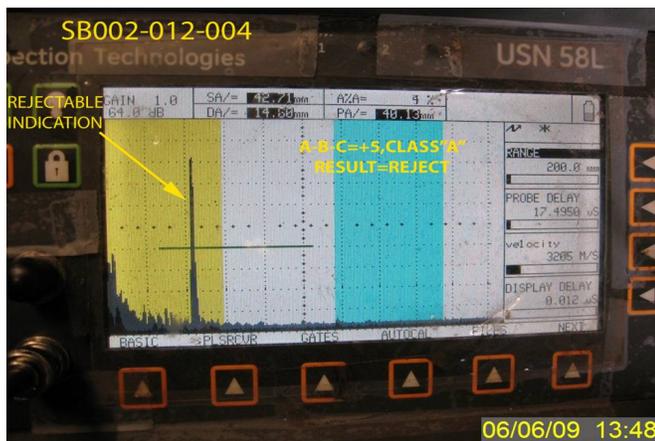
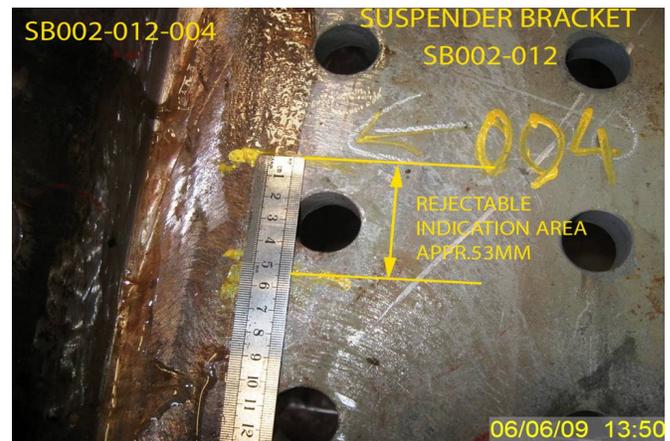
Caltrans Quality Insurance (QA) Inspector performed 10% verification ultrasonic testing (UT) on weld joint SB002-012-004 for Suspender Bracket SB002-012 (Segment 1BW). QA Inspector discovered a class "A" rejectable indication measuring approximately 53mm in length. This weld was previously tested and accepted by ZPMC Quality Control (QC) UT technicians.

Repair area in question and perform subsequent NDT.

Contractor submitted WRR as well as UT and VT reports to verify that repair was performed in conformance with Contract specifications.

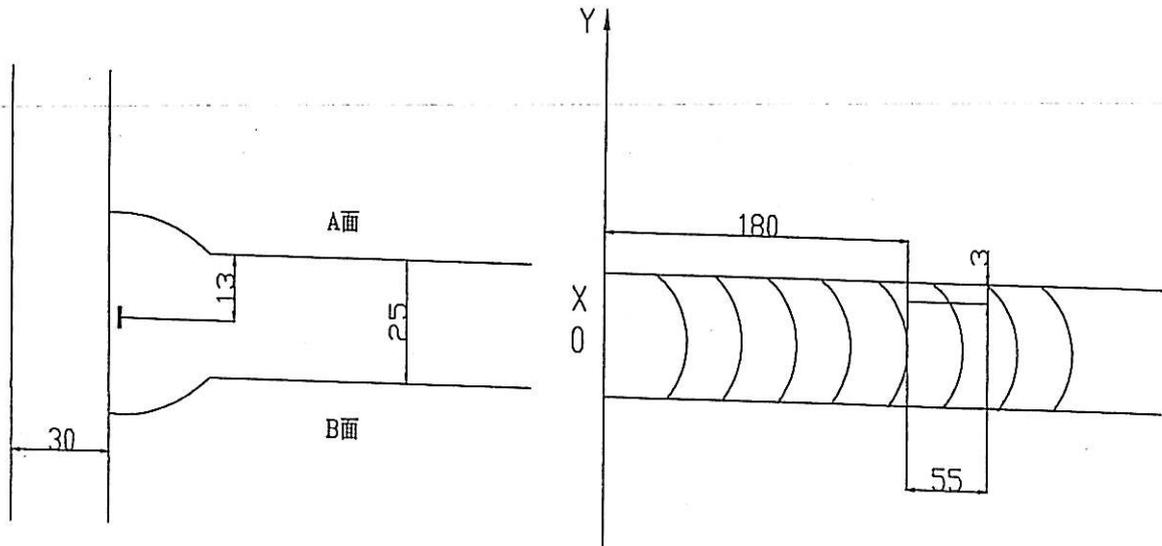
WELD NUMBER: SB002-012-004

Rejected indication found by ultrasonic inspection is less than the maximum allowance aggregate length.

1. Did not clear the weld pass completely in time.

1. Gouge or grind from nearer side from metal edge ($D \leq 0.65T$, " D " is depth of defects, " T " is thickness of metal) to remove all defects;
2. Follow repair WPS for joint preparation, preheat, and weld deposit;
3. Verify with VT no defects remain in the weld joint prior to welding;
4. Grind the repaired area flush with base metal or the adjacent weld;
5. Check the welds according to the working drawings.

1. Improve monitoring of welding and interpass cleaning.
