Contract #: 04-0120F4Cty: SF/ALA Rte: 80 PM: 13.2/13.9File #: 69.25B**QUALITY ASSURANCE -- NON-CONFORMANCE REPORT****Location:** Changxing Island, Shanghai, P.R. China**Report No:** NCR-000314**Prime Contractor:** American Bridge/Fluor Enterprises, a JV**Date:** 06-Jun-2009**Submitting Contractor:** Zhenhua Port Machinery Company, Ltd (ZPMC), Changxing Island**NCR #:** ZPMC-0288**Type of problem:****Welding****Concrete****Other****Welding****Curing****Procedural****Bridge No:** 34-0006**Joint fit-up****Coating****Other****Component:** OBG Suspender Brackets**Procedural****Procedural****Description:**

Reference Description: Fabrication that does not comply with the contract drawings, OBG suspender brackets

Job Name: SAS Superstructure

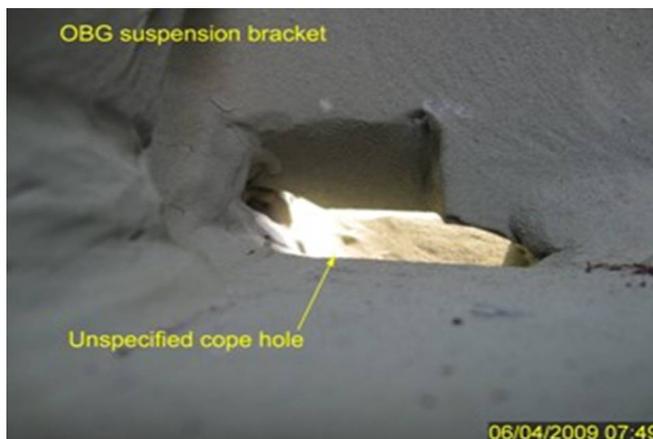
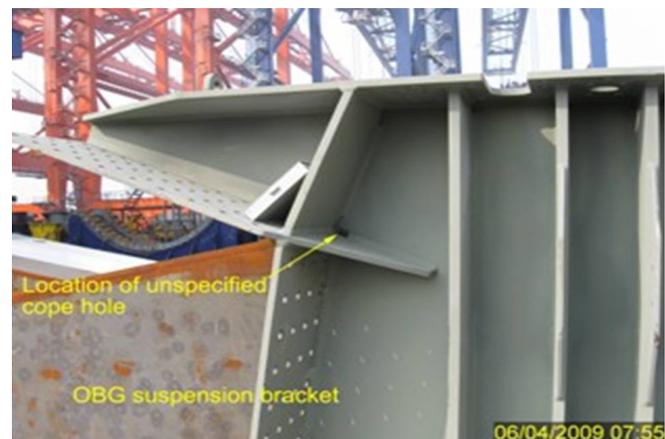
Caltrans Quality Assurance (QA) Inspector observed that the Contractor appears to either have a complete joint penetration (CJP) weld that has not been completed, or has an unspecified cope hole that is not identified on the approved contract drawings. The weld in question is located on the suspender brackets where the deck panel mounting flange (X53B) intersects and welds to the web plate. This condition was observed on Suspender Brackets SB20E, SB20W, SB22E, SB22W, SB24E, SB24W, SB26E, SB26W, SB28E and SB28W.

The proposed resolution is acceptable. This detail is according to what is shown on the contract drawings, and each of the cope holes mentioned in the Non-Conformance has been ground smooth and uniform. The Department concurs that Non-Conformance ZPMC-0288 is closed.

将过焊孔打磨光滑, 并对每个制作错误的悬索支架过焊孔一一检查, 确定是否打磨光滑到位。
同时, 加强现场监控的检查力度严格按照图纸要求进行制作。
Grind the unspecified cope hole to a smooth and shiny finish, and check every unspecified cope hole on the wrong fabricated suspender brackets to ensure all the grindings meet the requirement; meanwhile, enhance supervision and inspection on-site and fabricate in accordance with the shop drawing strictly.

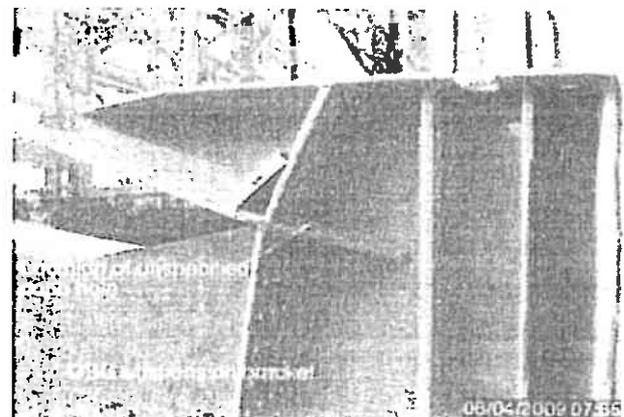
Caltrans Quality Assurance (QA) Inspector observed that the Contractor appears to either have a complete joint penetration (CJP) weld that has not been completed, or has an unspecified cope hole that is not identified on the approved contract drawings. The weld in question is located on the suspender brackets where the deck panel mounting flange (X53B) intersects and welds to the web plate. This condition was observed on Suspender Brackets SB20E, SB20W, SB22E, SB22W, SB24E, SB24W, SB26E, SB26W, SB28E and SB28W.
