Contract #: 04-0120F4Cty: SF/ALA Rte: 80 PM: 13.2/13.9File #: 69.25B**QUALITY ASSURANCE -- NON-CONFORMANCE REPORT****Location:** Changxing Island, Shanghai, P.R. China**Report No:** NCR-000315**Prime Contractor:** American Bridge/Fluor Enterprises, a JV**Date:** 05-Jun-2009**Submitting Contractor:** Zhenhua Port Machinery Company, Ltd (ZPMC), Changxing Island**NCR #:** ZPMC-0289**Type of problem:**

Reference Description: Missed MT Indications by QC, Segment 4BE**Description of Non-Conformance:**

NON-CONFORMANCE REPORT TRANSMITTAL

Job Name: SAS Superstructure

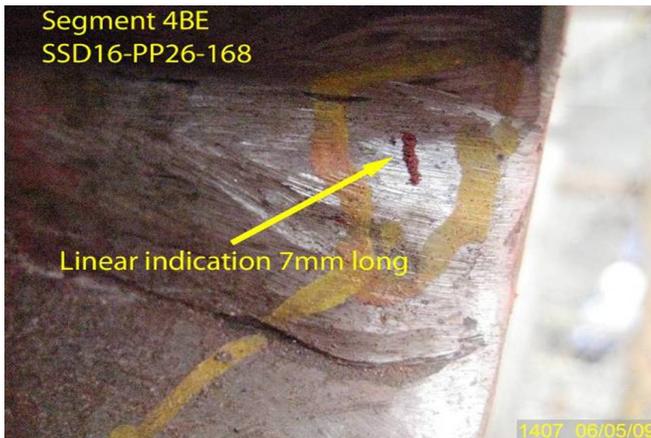
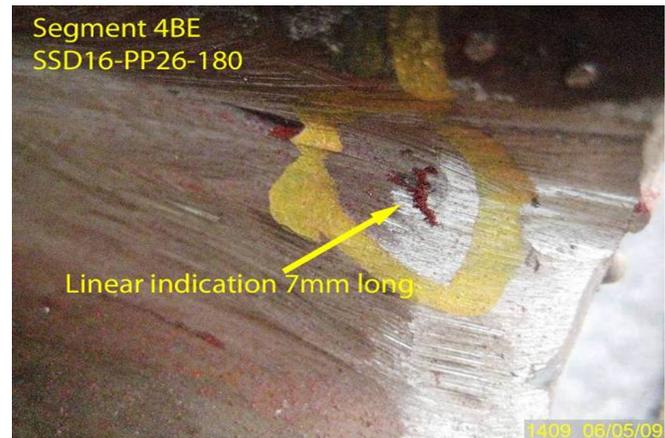
During random verification magnetic particle testing (MT) of the internal components of OBG Segment 4BE, Caltrans Quality Assurance (QA) Inspector discovered a total of four (4) linear indications ranging from 7 to 10mm in length in the following welds: SSD16-PP26-168, SSD16-PP26-180, SSD16-PP26-177 and SSD16-PP26-172. These welds have been previously tested and accepted by ZPMC Quality Control MT technicians.

AWS D1.5 (02) Section 6.26.2 – “Welds that are subject to MT in addition to visual inspection shall have no cracks.”

Propose a resolution for the identified recurring non-conformance which constitutes a systematic problem in quality control with revised procedures to prevent future occurrences. A response for the resolution of this issue is expected within 14 days.

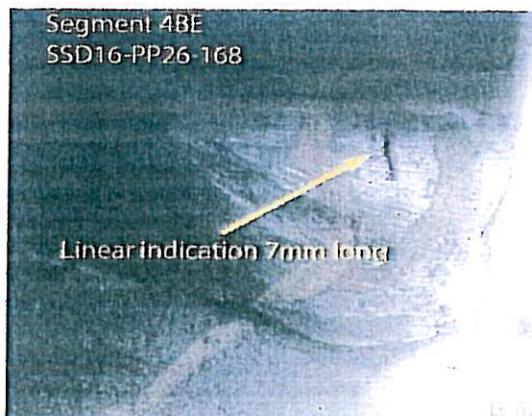
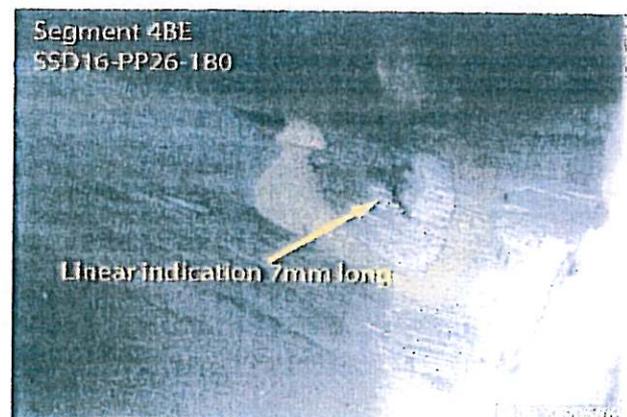
During random verification magnetic particle testing (MT) of the internal components of OBG Segment 4BE, Caltrans Quality Assurance (QA) Inspector discovered a total of four (4) linear indications ranging from 7 to 10mm in length in the following welds: SSD16-PP26-168, SSD16-PP26-180, SSD16-PP26-177 and SSD16-PP26-172. These welds have been previously tested and accepted by ZPMC Quality Control MT technicians.

AWS D1.5 (02) Section 6.26.2 – “Welds that are subject to MT in addition to visual inspection shall have no cracks.”

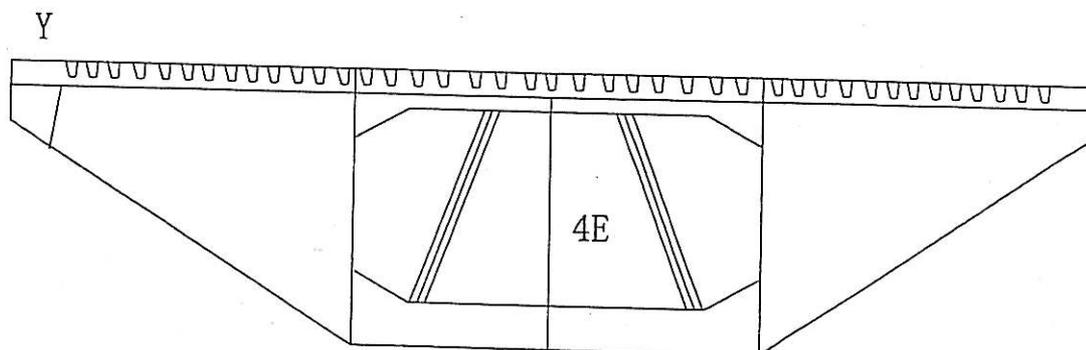
Draft of welding discontinuity:

- One line indication was found by use of MT on weld SSD16-PP26-168. L=7 720
- One line indication was found by use of MT on weld SSD16-PP26-180. L=7 720
- One line indication was found by use of MT on weld SSD16-PP26-177. L=8 720
- One line indication was found by use of MT on weld SSD16-PP26-172. L=10 720

1. Remove all the defects according to the approved repair WPS by means of grinding.
2. Prepare a groove based on the repair WPS.
3. Verify with MT and VT no defects remain in the repair area prior to welding;
4. Preheat and weld according to the relevant WPS.
5. Grind the weld flush with adjacent base metal after welding.
6. Perform VT and MT inspection to the repaired area.
