Contract #: 04-0120F4Cty: SF/ALA Rte: 80 PM: 13.2/13.9File #: 69.25B**QUALITY ASSURANCE -- NON-CONFORMANCE REPORT****Location:** Changxing Island, Shanghai, PRC**Report No:** NCR-000317**Prime Contractor:** American Bridge/Fluor Enterprises, a JV**Date:** 12-Jun-2009**Submitting Contractor:** Zhenhua Port Machinery Company, Ltd (ZPMC), Changxing Island**NCR #:** ZPMC-0291**Type of problem:**

Reference Description: Missed MT indications on West Tower, Lift 1 doubler plate welds**Description of Non-Conformance:**

To:	AMERICAN BRIDGE/FLUOR, A JV 375 BURMA ROAD OAKLAND CA 95607	Date:	15-Jun-2009
Dear:	Mr. Charles Kanapicki	Contract No:	04-0120F4 04-SF-80-13.2 / 13.9
Attention:	Mr. Thomas Nilsson Project/Fabrication Manager	Job Name:	SAS Superstructure
Subject:	NCR No. ZPMC-0291	Document No:	05.03.06-000280

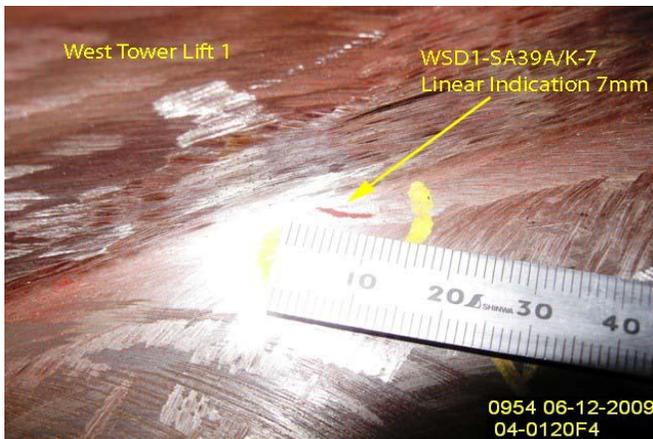
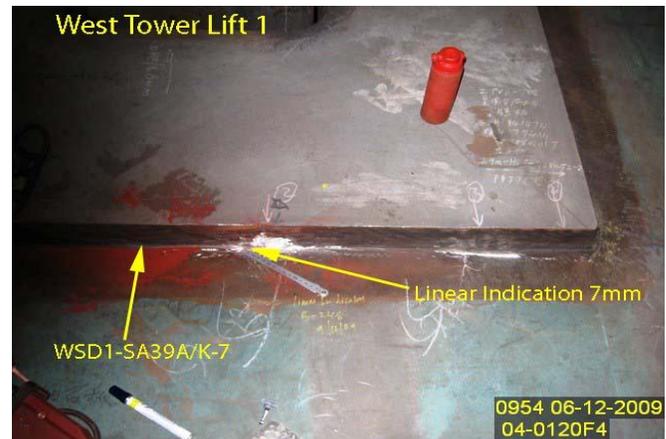
QA discovered two 7mm long linear indications during random verification Magnetic Particle Testing (MT) of West Tower, Lift 1 doubler plate welds WSD1-SA39A/K-7 and WSD1-SA39B/K-6. These welds were previously tested and accepted by ZPMC QC MT Technicians.

AWS D1.5-2002 Section 6.26.2 – “Welds that are subject to MT in addition to visual inspection shall have no cracks.”

The linear indication didn't find during inspection west tower first lifting double diaphragm by use of MT.

In addition to the Quality Control failure, propose a resolution for the identified material/workmanship non-conformance, documenting that the repaired welds are in compliance with the contract requirements.

Recommendation:
 建议: 返修, 加强对梯脚角处 MT 检测
 Repair and enhance MT inspection at corner.

perform according to procedure and enhance training.

Repair affected welds.

The affected welds have been repaired and a NDT report indicating sound welds has been submitted. The welds were verified by QA following the repair.
