## QUALITY ASSURANCE -- NON-CONFORMANCE REPORT

**Report No:** NCR-000318

**NCR #:** ZPMC-0292

**Reference Description:** Missed linear indication on West Tower, Lift 1 fit lug weld

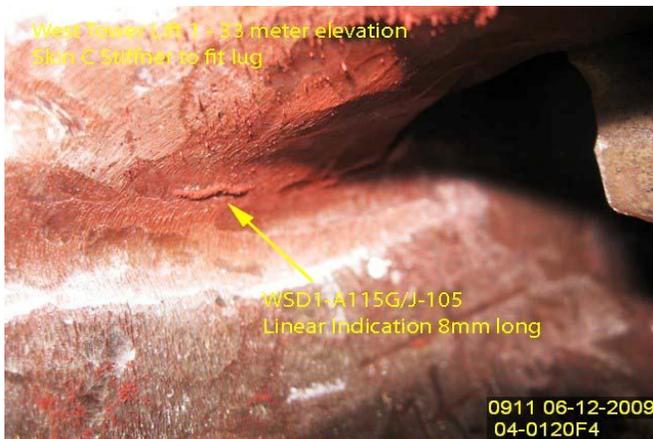
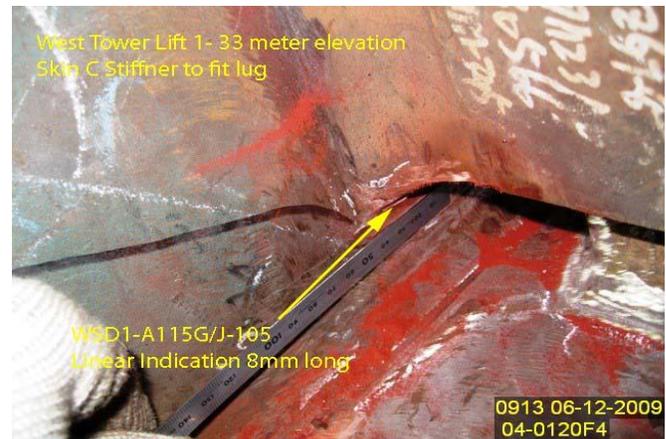
QA discovered an 8mm long linear indication during random verification visual inspection of West Tower, Lift 1, Skin C Stiffener to fit lug weld WSD1-A115G/J-105. This weld was previously accepted by ZPMC QC personnel.

AWS D1.5-2002 Section 6.26.2 – “Welds that are subject to MT in addition to visual inspection shall have no cracks.”

Propose a resolution for the identified non-conformance including documentation that the deficiency has been brought into compliance with the contract requirements. Additionally address the probable causes for the indication and any actions that will be taken to limit future occurrences.

The proposed resolution is acceptable. The weld in question has been accepted by VT and MT as shown in the attached documents. The Department concurs that Non-Conformance ZPMC-0292 is closed.
