Contract #: 04-0120F4Cty: SF/ALA Rte: 80 PM: 13.2/13.9File #: 69.25B**QUALITY ASSURANCE -- NON-CONFORMANCE REPORT****Location:** Changxing Island, Shanghai, PRC**Report No:** NCR-000320**Prime Contractor:** American Bridge/Fluor Enterprises, a JV**Date:** 15-Jun-2009**Submitting Contractor:** Zhenhua Port Machinery Company, Ltd (ZPMC), Changxing Island**NCR #:** ZPMC-0294**Type of problem:**

Reference Description: Missed MT indication on North Tower, Lift 1, Skin A plate weld**Description of Non-Conformance:**

To:	AMERICAN BRIDGE/FLUOR, A JV 375 BURMA ROAD OAKLAND CA 95607	Date:	16-Jun-2009
Dear:	Mr. Charles Kanapicki	Contract No:	04-0120F4 04-SF-80-13.2 / 13.9
Attention:	Mr. Thomas Nilsson Project/Fabrication Manager	Job Name:	SAS Superstructure
Subject:	NCR No. ZPMC-0294	Document No:	05.03.06-000283

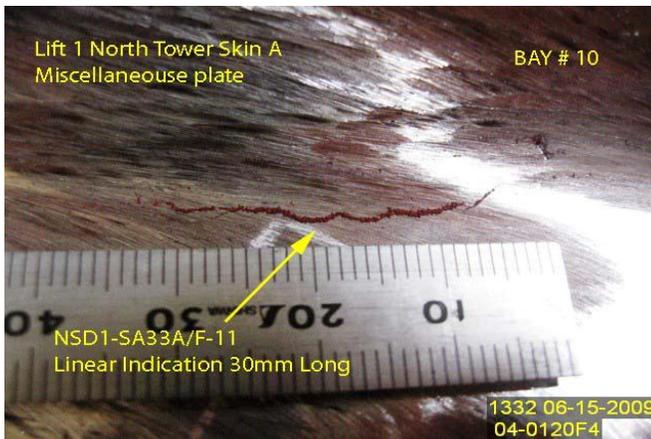
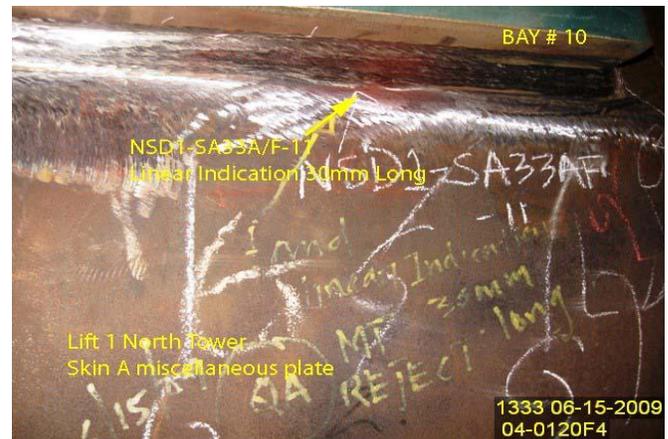
QA discovered an approximately 30mm long linear indication during random verification Magnetic Particle Testing (MT) of North Tower, Lift 1, Skin A plate weld NSD1-SA33A/F-11. This weld was previously tested and accepted by ZPMC QC MT Technicians.

AWS D1.5-2002, Section 6.26.2 – “Welds that are subject to MT in addition to visual inspection shall have no cracks.”

In addition to the Quality Control failure, propose a resolution for the identified material/workmanship non-conformance, documenting that the repaired weld is in compliance with the contract requirements.
