QUALITY ASSURANCE -- NON-CONFORMANCE REPORT

Report No: NCR-000321

Reference Description: Missed MT indication in North Tower, Lift 1

Dear: Mr. Charles Kanapicki
Job Name: SAS Superstructure

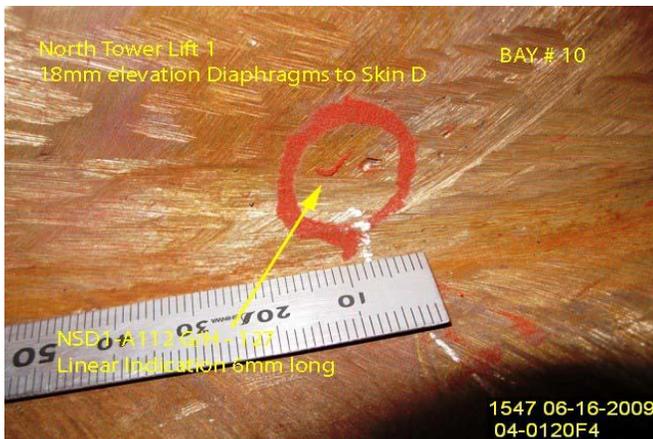
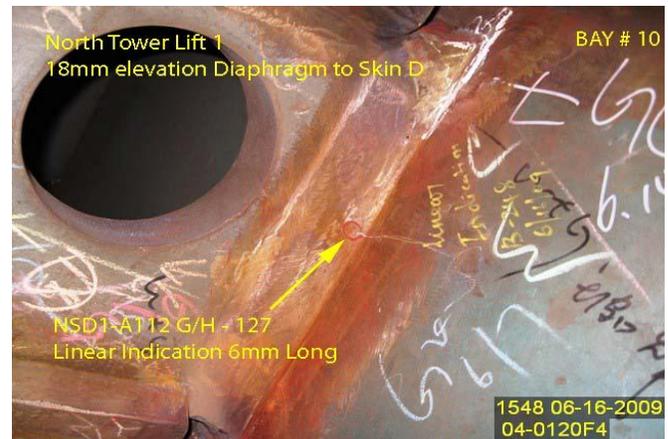
During random verification Magnetic Particle Testing (MT) of North Tower, Lift 1, QA discovered a 6mm long linear indication on 18m Diaphragm to Skin D weld NSD1-A112G/H-127. This weld was previously tested and accepted by ZPMC QC MT Technicians.

AWS D1.5-2002, Section 6.26.2 – “Welds that are subject to MT in addition to visual inspection shall have no cracks.”

Propose a resolution for this systematic non-conformance that addresses the failure of Quality Control to identify the linear indication (MT). Provide documentation of the steps taken by the Quality Control Manager to prevent future occurrences.

In addition to the Quality Control failure, propose a resolution for the identified material/workmanship non-conformance, documenting that the repaired weld is in compliance with the contract requirements.

ZPMC acknowledged this problem, and already put forward ZPMC's NCR-T-056. As a result, ZPMC had removed the indication and repaired it and finally performed re-inspection by MT. In order to avoid such problem occurs again ZPMC will perform NDT work according to related procedures strictly, and enhance QC responsibility. Here attached the MT report T787-MT-4604, prove the welds are perfect after repairing.

The affected weld has been repaired and a NDT report indicating sound welds has been submitted. The weld was verified by QA following the repair.
