Contract #: 04-0120F4Cty: SF/ALA Rte: 80 PM: 13.2/13.9File #: 69.25B**QUALITY ASSURANCE -- NON-CONFORMANCE REPORT****Location:** Changxing Island, Shanghai, PRC**Report No:** NCR-000322**Prime Contractor:** American Bridge/Fluor Enterprises, a JV**Date:** 15-Jun-2009**Submitting Contractor:** Zhenhua Port Machinery Company, Ltd (ZPMC), Changxing Island**NCR #:** ZPMC-0296**Type of problem:**

Reference Description: Missing backing bars on diaphragm corner piece welds in South Tower, Lift 1**Description of Non-Conformance:**

Job Name: SAS Superstructure

Reference Description: Backing Bars / South Shaft Lift 1 / 43m & 47.6m Diaphragm CJP Welds

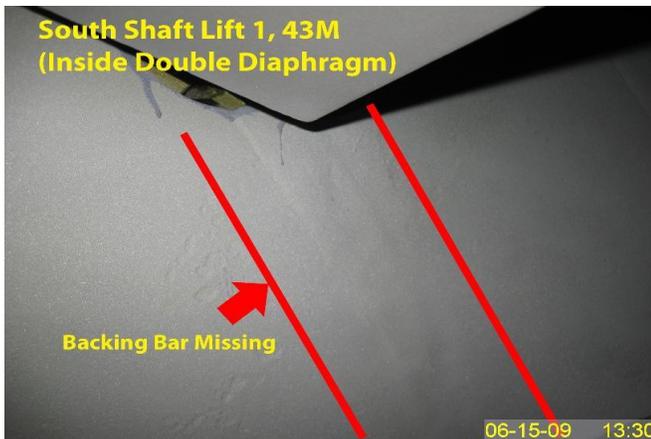
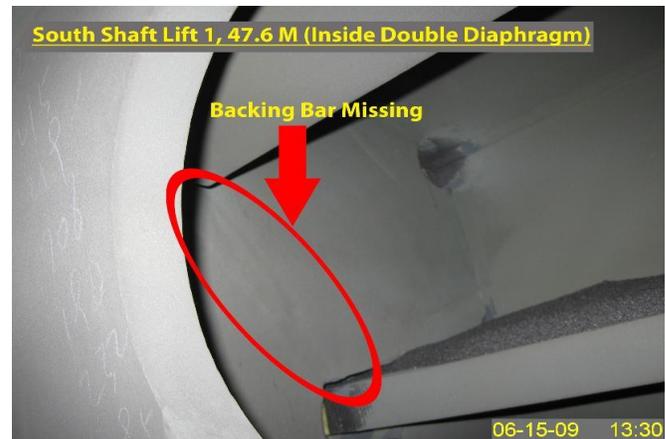
During random visual after blast inspection of South Tower, Lift 1, QA observed that there are no backing bars on diaphragm corner piece welds SSD1-A164H/J-194 & SSD1-A164G/J-215. These welds were previously accepted by ZPMC QC Personnel.

Weld Joint Detail WT-63 specifies backing bar.

For ZPMC-0296, ZPMC found indications deeply in the welds SSD1-A164H/J-194, SSD1-A164G/J-215, and they had to be gouged from the backing bars, so the backing bars were removed. For ZPMC ZPMC-0385, ZPMC had realized this problem, and already made continuous full length weld on the backing bars, according to AWS D1.5-2002 Section 3.3.7.6. As a result, ZPMC finally performed re-inspection by UT, and the result showed the welds were acceptable. In order to avoid such problem occurs again ZPMC will perform welding work according to related procedures strictly, and engineer will be informed when backing bars will be removed, also ZPMC will enhance welder and QC be more responsible. Here attached reports to prove the welds were perfect after re-welding on the backing bars.

ZPMC removed the backing bars from the welds, SSD1-A164H/J-194 and SSD1-A164G/J-215 to perform repairs. ZPMC has provided UT reports which show that the weld is sound after the repairs. ZPMC requests closure of this NCR.

The Contractor has explained that the backing bars were removed to access and repair rejectable UT (Ultrasonic Testing) indications. The Contractor will notify the Engineer if additional backing bars are removed in the future.

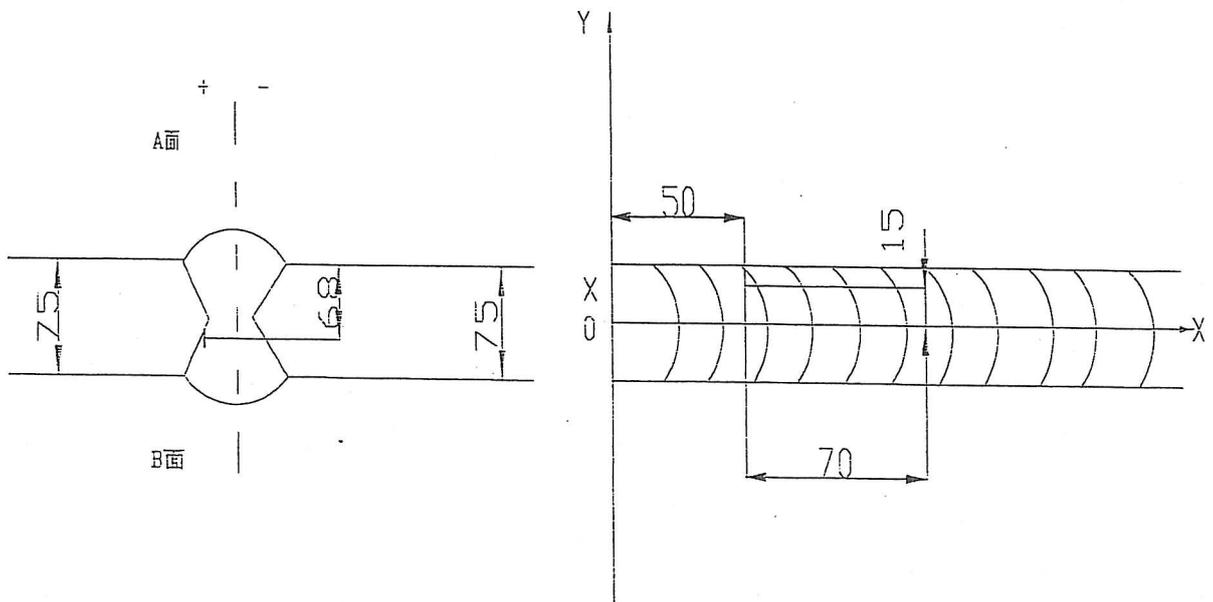
WELD NUMBER: SSD1-A164H/J-194

Rejected indication found by ultrasonic inspection is less than the maximum allowance aggregate length.

- 1、 碳弧气刨, 焊接接头没有有效打磨;
 - 2、 起弧和收弧没有交错布置, 以减少熔渣最少到最少;
 - 3、 保温层没有有效的清理。
1. The weld joint was not ground sufficiently after arc-gouging.
 2. The arc starts and stops were not staggered to minimize slag entrapment.
 3. Interpass cleaning was not performed properly.

- 1、 Gouge off the defect weld;
- 2、 Grind smoothly the gouged surface;
- 3、 If User's request, check with VT or other NDT method to make sure the defect remove completely;
- 4、 Preheat and the interpass temperature control according to the relative WPS-repair;
- 5、 Check the welding according to the approved shop drawing.

- 1、碳钎后的接头位置打磨更滑过渡，保证每道焊缝的接头可以交错布置。
 - 2、认真仔细检查每道焊缝和加强焊道的清理。
 3. 焊缝中所有的焊渣全部去除后，表面的缺陷全部打磨干净。
1. The joint shall be ground to a smooth transition to ensure that arc starts and stops are in a staggered Arrangement.
 2. QC shall inspect the weld passes more carefully and enforcing interpass cleaning.
 3. All weld slag shall be removed and surface defects ground during interpass cleaning.

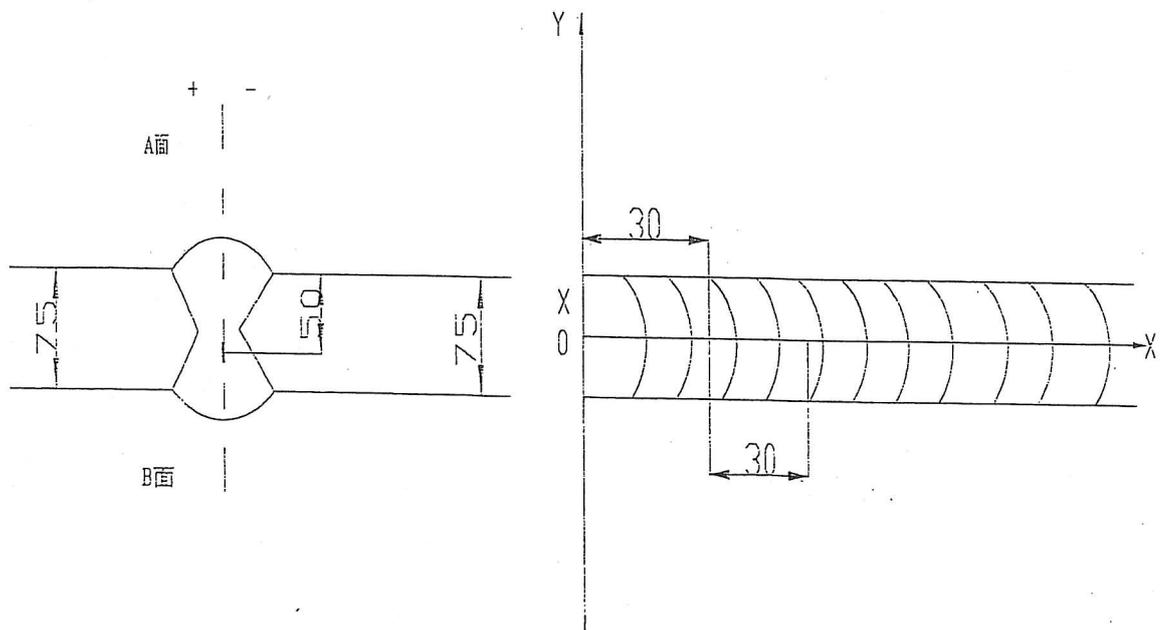
WELD NUMBER: SSD1-A164GJ-215

Rejected indication found by ultrasonic inspection is less than the maximum allowance aggregate length.

1. 电弧引弧时没有有效打磨。
 2. 起弧和收弧没有交错布置,以将焊缝减少到最少。
 3. 焊缝间没有有效的清理。
1. The weld joint was not ground sufficiently after arc-gouging.
2. The arc starts and stops were not staggered to minimize slag entrapment.
3. Interpass cleaning was not performed properly.

1. Gouge off the defect weld;
2. Grind smoothly the gouged surface;
3. If User's request, check with VT or other NDT method to make sure the defect remove completely;
4. Preheat and the interpass temperature control according to the relative WPS-repair;
5. Check the welding according to the approved shop drawing.

1. 碳钎后的接头位置打磨及滑过渡, 保证每道焊缝的接头可以交错布置;
 2. 认真仔细检查每道焊缝和加强焊道的清理;
 3. 焊缝中所有的焊渣全部去除后, 表面的缺陷全部打磨干净。
1. The joint shall be ground to a smooth transition to ensure that arc starts and stops are in a staggered Arrangement.
 2. QC shall inspect the weld passes more carefully and enforcing interpass cleaning.
 3. All weld slag shall be removed and surface defects ground during interpass cleaning.

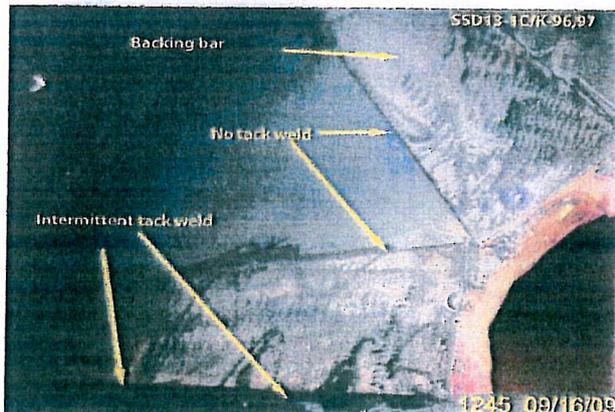
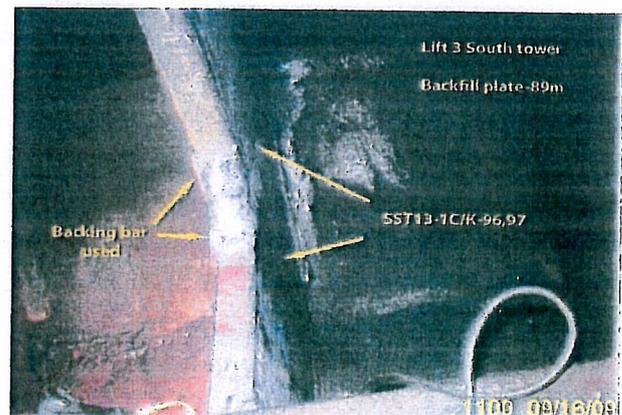
During Ultrasonic Testing (UT) of the South Tower, Lift 3 welds SST13-1C/K-96 & 97, QA discovered that backing bars have been attached with intermittent fillet welds outside of the weld joints. These weld joints were previously tested and accepted by ZPMC Quality Control Personnel.

AWS D1.5-2002, Section 3.3.7.6 - "Tack welds used to attach steel backing and placed external to the weld joint shall be made continuous by fillet welding for the full length of the backing or shall be removed."

Propose a resolution for the identified non-conformance, documenting that the deficiency has been brought in compliance with the contract requirements.
