QUALITY ASSURANCE -- NON-CONFORMANCE REPORT

Report No: NCR-000323

NCR #: ZPMC-0297

Reference Description: Tower, Lift 1, 38m diaphragm to skin E weld gouge

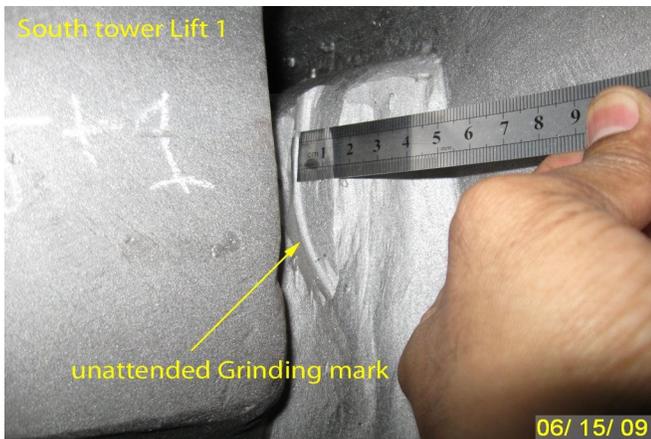
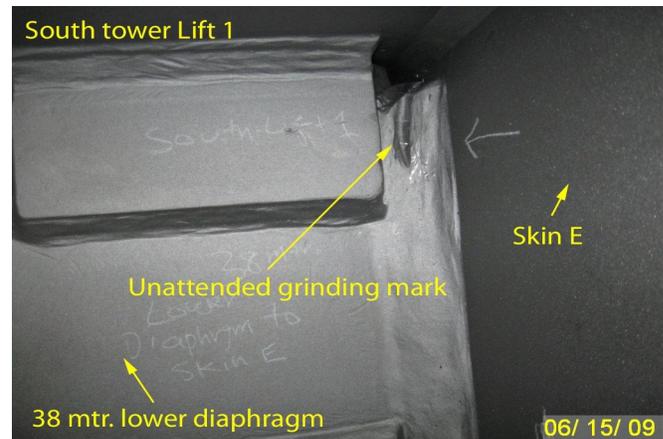
QA observed a 12mm deep gouge in 38m diaphragm to skin E weld during after grit blast random verification of South Tower, Lift 1. This weld was previously accepted by ZPMC QC personnel.

AWS D 1.5-2002, Section 3.7.1 - "The removal of weld metal or portions of the base metal may be done by machining, air carbon arc cutting and gouging, thermal cutting, chipping, or grinding. It shall be done in such a manner that the remaining weld metal or base metal is not nicked or undercut..."

Propose a resolution for the identified non-conformance including documentation that the weld has been brought into compliance with the contract requirements. Additionally address actions that will be taken to limit future occurrences.

The affected weld has been repaired and subsequently green tagged.

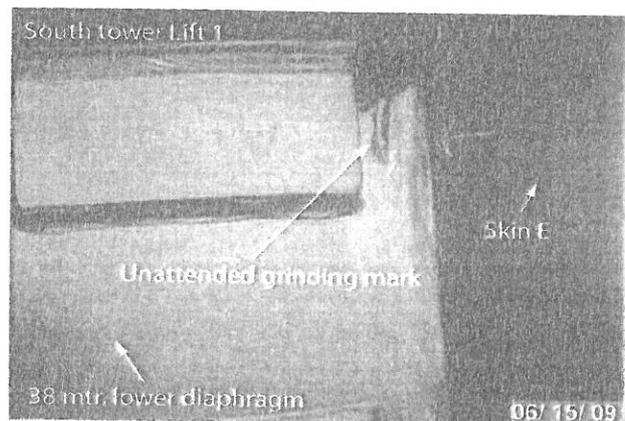
QA observed a 12mm deep gouge in 38m diaphragm to skin E weld during after grit blast random verification of South Tower, Lift 1. This weld was previously accepted by ZPMC QC personnel.

AWS D 1.5-2002, Section 3.7.1 - "The removal of weld metal or portions of the base metal may be done by machining, air carbon arc cutting and gouging, thermal cutting, chipping, or grinding. It shall be done in such a manner that the remaining weld metal or base metal is not nicked or undercut..."

As a result, ZPMC performed re-welding on this pot hole, and this weld was finally rechecked by ZPMC, AB/F and CT and already been green tagged. Here attached the NDT report to prove the weld was sound.

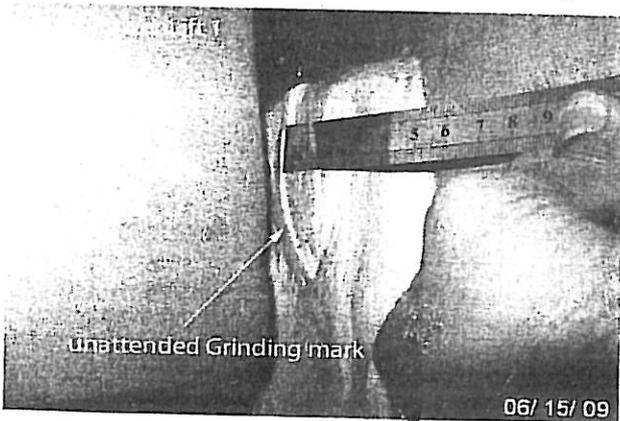
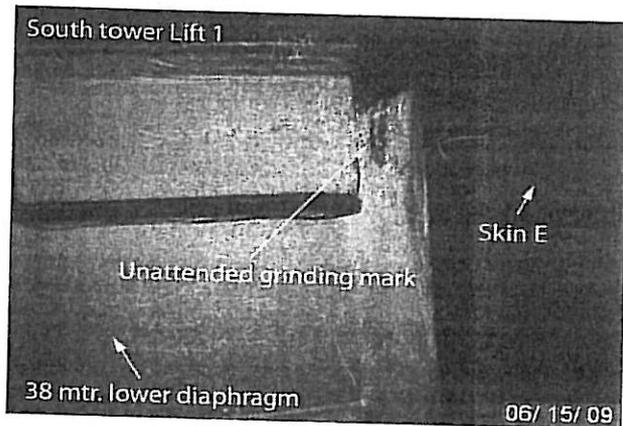
QA observed a 12mm deep gouge in 38m diaphragm to skin E weld during after grit blast random verification of South Tower, Lift 1. This weld was previously accepted by ZPMC QC personnel.

AWS D 1.5-2002, Section 3.7.1 - "The removal of weld metal or portions of the base metal may be done by machining, air carbon arc cutting and gouging, thermal cutting, chipping, or grinding. It shall be done in such a manner that the remaining weld metal or base metal is not nicked or undercut..."

The ABF QCM has notified the ZPMC QA and QC staff to be more thorough with inspections prior to and after sand blasting, to use proper lighting and understand where problem areas are most likely to occur based on welding position, welding processes and accessibility of welding. The ABF QCM has also discussed these same topics with the ABF lead inspectors as well as our subcontract line inspectors to prevent future occurrences. ZPMC requests closure of this NCR.
