Contract #: 04-0120F4Cty: SF/ALA Rte: 80 PM: 13.2/13.9File #: 69.25B**QUALITY ASSURANCE -- NON-CONFORMANCE REPORT****Location:** Changxing Island, Shanghai, P.R. China**Report No:** NCR-000324**Prime Contractor:** American Bridge/Fluor Enterprises, a JV**Date:** 16-Jun-2009**Submitting Contractor:** Zhenhua Port Machinery Company, Ltd (ZPMC), Changxing Island**NCR #:** ZPMC-0298**Type of problem:****Welding****Concrete****Other****Welding****Curing****Procedural****Bridge No:** 34-0006**Joint fit-up****Coating****Other****Component:** OBG Segment Splice 2AW/2BW**Procedural****Procedural****Description:****Reference Description:** Missed MT Indication by QC, Weld SP642-001-022, 2AW/2BW Segment Splice**Description of Non-Conformance:**

Job Name: SAS Superstructure

Reference Description: Missed MT Indication by QC, Weld SP642-001-022, 2AW/2BW Segment Splice

Report No: NCR-000324

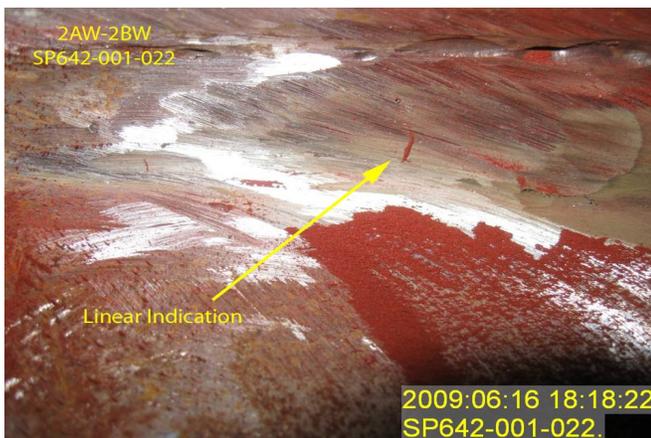
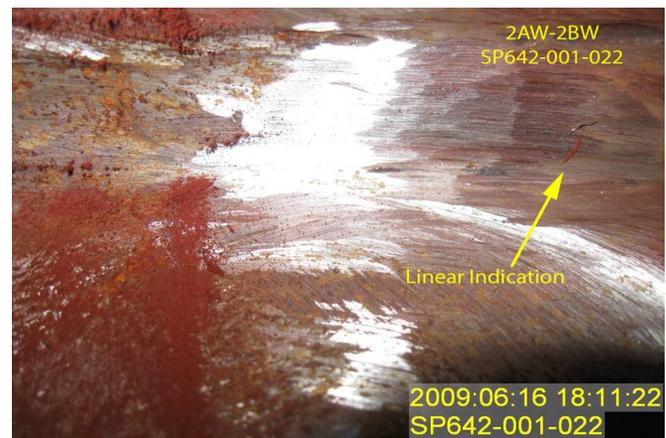
During random verification magnetic particle testing (MT) of weld SP642-001-022 (segment splice 2AW/2BW), Caltrans Quality Assurance (QA) Inspector discovered one linear indication measuring 10mm in length. This weld was previously MT tested and accepted by ZPMC Quality Control (QC) technicians (notification to perform QA Inspection for this weld was given to Caltrans on June 16, 2009).

AWS D1.5 (02) Section 6.26.2 – “Welds that are subject to MT in addition to visual inspection shall have no cracks.”

Perform repair to weld in question and submit required NDT verifying repair is in conformance with Contract requirements.
