QUALITY ASSURANCE -- NON-CONFORMANCE REPORT

Location: Changxing Island, Shanghai, P.R. China **Report No:** NCR-000326
Prime Contractor: American Bridge/Fluor Enterprises, a JV **Date:** 16-Jun-2009
Submitting Contractor: Zhenhua Port Machinery Company, Ltd (ZPMC), Changxing Island **NCR #:** ZPMC-0300

Reference Description: Missed UT Indications by QC, Welds SEG032D-007 and SEG033B-020, Segment 6CE

Job Name: SAS Superstructure

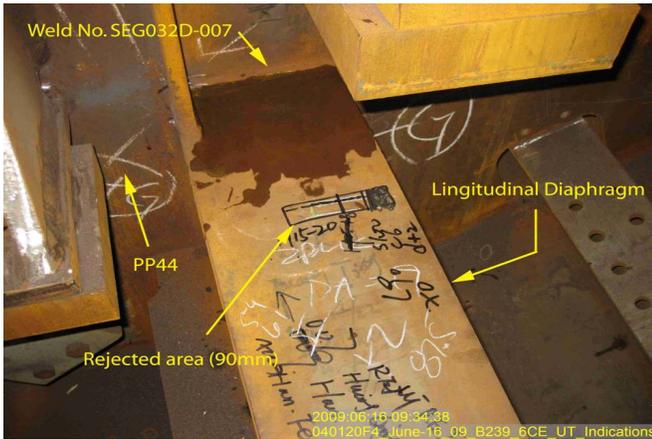
During random verification ultrasonic testing (UT) of longitudinal diaphragm to floor beam weld SEG032D-007 and side panel to bottom panel weld SEG033B-020, Caltrans Quality Assurance (QA) Inspector discovered two (2) rejectable indications measuring 90mm and 20mm in length respectively. These welds have been previously tested, rejected, and the repairs accepted, by ZPMC Quality Control (UT) Technicians.

Propose a resolution for the identified recurring non-conformance which constitutes a systematic problem on both materials/workmanship and quality control issues to remedy the defected work and with revised procedures to prevent future occurrences. A response for the resolution of this issue is expected within 14 days.

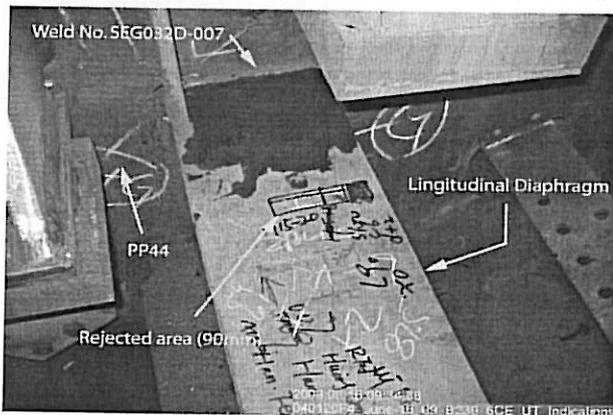
During random verification ultrasonic testing (UT) of longitudinal diaphragm to floor beam weld SEG032D-007 and side panel to bottom panel weld SEG033B-020, Caltrans Quality Assurance (QA) Inspector discovered two (2) rejectable indications measuring 90mm and 20mm in length respectively. These welds have been previously tested, rejected, and the repairs accepted, by ZPMC Quality Control (UT) Technicians.

Repair said indications and perform NDT required to verify weld quality

Contractor has submitted WRR used to perform repairs along with subsequent NDT reports verifying the welds are in conformance with Contract specifications. It shall be noted that weld ID referenced as SEF032B-020 above should have been referenced as SEG033B-020.

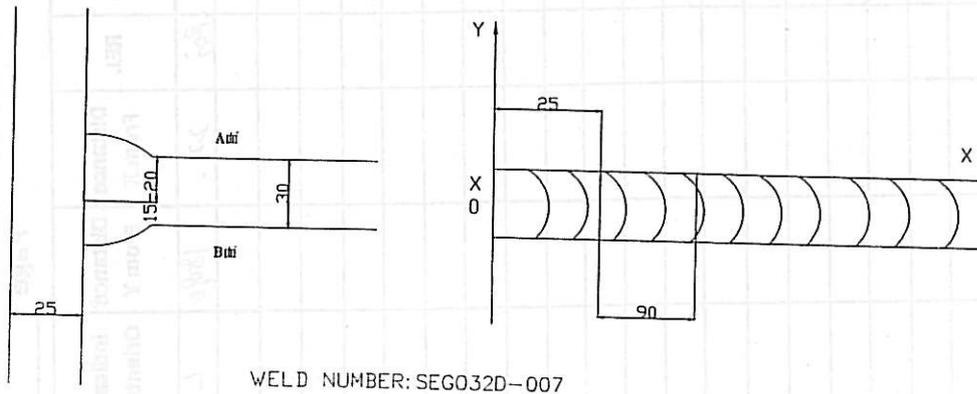
焊缝返修位置示意图:

Rejected indication found by ultrasonic inspection is less than the maximum allowance aggregate length.

(UT探伤发现的缺陷总长度小于最大允许长度。) SEG032D-007

- 1、焊道未及时处理干净。
- 1. Did not clear the weld pass completely in time.

- 1. 从缺陷距离端面较近一侧 ($D \leq 1/2T$, D为缺陷深度, T为板厚) 采用碳刨或打磨的方法去除焊缝缺陷;
 - 2. 参照返修焊接工艺规程 (WPS) 准备正确的接头型式, 预热和焊接;
 - 3. 若返修需要进行多道修补时, 需将前道焊缝清理干净并与周围焊缝平滑过渡再进行后续操作;
 - 4. 焊前对修补区域进行VT检测保证缺陷完全被消除;
 - 5. 将修补区域打磨到与母材或邻近焊缝平齐;
 - 6. 根据批准的车间图纸检查焊缝.
- 1. Gouge or grind from nearer side from metal edge ($D \leq 1/2T$, "D" is depth of defects, "T" is thickness of metal) to remove all defects;
 - 2. Follow repair WPS for joint preparation, preheat, and weld deposit;
 - 3. It is necessary to grind the above repair root welding cleaning and flush with the adjacence weld before go to next working procedure if the repair area need to be repaired by multiple pass.
 - 4. Verify with VT no defects remain in the weld joint prior to welding;
 - 5. Grind the repaired area flush with base metal or the adjacent weld;
 - 6. Check the welds according to the working drawings.

1. 加强焊接监控和道间清理.
1. Improve monitoring of welding and interpass cleaning.
