Contract #: 04-0120F4Cty: SF/ALA Rte: 80 PM: 13.2/13.9File #: 69.25B**QUALITY ASSURANCE -- NON-CONFORMANCE REPORT****Location:** Changxing Island, Shanghai, P.R. China**Report No:** NCR-000328**Prime Contractor:** American Bridge/Fluor Enterprises, a JV**Date:** 15-Jun-2009**Submitting Contractor:** Zhenhua Port Machinery Company, Ltd (ZPMC), Changxing Island**NCR #:** ZPMC-0302**Type of problem:****Welding****Concrete****Other****Welding****Curing****Procedural****Bridge No:** 34-0006**Joint fit-up****Coating****Other****Component:** OBG Segment Splice 2AW/2BW**Procedural****Procedural****Description:****Reference Description:** UT Over Painted Surfaces, 2AW/2BW Deck Panel Stiffener Splices**Description of Non-Conformance:**

**Job Name:** SAS Superstructure

**Reference Description:** UT Over Painted Surfaces, 2AW/2BW Deck Panel Stiffener Splices

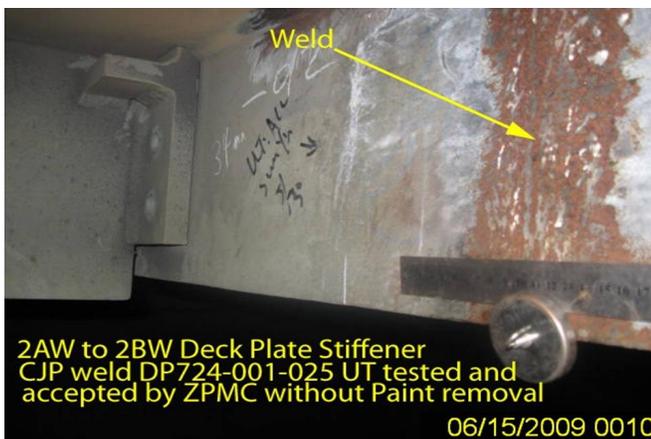
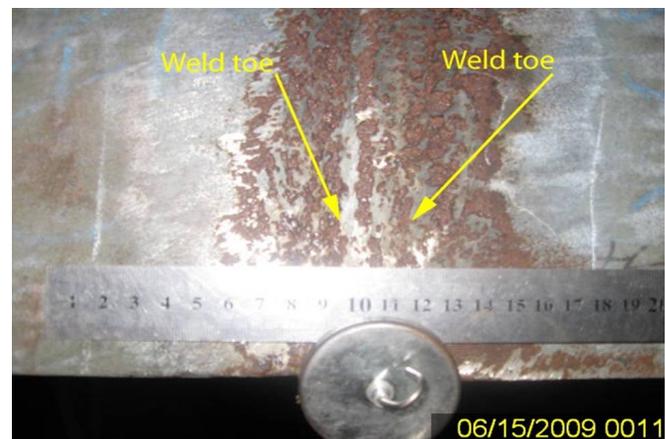
During ultrasonic testing (UT) verification of 2AW to 2BW stiffener complete joint penetration (CJP) welds (as requested in NDT Inspection Notification Sheet #003423), Caltrans Quality Assurance (QA) Inspector observed that weld DP724-001-025 and several adjacent welds were UT tested and accepted by ZPMC Quality Control (QC) without the removal of paint from the base metal for the full scanning distance surface area. The thicknesses of the stiffener base metal of the associated weld joints were 30mm and 35mm. These base metal thicknesses require 88mm and 102mm of scanning distance respectively. The paint was observed to only be removed from approximately 50 mm of the base metal surface both sides of weld centerline.

AWS D1.5 (02) Section 6.19.3 – “All surfaces to which a search unit is applied shall be free of weld spatter, dirt, grease, oil, paint, and loose scale and shall have a contour allowing intimate coupling.”

Propose a resolution for the identified non-conformance with revised procedures to prevent future occurrences.

建议: 打磨到一定的扫查距离,重新UT.  
Grind and do UT again.

ZPMC has issued instructions to NDT technicians not to perform Ultrasonic Testing over painted welds and has submitted documentation verifying the the welds are in conformance.
