QUALITY ASSURANCE -- NON-CONFORMANCE REPORT

Report No: NCR-000333

Reference Description: Missed MT Indications After Heat Straightening Longitudinal Diaphragms, Segment Splice 4AE/4BE

Job Name: SAS Superstructure

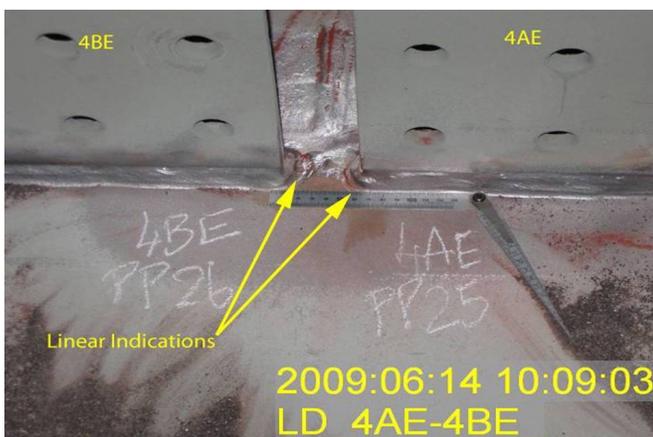
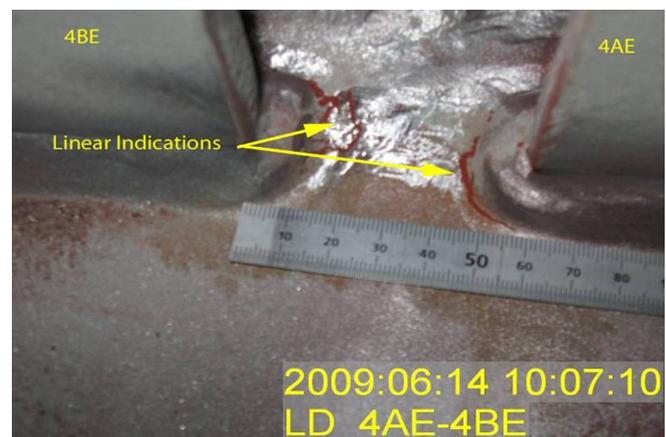
During random verification magnetic particle testing (MT) of longitudinal diaphragm welds SEG020B-008 and SEG018C-026 (4AE/4BE segment splice, bike path side), Caltrans Quality Assurance (QA) Inspector observed two linear indications measuring 20mm and 30mm in length respectively. These welds were earlier subjected to multiple heat straightening cycles to correct alignment and distortion. One hundred percent (100%) of the affected welds were MT tested and accepted by ZPMC Quality Control (QC) technicians after heat straightening. ZPMC provided Caltrans a notification to perform QA inspections for these welds on June 13, 2009 which indicated ZPMC's acceptance of the associated welds.

WQCP Section 11.2.5.1: "Final NDT shall be performed after heat straightening."

AWS D1.5 (02) Section 6.26.2 – "Welds that are subject to MT in addition to visual inspection shall have no cracks."

The proposed resolution is not acceptable. The heat straightening report and MT reports were submitted. However, repairs must be performed in the areas where defects were documented in the Non-Conformance report.

Please submit the Critical Weld Repair report and the follow-up Non-Destructive Testing reports showing that the repairs were acceptable. The Department will review the Contractor's proposal to close Non-Conformance ZPMC-0307 at that time.

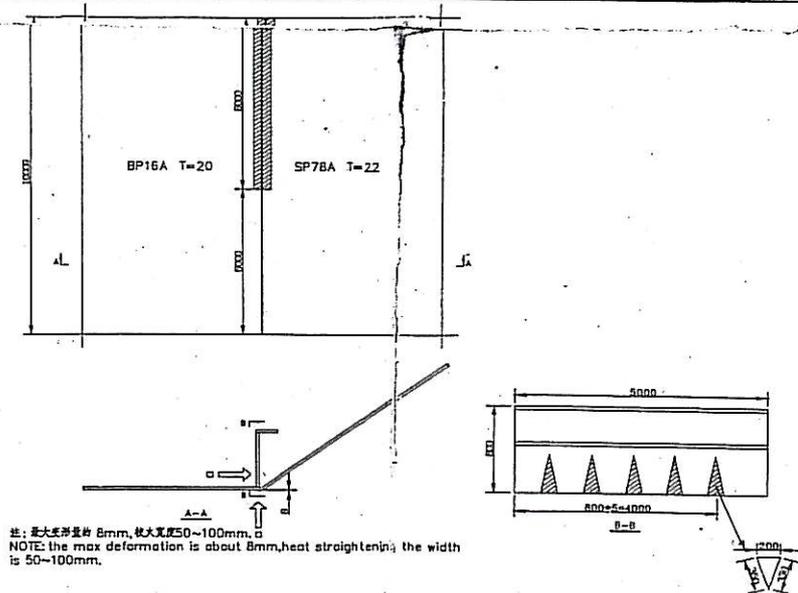
简图 Sketch

情况描述 Description of Condition

Cause原因 Welding distortion 焊接变形

Type of Defect缺陷类型 Welding distortion 焊接变形

缺陷去除方法(Defect Removal Method): Flame Straightening by oxygen acetylene 运用氧乙炔进行校火

后续NDE(Post-Removal NDE): After finishing heat straightening, the weld of the heat area shall perform NDT according to the approved shop drawing 校火后, 根据图纸要求对热影响区域进行 NDT 检测。

纠正措施(Corrective Action(s)): Control current, voltage and weld speed according to relevant WPS. If necessary anti-deformation or hold down device can be added. 依据相应的WPS的要求控制电流, 电压和焊接速度。如有必要, 可使用反变形设施进行校正。

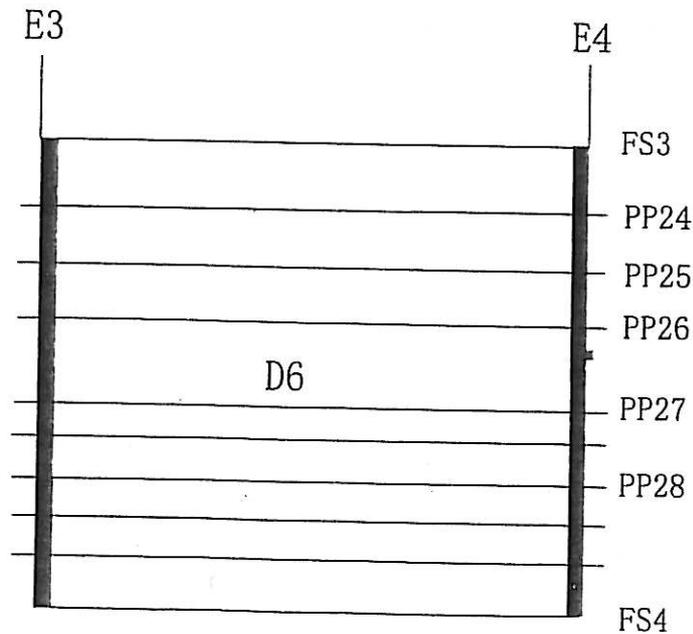
Draft of welding discontinuity:

One line indication was found by use of MT on weld SEG020B-008. L=20 Y=0

One line indication was found by use of MT on weld SEG018C-026. L=30 Y=0

1. 焊道未及时处理干净。
1. Did not clear the weld pass completely in time.

1. 按照焊接返修工艺规程 (WPS) 打磨缺陷区域;
 2. 按照返修WPS准备焊接破口;
 3. 返修前对进行返修的区域作100%MT检查, 确保缺陷全部去除;
 4. 根据批准的焊接返修工艺规程 (WPS) 进行预热及焊接;
 5. 将焊接区域打磨至与周围母材平齐;
 6. 对修补区域进行VT与MT检测;
-
1. Remove all the defects according to the approved repair WPS by means of grinding.
 2. Prepare a groove based on the repair WPS.
 3. Verify with MT and VT no defects remain in the repair area prior to welding;
 4. Preheat and weld according to the relevant WPS.
 5. Grind the weld flush with adjacent base metal after welding.
 6. Perform VT and MT inspection to the repaired area.

1. Improve monitoring of welding and interpass cleaning.

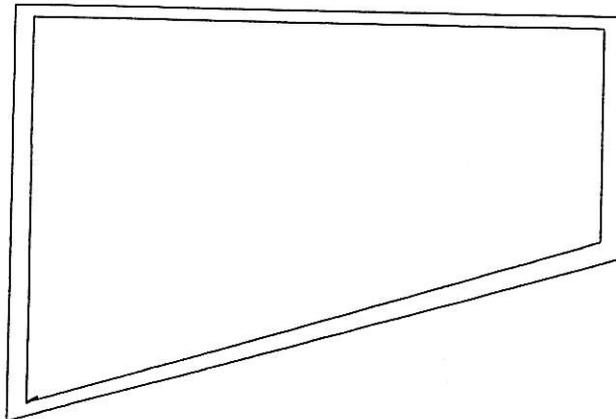
Draft of welding discontinuity:

We found one line indication in material after removed tack welding PL1A. L=10 Y=0

1. 按照焊接返修工艺规程 (WPS) 打磨缺陷区域;
 2. 按照返修WPS准备焊接破口;
 3. 返修前对进行返修的区域作100%MT检查, 确保缺陷全部去除;
 4. 根据批准的焊接返修工艺规程 (WPS) 进行预热及焊接;
 5. 将焊接区域打磨至与周围母材平齐;
 6. 对修补区域进行VT与MT检测;
1. Remove all the defects according to the approved repair WPS by means of grinding.
 2. Prepare a groove based on the repair WPS.
 3. Verify with MT and VT no defects remain in the repair area prior to welding;
 4. Preheat and weld according to the relevant WPS.
 5. Grind the weld flush with adjacent base metal after welding.
 6. Perform VT and MT inspection to the repaired area.
