QUALITY ASSURANCE -- NON-CONFORMANCE REPORT

Report No: NCR-000334

Reference Description: Missed linear indication on West Tower, Lift 1, 43m diaphragm to fit-lug weld

To:	AMERICAN BRIDGE/FLUOR, A JV 375 BURMA ROAD OAKLAND CA 95607	Date:	22-Jun-2009
Dear:	Mr. Charles Kanapicki	Contract No:	04-0120F4 04-SF-80-13.2 / 13.9
Attention:	Mr. Thomas Nilsson Project/Fabrication Manager	Job Name:	SAS Superstructure
Subject:	NCR No. ZPMC-0308	Document No:	05.03.06-000287

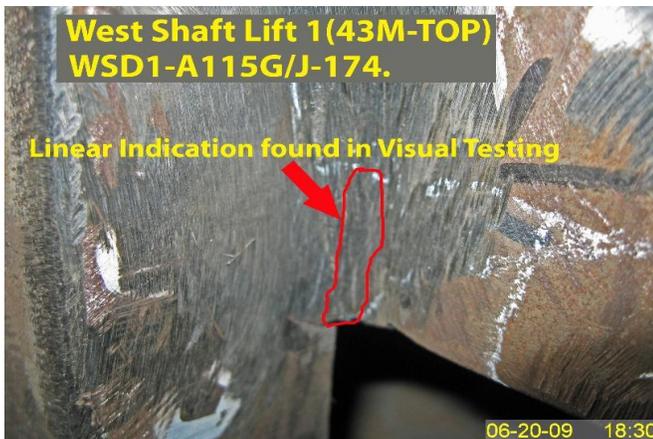
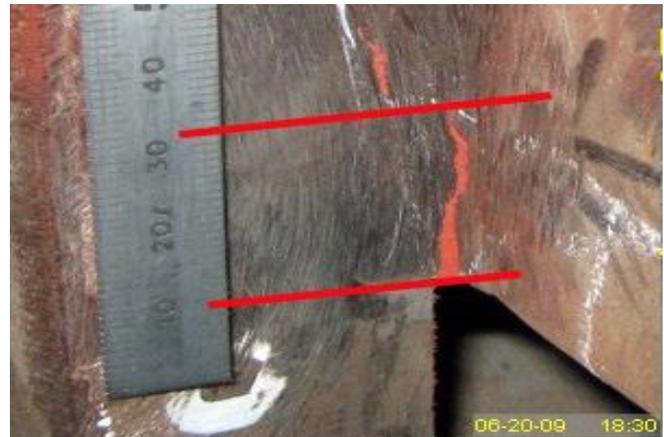
During random verification Visual Inspection of West Tower, Lift 1, QA discovered a linear indication on 43m diaphragm to fit-lug weld WSD1-A115G/J-174. This weld was previously accepted by ZPMC QC personnel.

AWS D1.5-2002, Section 6.26.2 – “Welds that are subject to MT in addition to visual inspection shall have no cracks.”

We ZPMC give the notification 3481 for the FINAL VT WORK, but CT people Amit K.Juvekar verify with the MT machine to make sure it is a crack, at evening about the 20:30 with the CT people Umesh Gaikwad witness we removed the crack ,and he also did the MT work himself to make sure remove the crack. About the crack we just grinded and removed the crack didn't do the welding repair work.

The linear indication was completely removed by grinding. The weld has been verified by QA.
