Contract #: 04-0120F4Cty: SF/ALA Rte: 80 PM: 13.2/13.9File #: 69.25B**QUALITY ASSURANCE -- NON-CONFORMANCE REPORT****Location:** Changxing Island, Shanghai, PRC**Report No:** NCR-000336**Prime Contractor:** American Bridge/Fluor Enterprises, a JV**Date:** 29-Jun-2009**Submitting Contractor:** Zhenhua Port Machinery Company, Ltd (ZPMC), Changxing Island**NCR #:** ZPMC-0310**Type of problem:**

**Reference Description:** Base metal gouges in East Tower, Lift 4, Skin Plate E to aid longitudinal stiffener fit-up**Description of Non-Conformance:**

**Report No:** NCR-000336

**Reference Description:** Base metal gouges in East Tower, Lift 4, Skin Plate E to aid longitudinal stiffener fit-up

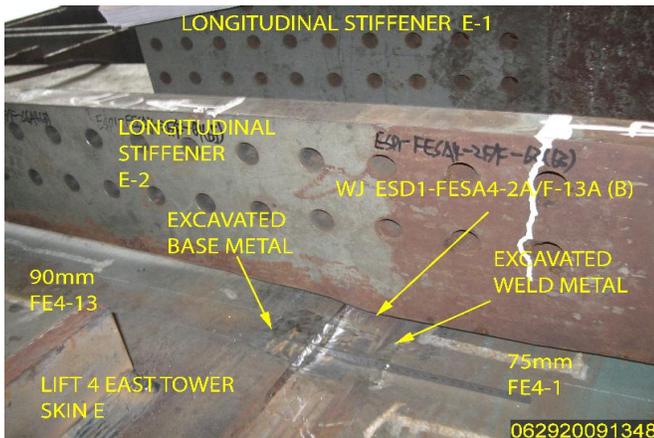
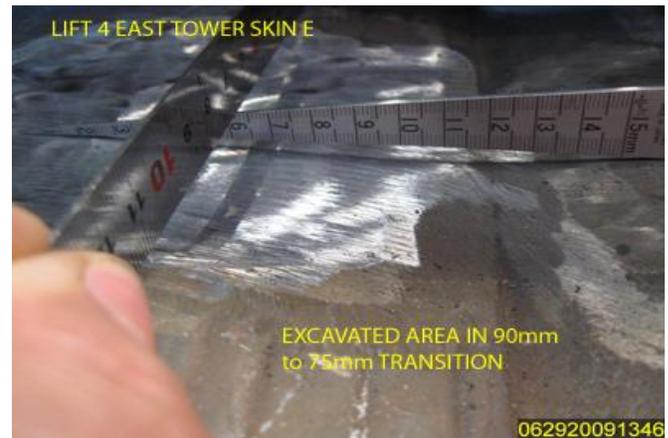
During in-process inspection of Lift 4, East Tower, Skin E, QA randomly observed two excavations at weld joint ESD1-FESA4-2A/F-13A(B) between 90mm plate FE4-13 and 75mm plate FE4-1. The excavations were made in the base and weld metals to allow for fit up of Longitudinal Stiffeners E1 and E2 to Skin Plate E. The repair procedure was not submitted nor approved by the Engineer at the time of repair.

While a CWR has been received subsequent to verbal notification of the occurrence, propose a resolution for the identified non-conformance that addresses both the procedures to minimize the repairs of the base metal and the corrective actions to be taken to ensure that the repairs performed are in compliance with the contract documents.

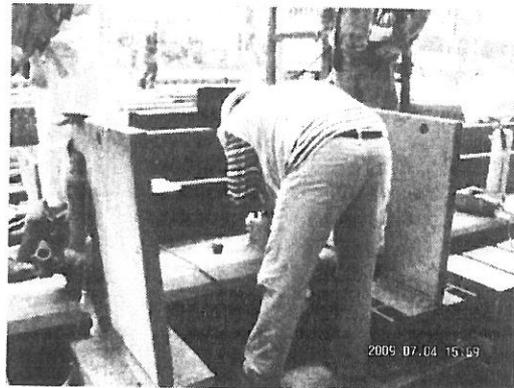
**NDT INSPECTION NOTIFICATION SHEET 3590**

About this situation Charles Franco found this problem, and then we issued the T-CWI171 approved by the CT engineer, and we did the MT and UT work about the repair work. And the CT inspector Baskar did the inspection about the MT and the UT work (see attachment photos) to make sure no problem.

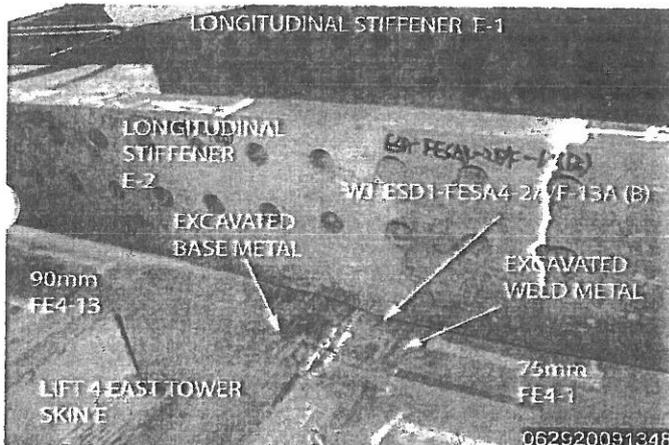
During in-process inspection of Lift 4, East Tower, Skin E, QA randomly observed two excavations at weld joint ESD1-FESA4-2A/F-13A(B) between 90mm plate FE4-13 and 75mm plate FE4-1. The excavations were made in the base and weld metals to allow for fit up of Longitudinal Stiffeners E1 and E2 to Skin Plate E. The repair procedure was not submitted nor approved by the Engineer at the time of repair.

While a CWR has been received subsequent to verbal notification of the occurrence, propose a resolution for the identified non-conformance that addresses both the procedures to minimize the repairs of the base metal and the corrective actions to be taken to ensure that the repairs performed are in compliance with the contract documents.

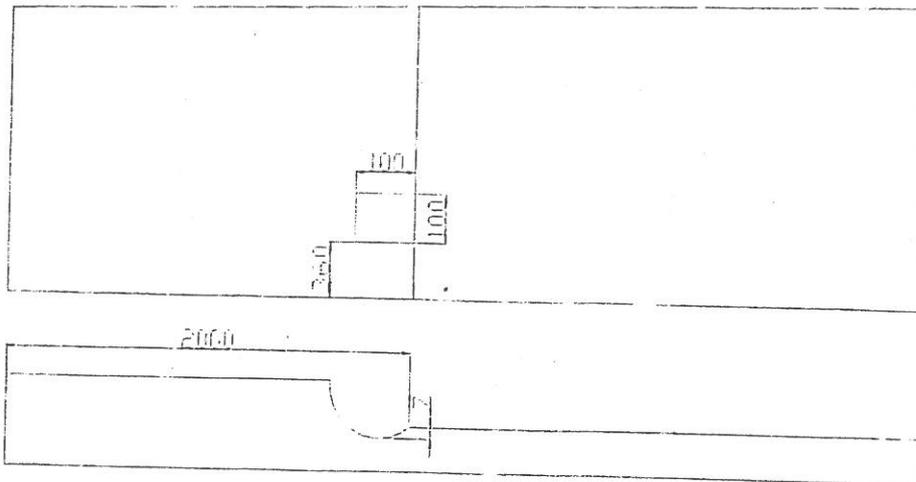
Draft of Welding Discontinuity:

东塔第四吊装段E面板，在装配纵向筋时，焊缝打磨过度造成母材损伤，经测量最大处深度为7MM。见照片示意图。

阴影部分为割伤区域。Gouged area in shadow.

During grinding excavation, the grinder operated error caused base metal gouged.

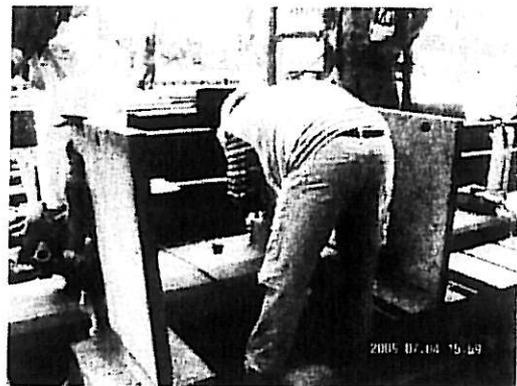
**NDT INSPECTION NOTIFICATION SHEET 3590**

About this situation Charles Franco found this problem, and then we issued the T-CWI171 approved by the CT engineer, and we did the MT and UT work about the repair work.And the CT inspector Baskar did the inspection about the MT and the UT work (see attachment photos)to make sure no problem.

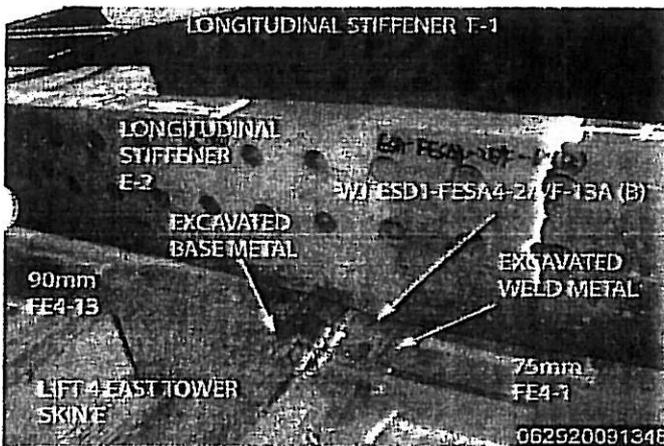
During in-process inspection of Lift 4, East Tower, Skin E, QA randomly observed two excavations at weld joint ESD1-FESA4-2A/F-13A(B) between 90mm plate FE4-13 and 75mm plate FE4-1. The excavations were made in the base and weld metals to allow for fit up of Longitudinal Stiffeners E1 and E2 to Skin Plate E. The repair procedure was not submitted nor approved by the Engineer at the time of repair.

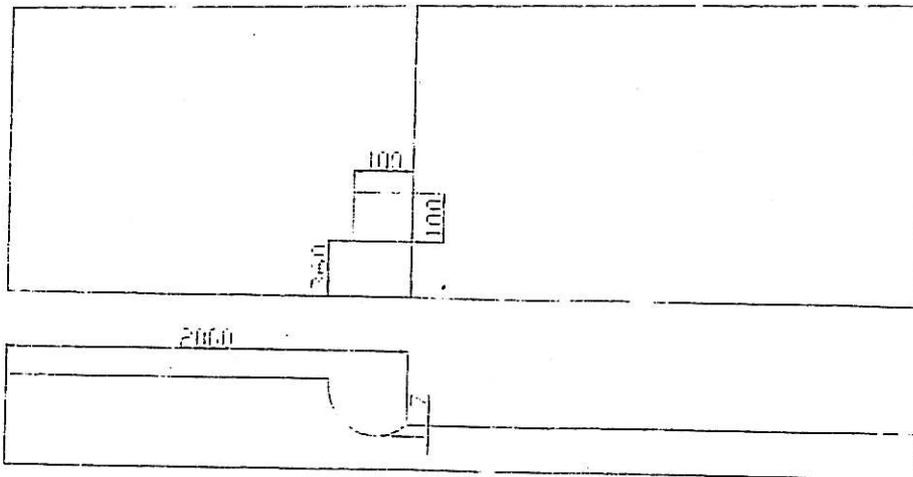
#### Draft of Welding Discontinuity:

东塔第四吊装段E面板，在装配纵向筋时，焊缝打磨过度造成母材损伤，经测量最大处深度为7MM。见照片示意图。

阴影部分为割伤区域。Gouged area in shadow.

During grinding excavation, the grinder operated error caused base metal gouged.

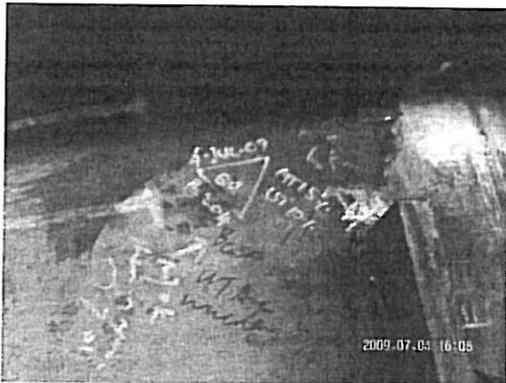
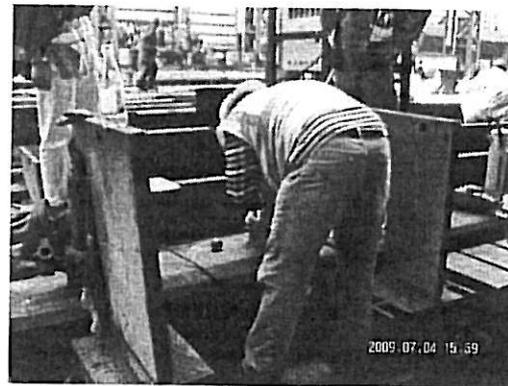
T-CWR171

2、 We issued the T-CWI171 approved by the CT engineer, and we did the MT and UT work about the repair work. And the CT inspector Baskar did the inspection about the MT and the UT work (see attachment photos) to make sure no problem.

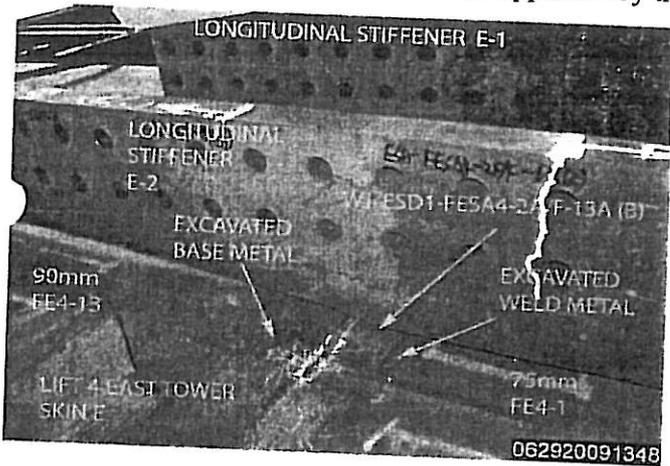
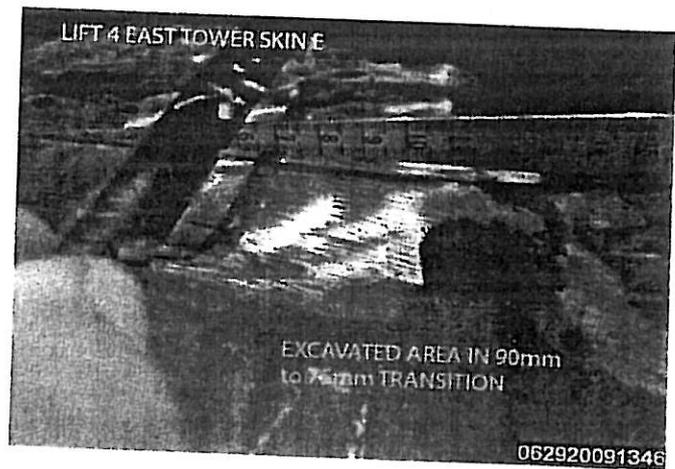
During in-process inspection of Lift 4, East Tower, Skin E, QA randomly observed two excavations at weld joint ESD1-FESA4-2A/F-13A(B) between 90mm plate FE4-13 and 75mm plate FE4-1. The excavations were made in the base and weld metals to allow for fit up of Longitudinal Stiffeners E1 and E2 to Skin Plate E. The repair procedure was not submitted nor approved by the Engineer at the time of repair.

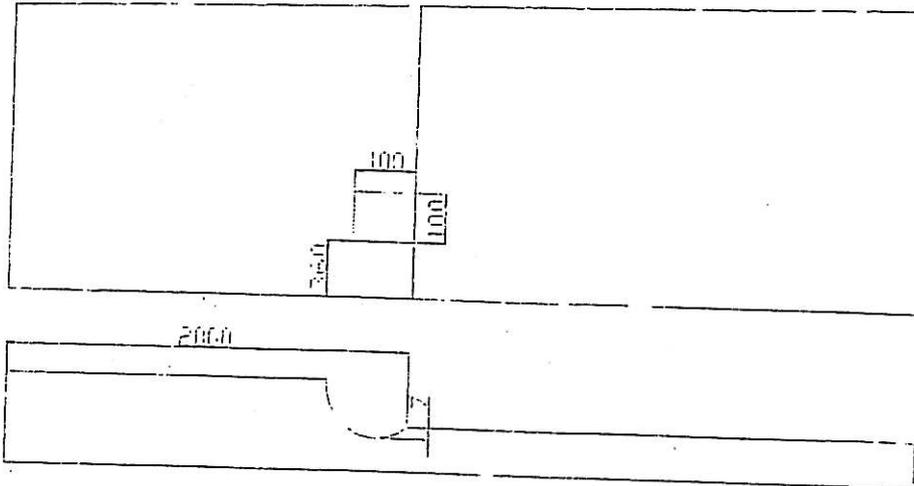
Draft of Welding Discontinuity:

东塔第四吊装段E面板，在装配纵向筋时，焊缝打磨过度造成母材损伤，经测量最大处深度为7MM。见照片示意图。

阴影部分为割伤区域。Gouged area in shadow.

During grinding excavation, the grinder operated error caused base metal gouged.
