Contract #: 04-0120F4  
 Cty: SF/ALA Rte: 80 PM: 13.2/13.9  
 File #: 69.25B

**QUALITY ASSURANCE -- NON-CONFORMANCE REPORT**

**Location:** Changxing Island, Shanghai, P.R. China **Report No:** NCR-000337  
**Prime Contractor:** American Bridge/Fluor Enterprises, a JV **Date:** 24-Jun-2009  
**Submitting Contractor:** Zhenhua Port Machinery Company, Ltd (ZPMC), Changxing Island **NCR #:** ZPMC-0311

**Reference Description:** MEP Removal, DP47A, Segment 4BW

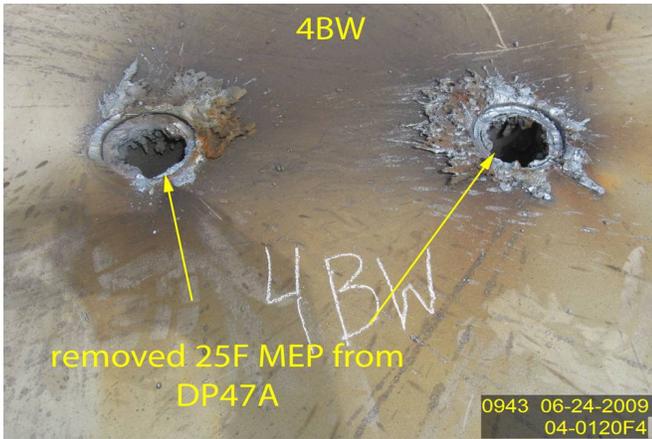
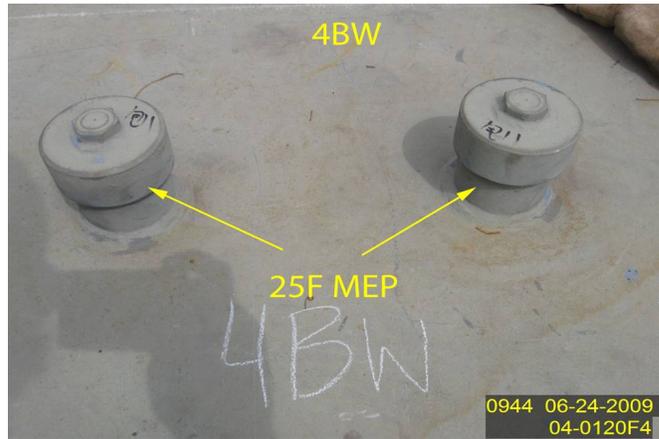
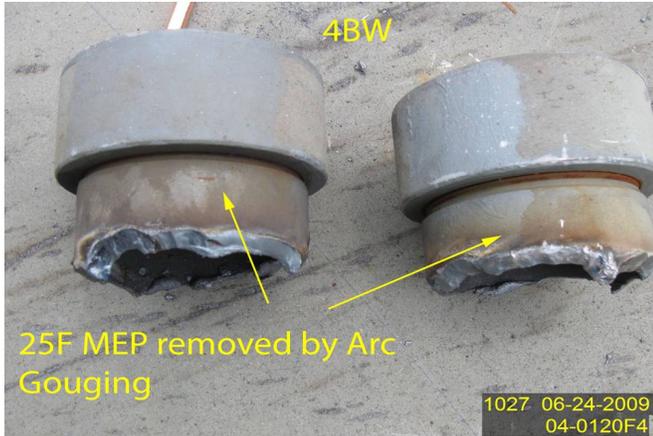
Caltrans Quality Assurance Inspector observed four (4) 25F MEP threaded penetrations being removed on Segment 4BW at DP47A by carbon arc air gouging the weld. The contractor failed to notify the engineer prior to removing the welds and the MEP pipe sleeves. The removal is not necessary as the previously approved RFI indicated that the current installed MEPs are acceptable.

AWS D1.5 2002, Section 3.7.5 Repairs: “The Engineer shall be notified before improperly fitted and welded members are cut apart”

Propose a resolution for the identified non-conformance with revised procedures to ensure that the base metal was not damaged and prevent future occurrences.

The proposed resolution is acceptable. The welding repair report is included, and the welds in question have been accepted by VT and MT as shown in the attached documents. The Department concurs that Non-Conformance ZPMC-0311 is closed.

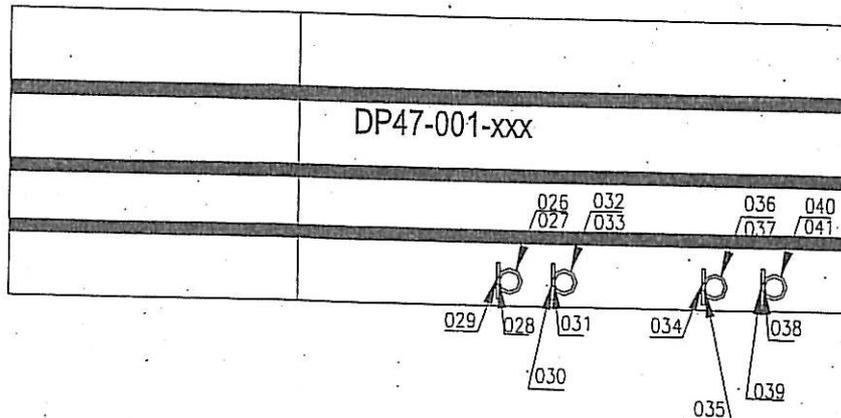
4AW/4BW顶板DP47A上的MEP管装错, 25C装配成25F, PP26-PP28四处(南侧), 现需要刨除。

MEP pipe was assembly error at 4AW/4BW deck plate DP47A; 25c assembly error as 25F, relevant four position form PP26 to PP28 at south side.

Worker didn't review drawing carefully caused assembly error.

1. Remove the MEP pipe by the way of gouging or Oxygen cutting, preheat according to the WPS prior to gouging . do not gouge the base metal.
2. Perform 100%VT inspection of the repaired area.
3. Afresh install MEP pipe , , preheat and weld according to the relevant WPS.
4. Perform VT,MT and UT inspections after welding.
5. Grind and blend the repaired area flush with base metal and adjacent weld.
6. Check the welds according to the working drawings.
