QUALITY ASSURANCE -- NON-CONFORMANCE REPORT

Report No: NCR-000339

Reference Description: Excessive Root Opening

Job Name: SAS Superstructure

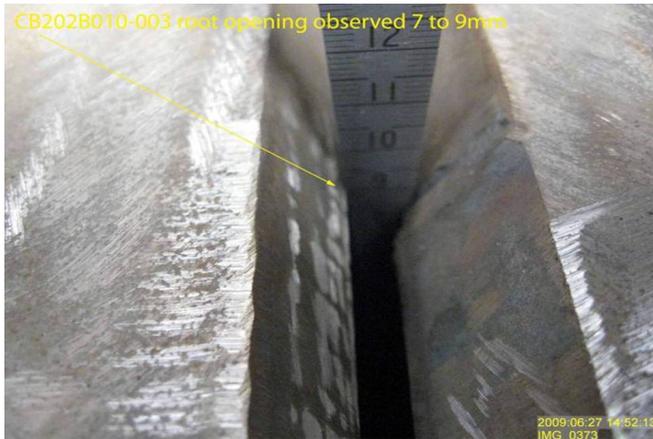
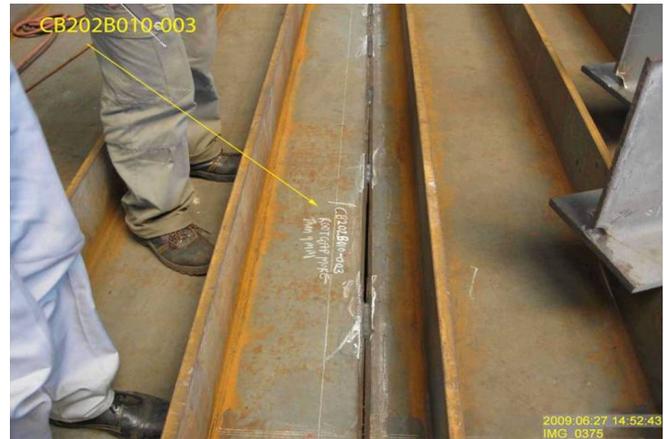
During random in-process visual inspection of Crossbeam CB10 Deck panel in Bay # 3, Caltrans Quality Assurance (QA) Inspector observed the root opening of weld CB202B010-003 to measure from 7mm to 9mm. This joint has been tack welded into position. This root opening exceeds the tolerances specified in the specified WPS and AWS D1.5 2002 requirement.

AWS D1.5 2002 section 3, paragraph 3.3.2.1 "The root opening between part shall not exceed 5mm except in cases involving rolled shapes or plate 75mm or greater in thickness if after straightening and in assembly, the root opening cannot be closed sufficiently to meet this tolerance. In such cases, a maximum root opening of 8mm may be used with backing weld and the final weld meet the requirement for the size.

Reference Resolution: ZPMC has since corrected this condition, welded and inspected this connection. ZPMC will submit the inspection reports at a later date to close this NCR.

Butter plates to bring the root opening into compliance with Contract specifications and perform required NDT.

Contractor submitted WRR confirming the root opening was brought into compliance prior to being welded along with NDT documentation verifying the added base material is in conformance with Contract specifications.

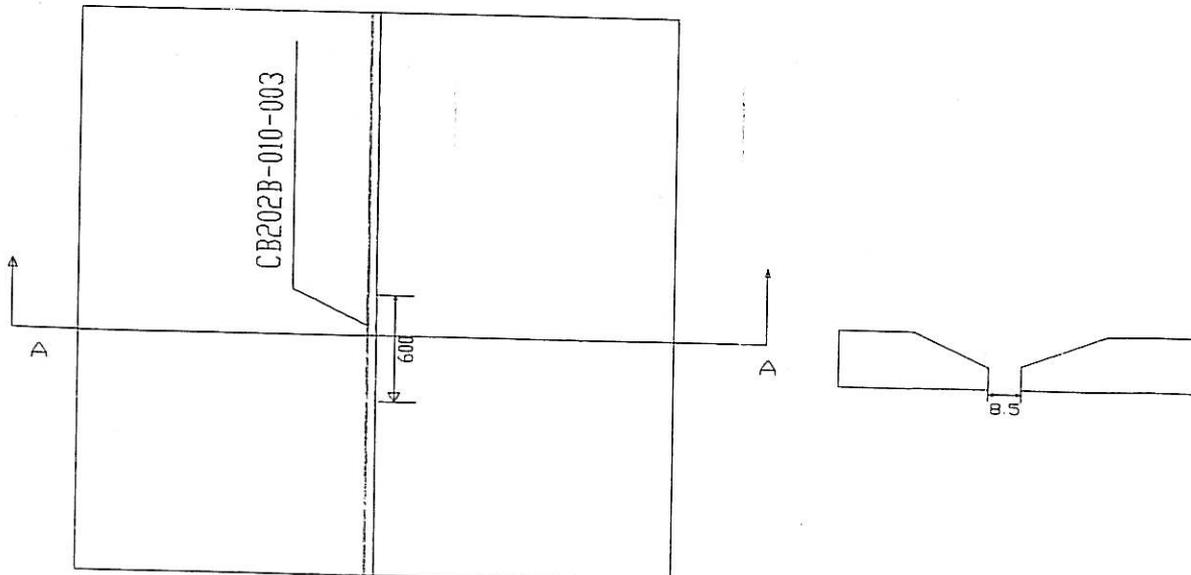
Draft of welding discontinuity:

The gap was 7-9mm at CB10 weld CB202B-010-003 after tack weld, which fabricated by work team: Shi Jiangan.

Weld distortion and fabricate error.

1. Grind the edge of the repair area cleanly;
2. Prepare an right joint according to the approved WPS;
3. Perform 100%VT and 100%MT, and add ceramic backing according to the attached drawing g 1 and AWS D1.5.3.13;
4. Preheat and weld according to the approved repair WPS;
5. Gouge off the ceramic backing after the gap meet the requirement of drawing at then grind the weld flush with adjacent weld or base metal after welding;
6. Perform VT and MT to the repair area according to these working drawings.
