Contract #: 04-0120F4
 Cty: SF/ALA Rte: 80 PM: 13.2/13.9
 File #: 69.25B

QUALITY ASSURANCE -- NON-CONFORMANCE REPORT

Report No: NCR-000340

Reference Description: Missed UT indications by QC

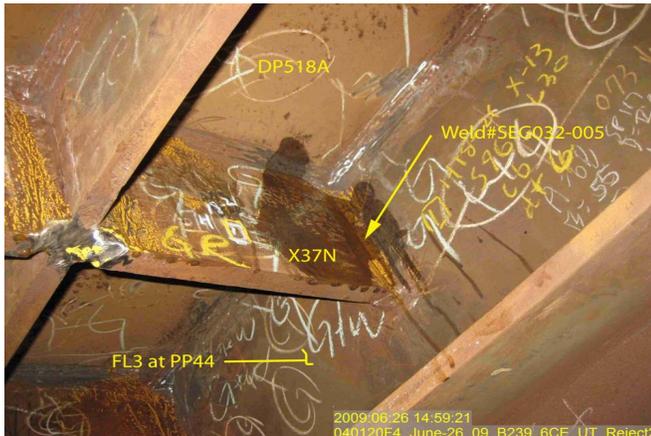
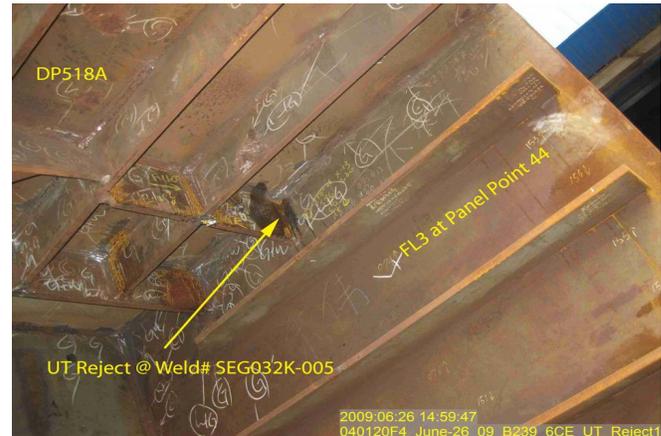
During random verification Ultrasonic Testing (UT) of the X37N longitudinal under Deck Stiffener plate to FL3 Floor Beam at Panel Point 44 and Deck Plate 518A splice weld to Deck Plate 302A. Caltrans Quality Assurance (QA) Inspector discovered a total of (2) two rejectable defects of up to 35mm in length by UT. The weld designations are as follows; SEG032*-032 (Deck Splice) and SEG032K-005 (Stiffener). These welds have been previously tested, rejected and the repairs accepted by ZPMC Quality Control (UT) Technicians.

Reference Resolution: ABF has notified ZPMC of this nonconformance and instructed the same UT operator to recheck this weld. ABF has discussed UT technique issues with ZPMC to prevent further nonconformances.

ABF has notified ZPMC of this nonconformance and instructed the same UT operator to recheck this weld. The UT operator verified the indication was an unacceptable Class "A" indication and has since marked the part for repair. ABF has discussed UT technique issues with ZPMC to prevent further nonconformances. ZPMC will submit repair reports at a later date to close this NCR.

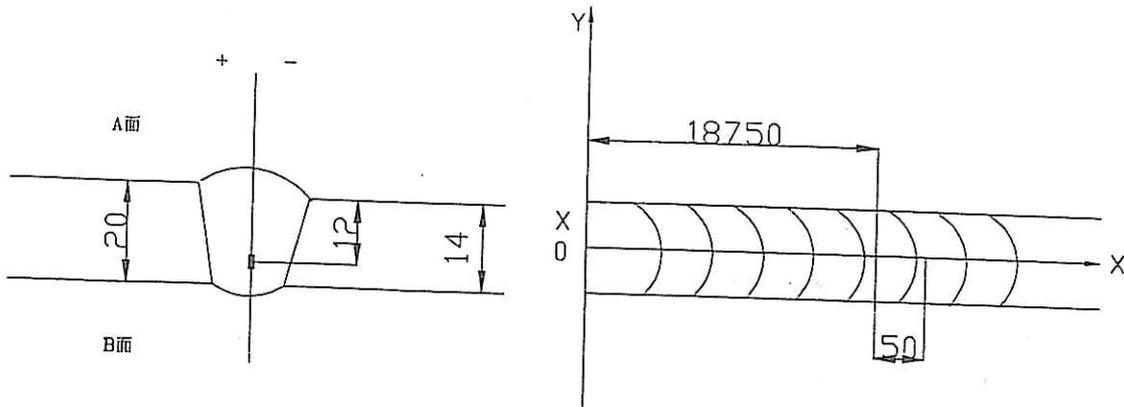
WELD NUMBER: SEG032*-032

Rejected indication found by ultrasonic inspection is less than the maximum allowance aggregate length.

1. 焊道未及时处理干净。
1. Did not clear the weld pass completely in time.

1. 从缺陷距离端面较近一侧 ($D \leq 0.65T$, D为缺陷深度, T为板厚) 采用碳刨或打磨的方法去除焊缝缺陷;
 2. 参照返修焊接工艺规程 (WPS) 准备正确的接头型式, 预热和焊接;
 3. 焊前对修补区域进行VT检测保证缺陷完全被清除;
 4. 将修补区域打磨到与母材或邻近焊缝平齐;
 5. 根据批准的车间图纸检查焊缝.
-
1. Gouge or grind from nearer side from metal edge ($D \leq 0.65T$, "D" is depth of defects, "T" is thickness of metal) to remove all defects;
 2. Follow repair WPS for joint preparation, preheat, and weld deposit;
 3. Verify with VT no defects remain in the weld joint prior to welding;
 4. Grind the repaired area flush with base metal or the adjacent weld;
 5. Check the welds according to the working drawings.

1. Improve monitoring of welding and interpass cleaning.

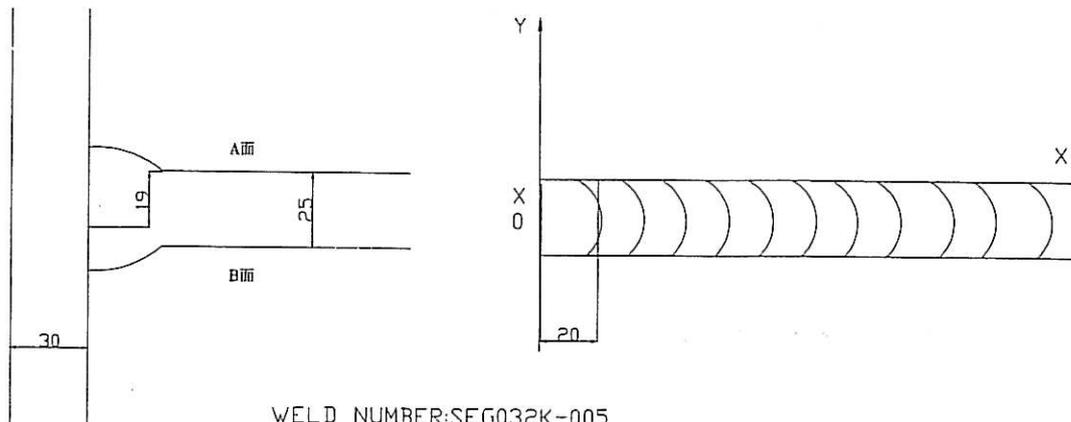
(UT探伤发现的缺陷总长度小于最大允许长度。) SEG032K-005

Rejected indication found by ultrasonic inspection is less than the maximum allowance aggregate length.

1. Did not clear the weld pass completely in time.

1. Gouge or grind from nearer side from metal edge ($D \leq 0.65T$, "D" is depth of defects, "T" is thickness of metal) to remove all defects;
2. Follow repair WPS for joint preparation, preheat, and weld deposit;
3. Verify with VT no defects remain in the weld joint prior to welding;
4. Grind the repaired area flush with base metal or the adjacent weld;
5. Check the welds according to the working drawings.

- 加强焊接监控和道间清理。
- Improve monitoring of welding and interpass cleaning.
