Contract #: 04-0120F4Cty: SF/ALA Rte: 80 PM: 13.2/13.9File #: 69.25B**QUALITY ASSURANCE -- NON-CONFORMANCE REPORT****Location:** Changxing Island, Shanghai, P.R. China**Report No:** NCR-000341**Prime Contractor:** American Bridge/Fluor Enterprises, a JV**Date:** 24-Jun-2009**Submitting Contractor:** Zhenhua Port Machinery Company, Ltd (ZPMC), Changxing Island**NCR #:** ZPMC-0315**Type of problem:**

Reference Description: CJP welds replaced with fillet at repair locations prior to engineer's approval**Description of Non-Conformance:**

NON-CONFORMANCE REPORT TRANSMITTAL

Subject: NCR No. ZPMC-0315

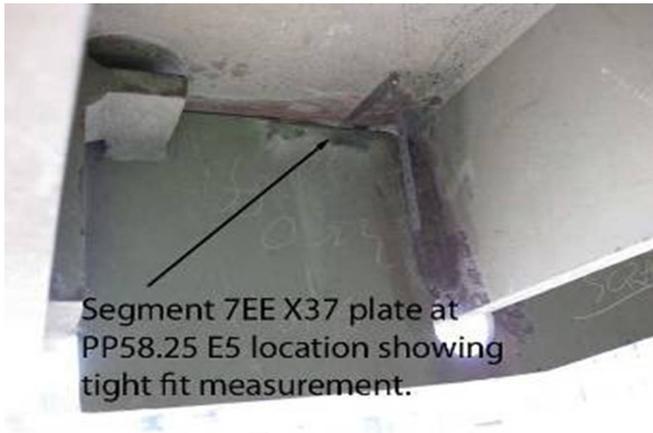
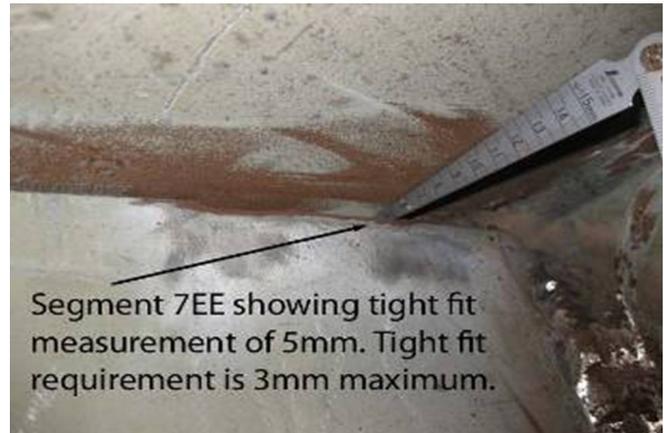
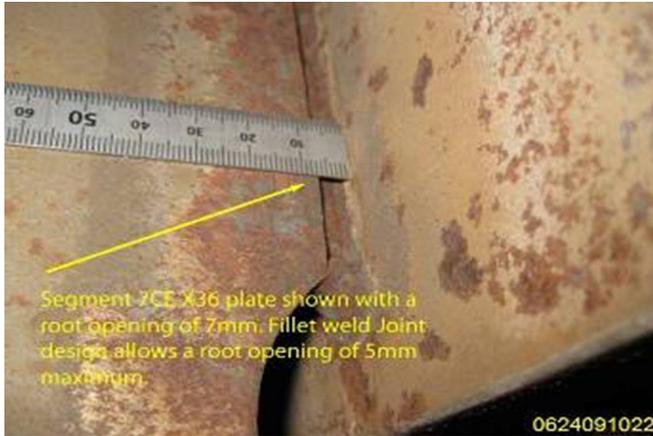
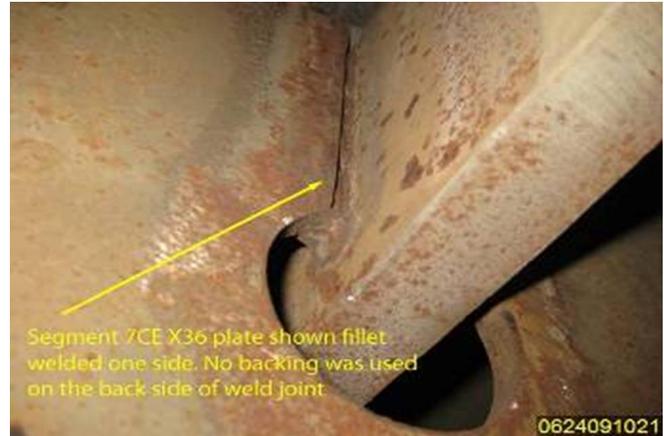
1. Segment 7CE plate X36 at panel point 54.5 fillet weld joints 97 & 98 at E2 location, a fillet weld was discovered welded from the weld joint 97 side only leaving the weld joint 98 exposed. The weld prep of the fillet weld joint # 98 revealed a root opening of 7mm. Maximum allowed root opening for a fillet weld is 5mm. Applicable reference listed as # 1 below.

2. X37A Stiffeners require a tight fit (= 2mm) per approved shop drawing X37A. The X37A stiffener locations listed in the table below were found to have a dimension greater than 2mm. Applicable reference listed as # 1 below.

3. Weld locations listed in the table below require a fillet weld per approved shop drawings. ZPMC has changed said welds to complete joint penetration welds due to root opening in excess of specified maximum root opening of 5mm. Applicable reference listed as # 1 below.

4. Corner assembly and Segment drawings list weld specifications for all locations. All welds on corner assemblies have been wrapped when approved drawings do not show any wrapping required. Applicable reference listed as # 3 below.

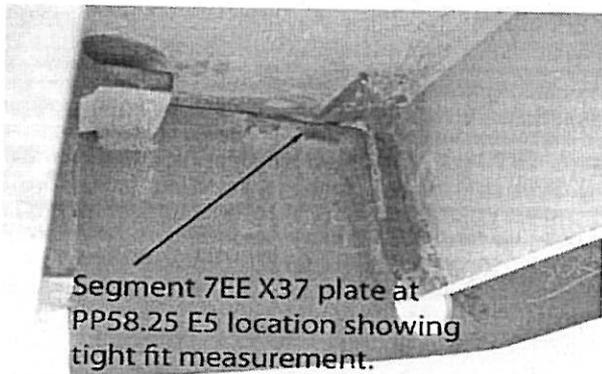
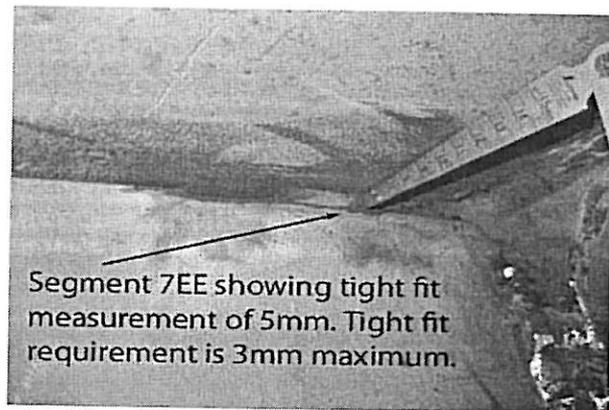
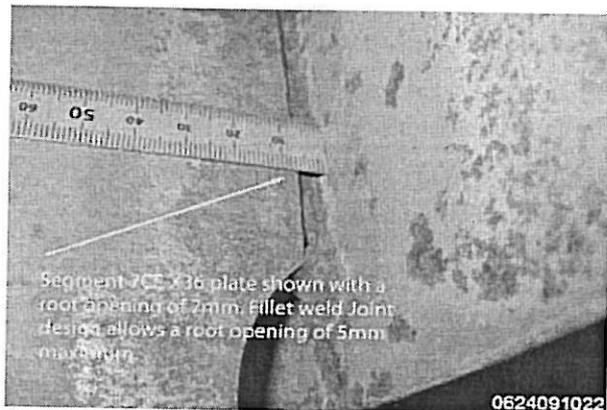
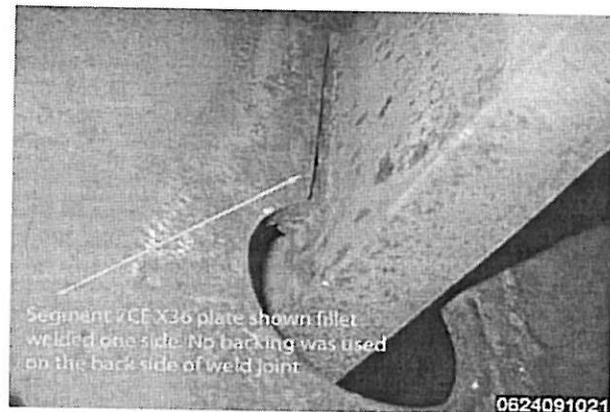
2. X37A Stiffeners require a tight fit (= 2mm) per approved shop drawing X37A. The X37A stiffener locations listed in the table below were found to have a dimension greater than 2mm. Applicable reference listed as # 1 below.

4. Corner assembly and Segment drawings list weld specifications for all locations. All welds on corner assemblies have been wrapped when approved drawings do not show any wrapping required. Applicable reference listed as # 3 below.
