Contract #: 04-0120F4
 Cty: SF/ALA Rte: 80 PM: 13.2/13.9
 File #: 69.25B

QUALITY ASSURANCE -- NON-CONFORMANCE REPORT

Location: Changxing Island, Shanghai, PRC **Report No:** NCR-000344
Prime Contractor: American Bridge/Fluor Enterprises, a JV **Date:** 11-Jul-2009
Submitting Contractor: Zhenhua Port Machinery Company, Ltd (ZPMC), Changxing Island **NCR #:** ZPMC-0318

Reference Description: Missed MT indication on West Tower, Lift 1, Skin B Doubler Plate

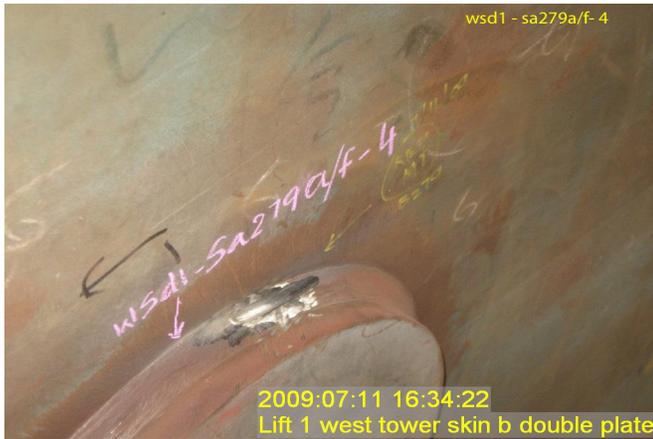
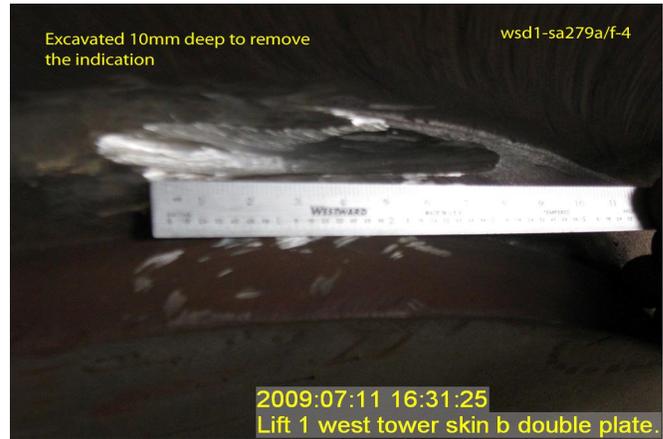
During Magnetic Particle Testing (MT) of West Tower, Lift 1, Skin B doubler plate weld joint WSD1-SA279A/F-4, QA discovered one (1) round indication. ZPMC personnel excavated approximately 10mm deep for complete removal. This weld was previously tested and accepted by ZPMC QC MT technicians.

AWS D1.5-2002, Section 3.7.2.3 – “Excessive Weld Porosity - Unacceptable portions shall be removed and rewelded.”

Propose a resolution for this systematic non-conformance that addresses the failure of Quality Control to identify the indication (MT). Provide documentation of the steps/actions being taken by the Quality Control Manager to prevent future occurrences and the cause of the continuing failure to identify indications with Magnetic Particle Testing (MT).

The affected weld has been repaired and a NDT report indicating sound welds has been submitted. The weld has been verified by QA and green tagged.
