Contract #: 04-0120F4Cty: SF/ALA Rte: 80 PM: 13.2/13.9File #: 69.25B**QUALITY ASSURANCE -- NON-CONFORMANCE REPORT****Location:** Changxing Island, Shanghai, PRC**Report No:** NCR-000347**Prime Contractor:** American Bridge/Fluor Enterprises, a JV**Date:** 31-Jul-2009**Submitting Contractor:** Zhenhua Port Machinery Company, Ltd (ZPMC), Changxing Island**NCR #:** ZPMC-0321**Type of problem:**

Reference Description: Excessive weld pass width on South Tower, Lift 3, AE corner seam weld**Description of Non-Conformance:**

Dear: Mr. Charles Kanapicki
Job Name: SAS Superstructure

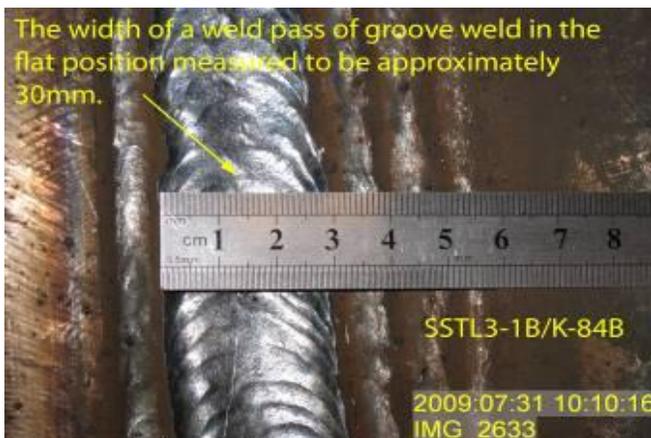
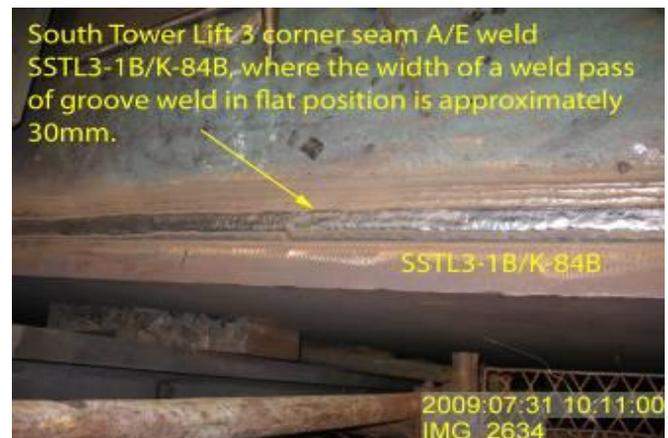
During in-process visual inspection of South Tower, Lift 3, AE corner seam weld no. SSSL3-1B/K-84B, QA observed an approximately 30mm wide weld pass. This Flux Core Arc Weld (FCAW) is a Complete Joint Penetration (CJP) performed in the flat position. The maximum FCAW weld pass width allowed in this position is 16mm.

AWS D1.5-2002, Section 4.14.1.5 FCAW: "When the width of a layer of a groove weld in the flat, horizontal, or overhead position is 16 mm [5/8 in.] or greater, a multiple-pass split-layer technique shall be used."

Propose a resolution for the identified non-conformance to prevent future occurrences and provide documentation of the corrective measures taken.

ZPMC QA has notified the welder and several other welders of this nonconformance and to perform welding within the guidelines of the welding parameters. ZPMC will submit inspection reports at a later date to close this NCR.

ZPMC has made the welder and other welders aware that weld passes should be in conformance with AWS D1.5 to prevent future occurrences of this non conformance. ZPMC has repaired the weld stated in the NCR and provided documentation showing that weld is acceptable. ZPMC requests closure of this NCR.

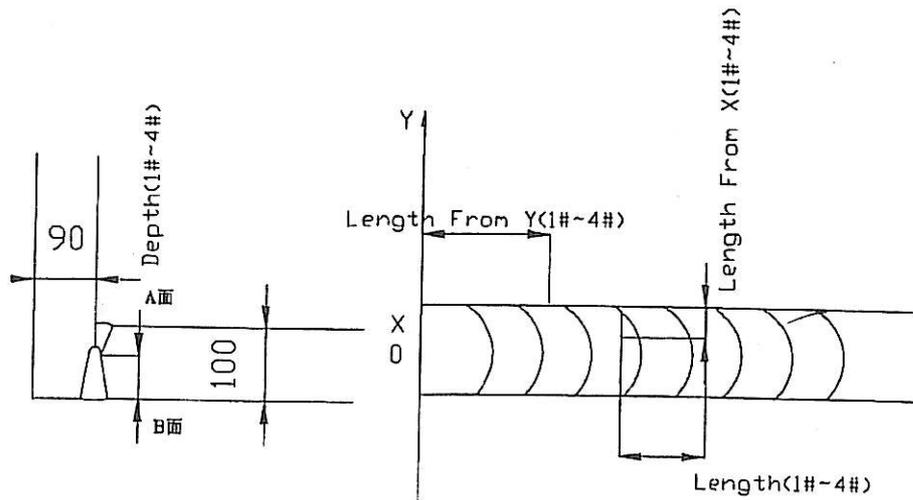
eWELD NUMBER: SSTL3-1B/K-84A/B

Rejected indication found by ultrasonic inspection at third time.

1. 焊缝的位置比较狭窄, 碳刨时, 不能准确的将缺陷刨出.
 2. 打磨工在打磨时, 不够仔细, 没有将所有的缺陷去除.
1. The access space was quite narrow resulting in making it difficult to arc-gouge the defects effectively.
 2. The grinder was not observant during the grinding operation resulting in the indications not being completely removed.

1. QC shall monitor and direct the welder and the grinder doing the repair operation.
 2. Preheat before gouging; the temperature shall be at least 65°C.

3. Gouge the weld to remove identified defects.
 4. Joint details shall refer to the approved WPS repair.
 5. Grind the gouged areas to a smooth and shiny surface.

6. Verify with VT and MT to ensure no defects remain in the weld joint prior to welding.
 7. QC shall monitor all welding passes being deposited.
 8. QC shall ensure all slag has been removed prior the deposition of next pass.

9. Preheat and maintain interpass temperature control in accordance with the WPS.
 10. Blend the weld repaired areas into the adjacent weld or base metal by grinding.

11. Perform VT, MT and UT NDT inspection to the repaired areas.
1. 在返修过程中, QC 应该监控和指导焊工和打磨工;
 2. 碳刨之前必须先进行预热, 温度不低于 65°C;
 3. 碳刨去除缺陷;
 4. 缺陷被完全清除后, 必须准备一个正确的接头型式, 具体接头型式请参见对应的修补焊接工艺规程(WPS);
