Contract #: 04-0120F4Cty: SF/ALA Rte: 80 PM: 13.2/13.9File #: 69.25B**QUALITY ASSURANCE -- NON-CONFORMANCE REPORT****Location:** Changxing Island, Shanghai, PRC**Report No:** NCR-000350**Prime Contractor:** American Bridge/Fluor Enterprises, a JV**Date:** 14-Jul-2009**Submitting Contractor:** Zhenhua Port Machinery Company, Ltd (ZPMC), Changxing Island**NCR #:** ZPMC-0324**Type of problem:****Welding****Concrete****Other****Welding****Curing****Procedural****Bridge No:** 34-0006**Joint fit-up****Coating****Other****Component:** OBG Segments 6AW, 7BW, 7DE, and 7DW**Procedural****Procedural****Description:****Reference Description:** Cope Holes not to Specification**Description of Non-Conformance:**

Job Name: SAS Superstructure
Document No: 05.03.06-000332

Reference Description: Cope Holes not to Specification

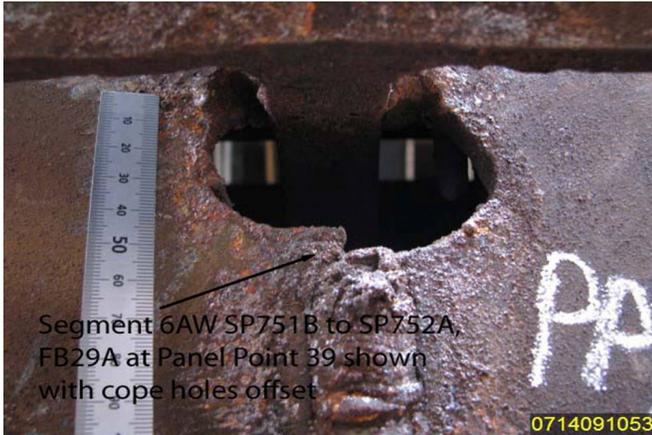
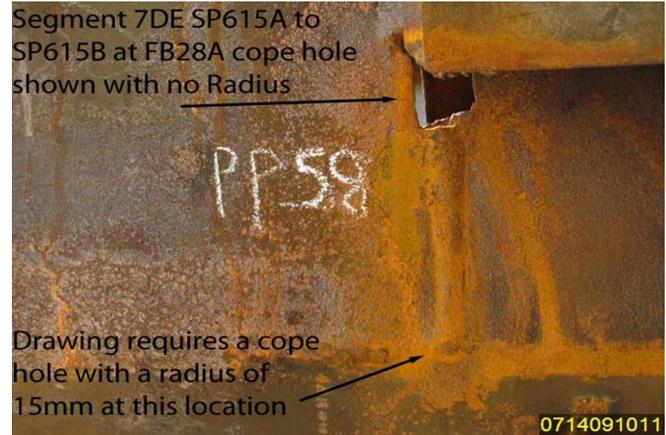
During in-process visual inspection of Segments 6AW, 7BW, 7DE, and 7DW Caltrans Quality Assurance Inspector observed cope hole sizes and locations do not comply with the approved shop drawings. Cope holes are located at the side panel (SP) complete joint penetration (CJP) butt welds and the bottom plates where the FL3 type floor beam (FB) penetrates through the side plates. Additionally, cope holes do not exhibit a smooth transition free from notches. Listed below are the locations of the cope holes.

Segment	Panel Point	SP to SP	Floor Beam	Required Cope Hole Size	Remarks
6AW	38	SP751A-SP751B	FB19A	R=25mm	Needs to be ground smooth
6AW	38	SP751A-SP751B	FB19A	R=25mm	Needs to be ground smooth
6AW	38	SP751A-SP751B	FB19A	R=15mm	Hole is missing
6AW	39	SP751B-SP752A	FB29A	R=25mm	Needs to be ground smooth
6AW	39	SP751B-SP752A	FB29A	R=15mm	Hole is missing
6AW	40	SP752A-SP752B	FB33A	R=25mm	Needs to be ground smooth
6AW	40	SP752A-SP752B	FB33A	R=15mm	Hole is missing
7BW	50	SP757A-SP757B	FB39A	R=25mm	Needs to be ground smooth
7BW	50	SP757A-SP757B	FB39A	R=15mm	Hole is missing
7BW	51	SP757B-SP758A	FB23A	R=25mm	Needs to be ground smooth
7BW	51	SP757B-SP758A	FB23A	R=15mm	Hole is missing
7BW	52	SP758A-SP758B	FB27B	R=25mm	Needs to be ground smooth
7BW	52	SP758A-SP758B	FB27B	R=15mm	Hole is missing
7DE	56	SP614A-SP614B	FB20B	R=25mm	Needs to be ground smooth
7DE	56	SP614A-SP614B	FB20B	R=15mm	Hole is missing
7DE	57	SP614B-SP615A	FB24A	R=25mm	Needs to be ground smooth

7DE	57	SP614B-SP615A	FB24A	R=15mm	Hole is missing
7DE	58	SP615A-SP615B	FB28A	R=25mm	Needs to be ground smooth
7DE	58	SP615A-SP615B	FB28A	R=15mm	Hole is missing

7DW	56	SP760A-SP760B	FB19B	R=25mm	Needs to be ground smooth
7DW	56	SP760A-SP760B	FB19B	R=15mm	Hole is missing
7DW	57	SP760B-SP761A	FB23A	R=25mm	Needs to be ground smooth
7DW	57	SP760B-SP761A	FB23A	R=15mm	Hole is missing
7DW	58	SP761A-SP761B	FB27A	R=25mm	Needs to be ground smooth
7DW	58	SP761A-SP761B	FB27A	R=15mm	Hole is missing

1. Side Plate Sub-Assembly Drawings SP615, SP615, SP751, SP752, SP757, SP758, SP760, and SP761. Standard Details Drawing SD5 details "5A", "5B", "5C", and "5D" Radius details.
2. AWS D1.5, Paragraph 3.2.5 "Radii of beam copes and weld access holes shall provide a smooth transition, free from notches or cutting past the points of tangency between adjacent surfaces.

Install and modify cope holes to conform to shop drawings.

ZPMC has informed ABF that the cope holes are not final inspected and therefore are considered inprocess. ZPMC is currently completing the work. Final inspection will be performed and documented as such during final VT inspection prior to blasting. ZPMC requests closure of this NCR.
