Contract #: 04-0120F4  
 Cty: SF/ALA Rte: 80 PM: 13.2/13.9  
 File #: 69.25B

## QUALITY ASSURANCE -- NON-CONFORMANCE REPORT

**Report No:** NCR-000352

**Reference Description:** Inadequate preheat on West Tower, Lift 4, Skin C longitudinal stiffener welds

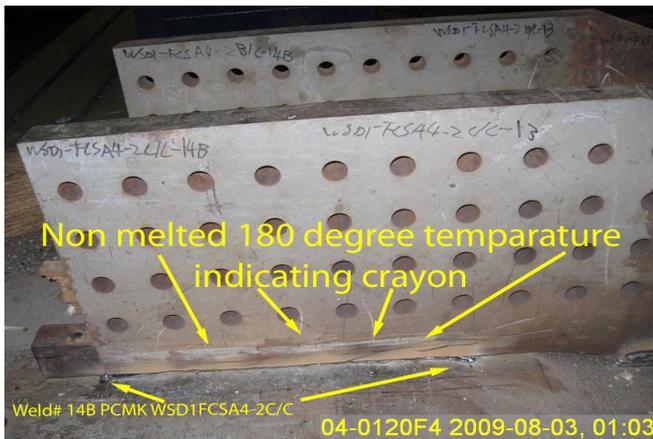
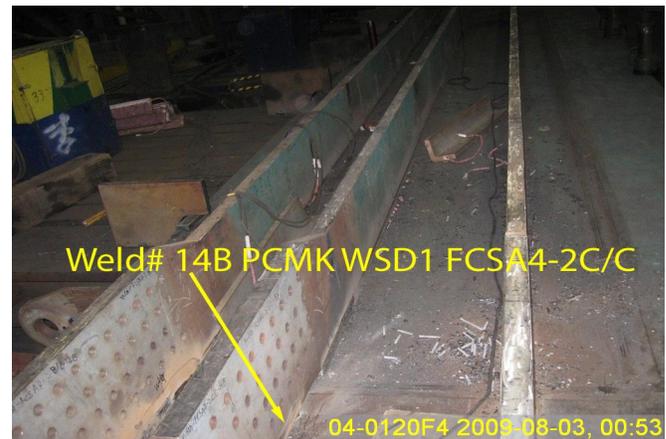
During in-process visual inspection, QA observed that welder #053916 was performing Shield Metal Arc Welding (SMAW) on weld joint WSD1-FCSA4-2C/C-14B without proper preheat. The recorded temperature of the adjacent base material was less than the 180 degrees Celcius required by approved Welding Procedure Specification WPS-B-T-3212-TC-U5b-1.

Welding Procedure Specification WPS-B-T-3212-TC-U5b-1 specifies a minimum preheat of 180 degrees Celcius.

Propose a resolution for this systematic non-conformance including documentation that the welds placed are in compliance with the contract requirements. In addition to addressing Production’s failure to perform the required preheat of the material, address the failure of Quality Control to identify the inadequate preheat. Provide documentation of the steps/ actions taken by Production and Quality Control to prevent future occurrences. Also detail what steps/ actions are being taken by ABFJV to address the quality control failures of ABFJV’s fabricator/ ZPMC.

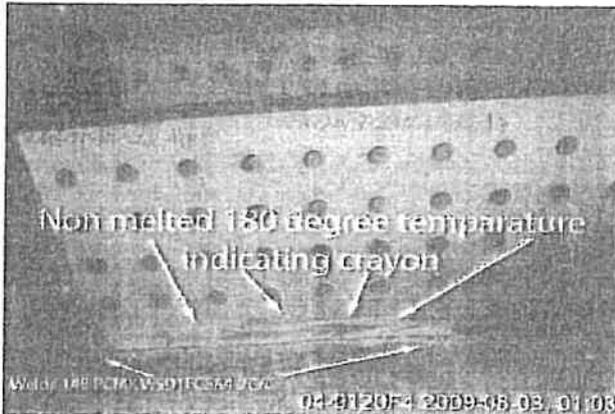
During in-process visual inspection, QA observed that welder #053916 was performing Shield Metal Arc Welding (SMAW) on weld joint WSD1-FCSA4-2C/C-14B without proper preheat. The recorded temperature of the adjacent base material was less than the 180 degrees Celcius required by approved Welding Procedure Specification WPS-B-T-3212-TC-U5b-1.

Welding Procedure Specification WPS-B-T-3212-TC-U5b-1 specifies a minimum preheat of 180 degrees Celcius.

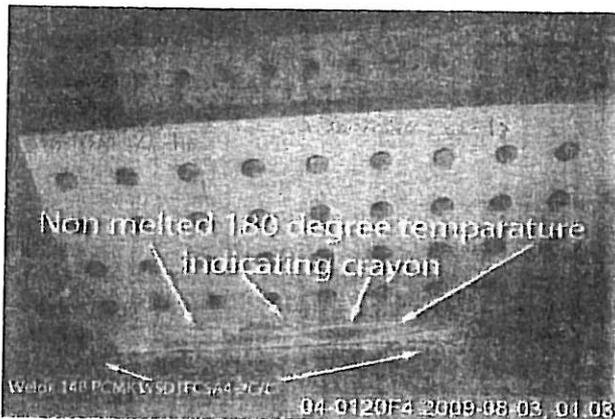
During in-process visual inspection, QA observed that welder #053916 was performing Shield Metal Arc Welding (SMAW) on weld joint WSD1-FCSA4-2C/C-14B without proper preheat. The recorded temperature of the adjacent base material was less than the 180 degrees Celcius required by approved Welding Procedure Specification WPS-B-T-3212-TC-U5b-1.

Welding Procedure Specification WPS-B-T-3212-TC-U5b-1 specifies a minimum preheat of 180 degrees Celcius.

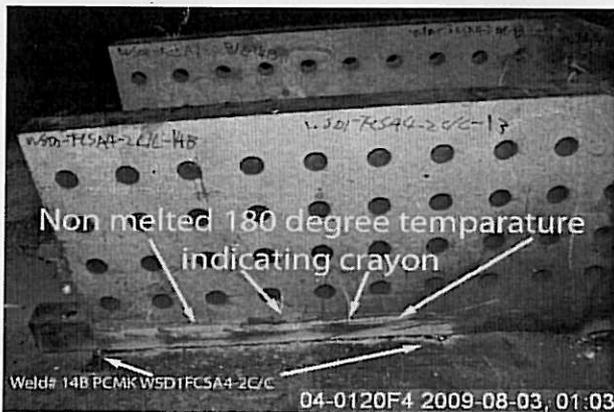
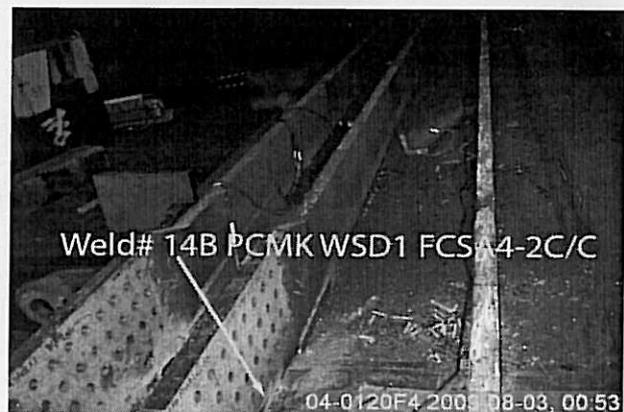
During in-process visual inspection, QA observed that welder #053916 was performing Shield Metal Arc Welding (SMAW) on weld joint WSD1-FCSA4-2C/C-14B without proper preheat. The recorded temperature of the adjacent base material was less than the 180 degrees Celcius required by approved Welding Procedure Specification WPS-B-T-3212-TC-U5b-1.

Welding Procedure Specification WPS-B-T-3212-TC-U5b-1 specifies a minimum preheat of 180 degrees Celcius.
