Contract #: 04-0120F4Cty: SF/ALA Rte: 80 PM: 13.2/13.9File #: 69.25B**QUALITY ASSURANCE -- NON-CONFORMANCE REPORT****Location:** Changxing Island, Shanghai, PRC**Report No:** NCR-000354**Prime Contractor:** American Bridge/Fluor Enterprises, a JV**Date:** 16-Jul-2009**Submitting Contractor:** Zhenhua Port Machinery Company, Ltd (ZPMC), Changxing Island**NCR #:** ZPMC-0328**Type of problem:**

**Reference Description:** Mechanical Damage to T-Stiffener**Description of Non-Conformance:**

**Job Name:** SAS Superstructure

Item: Mechanical Damage to  
 T-Stiffener  
 名称描述: T 肋翼板损伤

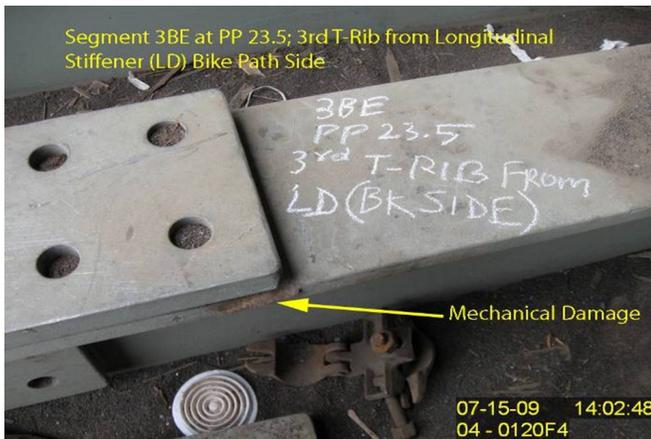
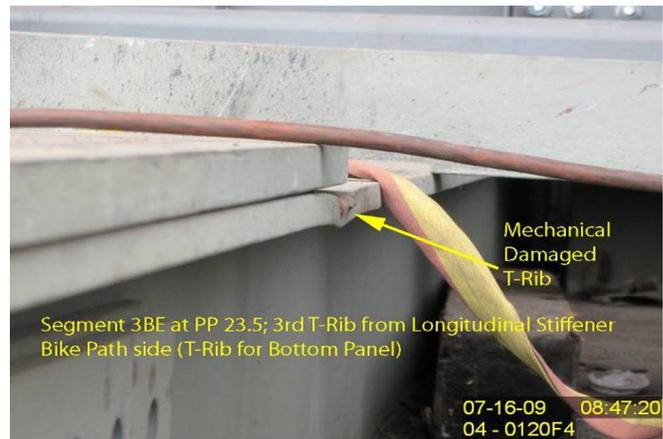
Caltrans Quality Assurance (QA) Inspector observed mechanical damage to the T-Rib flange area which is welded to the Bottom Panel. The damage was observed to be on the 3rd T-Rib from the Longitudinal Stiffener from the bike path side of Segment 3BE.

For further information, please see the attached pictures below.

Standard Specification Section 55 section 55-1.04; 'Shipping, Handling and Storing Materials': "In handling and shipping of the steel work, every care shall be taken to avoid bending, scraping or overstressing the pieces. All pieces bent or otherwise injured will be rejected."

Submit repair procedure for approval.

With this letter of response, ZPMC requests closure for Caltrans NCR-000354 (ZPMC-0328). We agree what describe in the non-conformance report, and have repair the T-rib with the flush grinding, according with the visual and NDT inspection , the three parties all accepted the final condition and already close out the item in the punchlist.

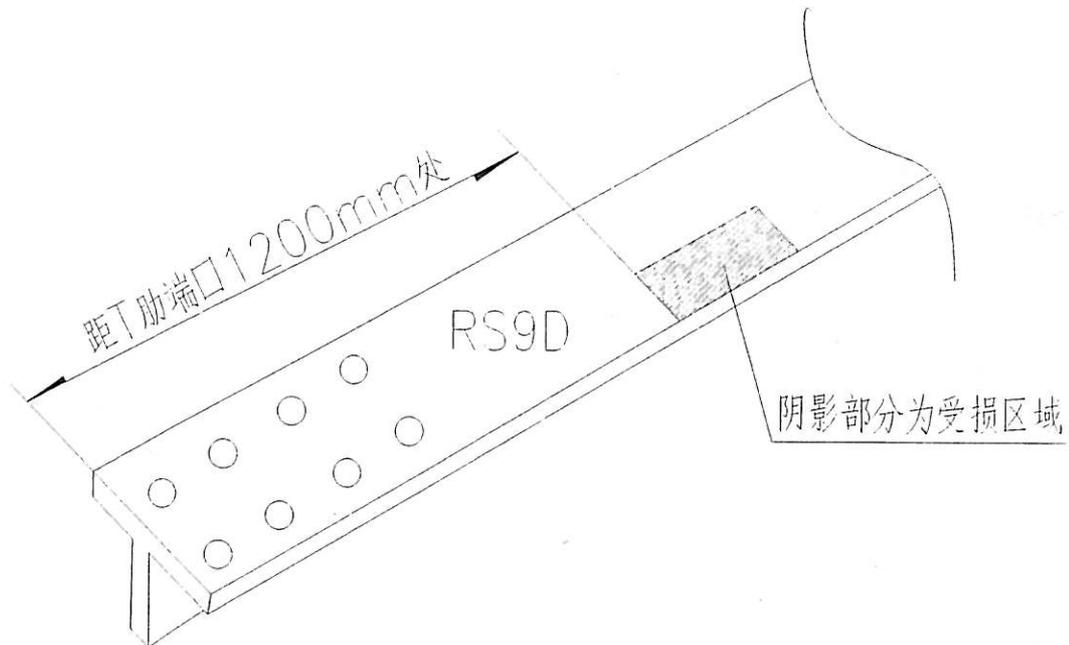
Draft of welding discontinuity:

After inspection: the third t-shape RS9D flange base metal was gouged at 3BE box bottom plate at bike way side, the detail see the following draft.

Gouged area in shadow.

Worker operated error during gouged caused base metal gouged.

1. Remove all the defects according to the approved repair WPS by means of grinding.
2. Verify with MT and VT no defects remain in the repair area prior to weld;
3. Preheat and weld according to the relevant WPS.
4. Grind the weld flush with base metal after welding.
5. Perform VT and MT inspection of the repaired area.
