Contract #: 04-0120F4Cty: SF/ALA Rte: 80 PM: 13.2/13.9File #: 69.25B**QUALITY ASSURANCE -- NON-CONFORMANCE REPORT****Location:** Changxing Island, Shanghai, PRC**Report No:** NCR-000355**Prime Contractor:** American Bridge/Fluor Enterprises, a JV**Date:** 15-Jul-2009**Submitting Contractor:** Zhenhua Port Machinery Company, Ltd (ZPMC), Changxing Island**NCR #:** ZPMC-0329**Type of problem:**

Bridge No: 34-0006**Component:** CA098-002 of OBG Segment 1BE**Reference Description:** Missed UT Indications**Description of Non-Conformance:**

Job Name: SAS Superstructure

Subject: NCR No. ZPMC-0329

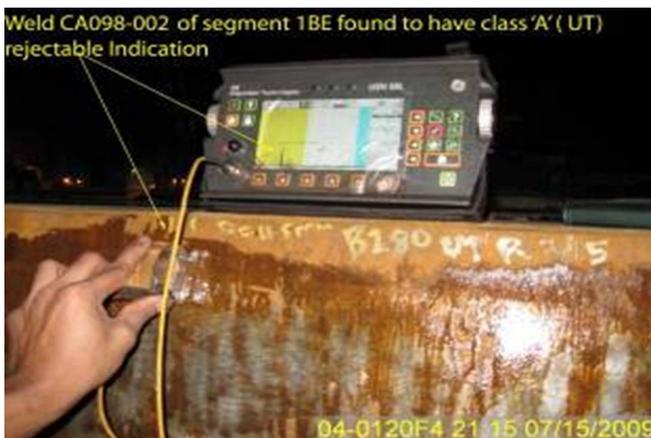
During random 10% verification Ultrasonic Testing (UT) on Deck Panel to Edge Panel corner weld (CA098-002) of Segment 1BE, Caltrans Quality Assurance (QA) Inspector discovered a class "A" non conforming indication measuring approximately 10mm to 15mm in length. ZPMC QC had previously accepted the weld joint mentioned above, but the subassembly was never signed by the ZPMC technician.

Submit repair procedure for approval.

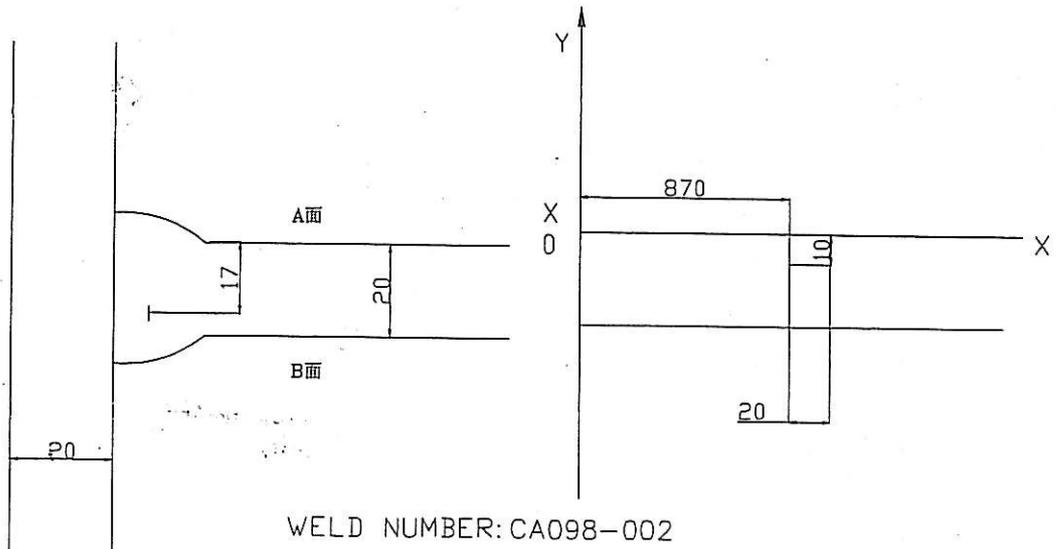
焊缝返修位置示意图:

Rejected indication found by ultrasonic inspection is less than the maximum allowance aggregate length.

(UT探伤发现的缺陷总长度小于最大允许长度。) CA098-002

- 1、焊道未及时处理干净。
1. Did not clear the weld pass completely in time.

1. Gouge or grind from nearer side from metal edge ($D \leq 0.65T$, "D" is depth of defects, "T" is thickness of metal) to remove all defects;
2. Follow repair WPS for joint preparation, preheat, and weld deposit;
3. Verify with VT no defects remain in the weld joint prior to welding;
4. Grind the repaired area flush with base metal or the adjacent weld;
5. Check the welds according to the working drawings.
