Contract #: 04-0120F4Cty: SF/ALA Rte: 80 PM: 13.2/13.9File #: 69.25B**QUALITY ASSURANCE -- NON-CONFORMANCE REPORT****Location:** Changxing Island, Shanghai, PRC**Report No:** NCR-000358**Prime Contractor:** American Bridge/Fluor Enterprises, a JV**Date:** 09-Jul-2009**Submitting Contractor:** Zhenhua Port Machinery Company, Ltd (ZPMC), Changxing Island**NCR #:** ZPMC-0332**Type of problem:**

Bridge No: 34-0006**Component:** DP673A of CA065**Reference Description:** Flame Cutting Damage to DP**Description of Non-Conformance:**

Job Name: SAS Superstructure

Subject: NCR No. ZPMC-0332

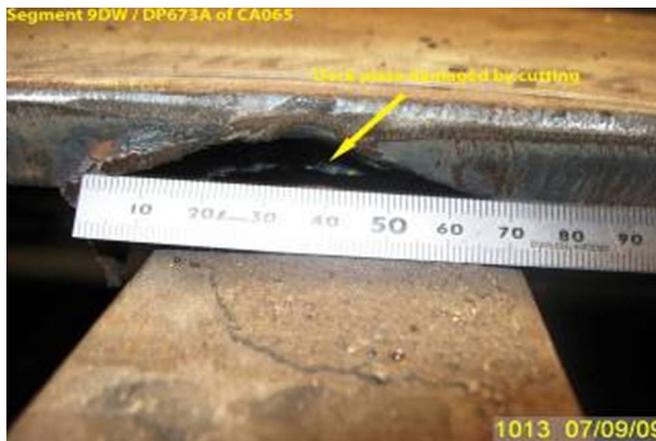
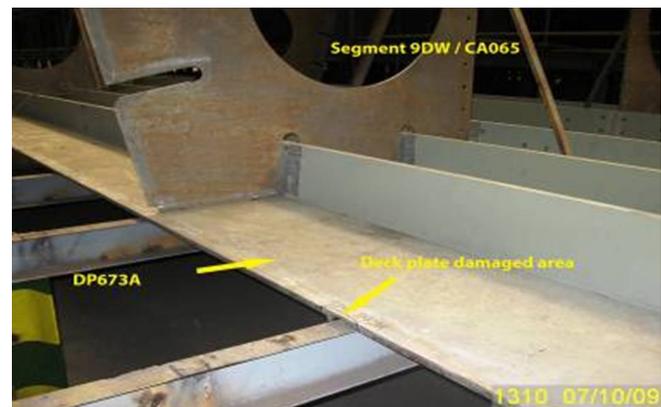
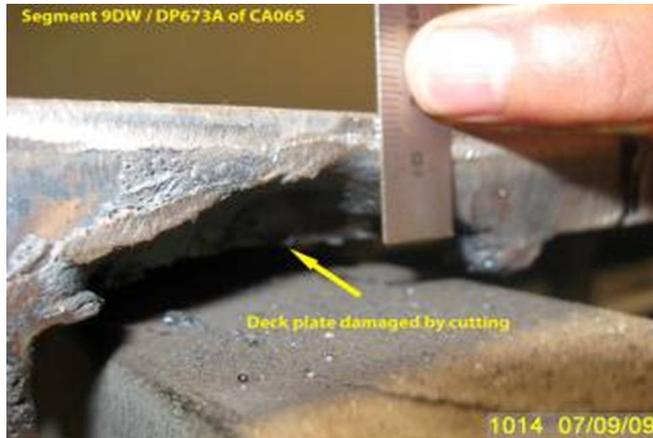
Caltrans Quality Assurance (QA) Inspector observed damage caused by Gas Flame Cutting to a Deck Plate identified as DP673A of CA065 in Segment 9DW. The damage measured 40mm in length and extended into the base metal approximately 65mm.

Please see the attached photos for details.

AWS D1.5-2002 section 3.2.2: "In all thermal cutting, the cutting flame shall be so adjusted and manipulated as to avoid cutting beyond (inside) the prescribed lines."

Contractor to submit repair procedure.

It's understood that the base metal will be repaired and documents will be submitted to the Department for review and acceptance once the repair work is completed.

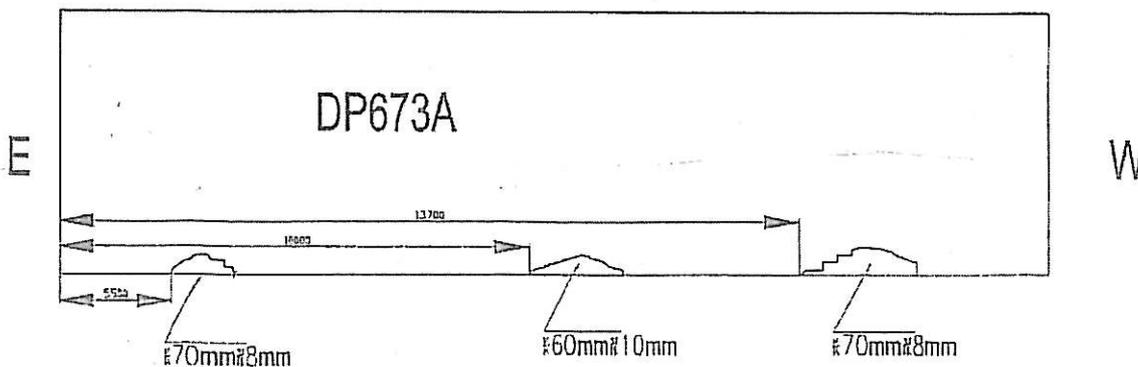
Draft of Welding Discontinuity:

板单元DP673A在余量切割过程中, 施工队错误施工将母材割伤。具体损伤尺寸见下图:

The base metal of plate panel DP673A was damaged during the workers were cutting the allowance because of their errors. See details as following drawing:

在余量切割过程中, 施工队错误施工导致割伤母材。

The workers made mistakes during cutting the allowance, leading to the base metal damaged.

1. 整个返修过程中, QC和CWI检测所有的打磨和焊接等工作;
2. 在返修时, QC和CWI必须在现场, 有CWR的复印件;
3. QC和CWI应该指导返修, 以保证按照返修的处理意见进行;
4. 根据批准的返修WPS打磨母材缺陷区域;
5. 按照返修的WPS准备正确的接头型式;
6. VT和MT检测所有的缺陷全部去除;
7. 按照返修的WPS进行预热和焊接;
8. 打磨返修后的焊缝与母材平齐;
9. 返修后, 按照图纸要求对返修区域进行VT,MT检测;

1. QC and a CWI shall be present and direct all grinding and welding operations during this repair.
2. QC and a CWI shall have an approved copy of the CWR in hand and shall be at the repair location during the entire repair.
3. QC and a CWI shall direct the repair to ensure the repair is per the disposition requirements.
4. Grind the defects of the base metal according to the approved repair WPS;
5. Prepare excavation according to the approved repair WPS.
6. Perform VT and MT inspection to ensure that repair area is free of defects.
7. Preheat and weld according to the relevant repair WPS.
8. Grind the repaired area flush with base metal.
9. Perform VT, MT inspection to repair area according to the shop drawing.
