Contract #: 04-0120F4Cty: SF/ALA Rte: 80 PM: 13.2/13.9File #: 69.25B**QUALITY ASSURANCE -- NON-CONFORMANCE REPORT****Location:** Changxing Island, Shanghai, PRC**Report No:** NCR-000359**Prime Contractor:** American Bridge/Fluor Enterprises, a JV**Date:** 11-Jul-2009**Submitting Contractor:** Zhenhua Port Machinery Company, Ltd (ZPMC), Changxing Island**NCR #:** ZPMC-0333**Type of problem:**

Reference Description: CWR Not Followed During Repair**Description of Non-Conformance:**

Job Name: SAS Superstructure

Document No: 05.03.06-000312

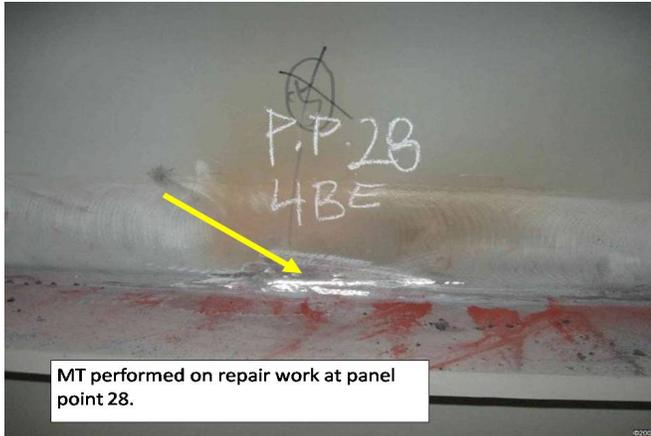
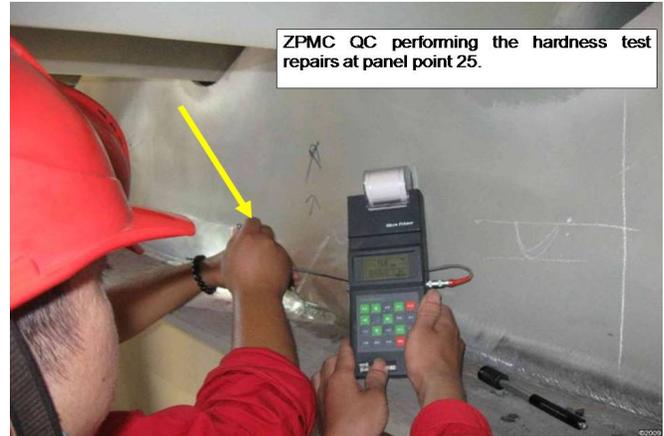
Caltrans Quality Assurance (QA) Inspector observed Critical Welding Repair (CWR) work was performed on Floor Beam to Diaphragm welds (SSD19-PP024-004/005, SSD20-PP025-004/005, SSD16A-PP026-003/004, SSD17A-PP027-003/004, SSD18A-PP028-004/005) located at Panel Points 24~28 of Segment 4AE and 4BE. The CWR is associated with the removal of transverse cracks observed by Magnetic Particle Testing (MT) performed by ZPMC. The below listed observations do not comply with the approved Critical Weld Repair procedure (B-CWR-595 R1).

1. ZPMC did not provide a written or verbal notification to the Engineer prior to performing Hardness Testing and facilitate the Engineer to witness the testing. Hardness Testing was only performed after the repair work was complete with no prior Engineer Notification provided by ZPMC.
2. The results of the Hardness Testing were not provided to the Engineer for review prior to repair.
3. A separate CWR is needed if cracks are found in the base metal HAZ.
4. If excessive root gap (5mm or more) is found during grinding of the repair area. The contractor shall seek Engineers approval.
5. Gouging shall not be used for this repair.

For further information, please see the attached pictures below.

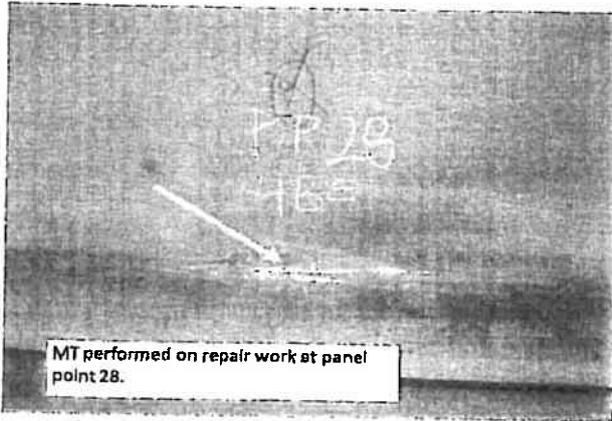
Caltrans Quality Assurance (QA) Inspector observed Critical Welding Repair (CWR) work was performed on Floor Beam to Diaphragm welds (SSD19-PP024-004/005, SSD20-PP025-004/005, SSD16A-PP026-003/004, SSD17A-PP027-003/004, SSD18A-PP028-004/005) located at Panel Points 24~28 of Segment 4AE and 4BE. The CWR is associated with the removal of transverse cracks observed by Magnetic Particle Testing (MT) performed by ZPMC. The below listed observations do not comply with the approved Critical Weld Repair procedure (B-CWR-595 R1).

1. ZPMC did not provide a written or verbal notification to the Engineer prior to performing Hardness Testing and facilitate the Engineer to witness the testing. Hardness Testing was only performed after the repair work was complete with no prior Engineer Notification provided by ZPMC.
2. The results of the Hardness Testing were not provided to the Engineer for review prior to repair.
3. A separate CWR is needed if cracks are found in the base metal HAZ.
4. If excessive root gap (5mm or more) is found during grinding of the repair area. The contractor shall seek Engineers approval.
5. Gouging shall not be used for this repair.

For further information, please see the attached pictures below.

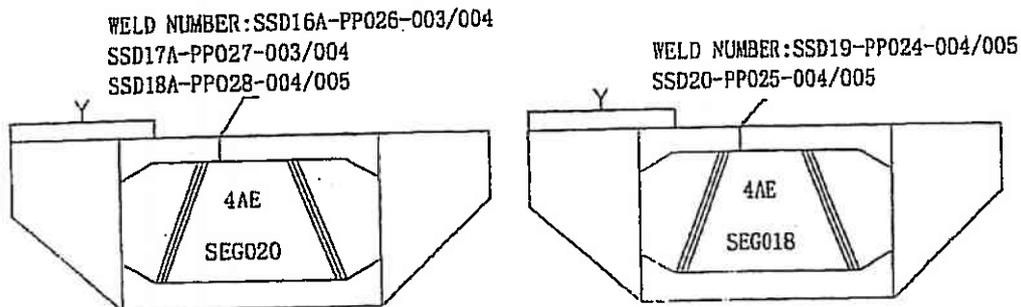
Draft of Welding Discontinuity:

Eighteen cracks were found by use of MT on weld SSD19-PP024-004 Welder ID No.058551 Position:2F Y1=40;Y2=3175;Y3=7100;Y4=10950;Y5=12280;Y6=14920;Y7=15900;Y8=15970;Y9=16080;Y10=16150;Y11=16520;Y12=17450;Y13=17660;Y14=18400;Y15=18680;Y16=18750;Y17=18800;Y18=19000;

Five cracks were found by use of MT on weld SSD19-PP024-005 Welder ID No.050242 Position:2F Y1=1750;Y2=2530;Y3=5640;Y4=6350;Y5=6570;

Twelve cracks were found by use of MT on weld SSD20-PP025-004 Welder ID No.058551 Position:2F Y1=500;Y2=560;Y3=1100;Y4=8900;Y5=9700;Y6=11860;Y7=12000;Y8=12160;Y9=12480;Y10=15130;Y11=15460; Y12=15520;

Fourteen cracks were found by use of MT on weld SSD20-PP025-005 Welder ID No.050242 Position:2F Y1=1700;Y2=3540;Y3=6000;Y4=7090;Y5=7140;Y6=14600;Y7=14880;Y8=15110;Y9=16200;Y10=17930;Y11=19200; Y12=20320; Y13=20400;Y14=20560;

One transverse crack was found by use of MT on weld SSD16A-PP026-003 Welder ID No.058551 Position:2F Y1=16100;

Three cracks were found by use of MT on weld SSD16A-PP026-004 Welder ID No.050242 Position:2F Y1=7100; Y2=7170;Y3=14430;

Four cracks were found by use of MT on weld SSD17A-PP027-003 Welder ID No.058551 Position:2F Y1=25; Y2=6420;Y3=16880;Y4=22250;

Four cracks were found by use of MT on weld SSD17A-PP027-004 Welder ID No. 050242 Position:2F Y1=1730; Y2=8080;Y3=17470;Y4=19220;

Seven cracks were found by use of MT on weld SSD18A-PP028-004 Welder ID No.058551 Position:2F Y1=7400; Y2=7500;Y3=7520;Y4=7735; Y5=14645;Y6=18630;Y7=17400;

Six cracks were found by use of MT on weld SSD18A-PP028-005 Welder ID No.050242 Position:2F Y1=7400; Y2=7460;Y3=13030;Y4=14250; Y5=16150;Y6=23200;

1. Moisture wasn't completely removed during drying operation (preheating) or the area wasn't preheated sufficiently.

1. The Engineer shall be notified and present during this repair. Indicate repair procedure, if illet weld; gouging shall not be used for this repair
2. QC and a Lead CWI shall be present and direct all gouging, grinding and welding operations during this repair.

3. QC and a Lead CWI shall have an approved copy of the CWR in hand prior to the repair.
4. QC and a Lead CWI shall direct the repair to ensure the repair is per the disposition requirements.

5. Paint shall be removed in the area requiring MT; - ET
6. Remove the crack by means of grinding. 2009. 7. 4.
7. Prepare excavation according to the approved repair WPS.

8. Before this repair, Verify with VT and MT repair areas are crack free, and also MT shall be perform on the base metal nearby transverse cracks to ensure that no cracks we re propagated in to the base metal;

9. Preheat and weld according to the approved repair WPS.
10. Grind the repaired area flush with base metal or the adjacent weld.
11. Perform VT after repair and additional% NDT requirement stated in special provisi on 10-1.59 "inspection testing" note 3;

12. 100%MT all these welds after the weld repair, including the opposite side of the r epaired weld that didn't require repair previously.

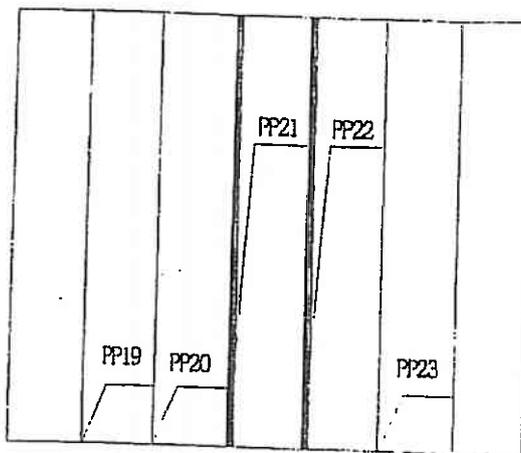
3E

1. 机构设计拘束应力大,
2. 火焰加热时, 水汽没有完全的去掉或者这个区域预热不够;
1. The inner stress restrained by the component design,
2. Moisture wasn't completely removed during drying operation (preheating) or the area wasn't preheated sufficiently.

2. Grind weld prep to bright metal.
3. MT weld preparations to verify cracks are completely removed and do not exist in the Base Metal.
4. Pre-heat base metal to 65-100°C;

10. Perform VT and MT weld after cooling to ambient temperature.
- PERFORM UT ON ALL CJP REPAIRS.*
- MT FILLET WELD ON BOTTOM SIDE OF FLANGE.*
- IF ENTIRE WELD IS REMOVED BY GOUGING, REMOVE CRACKS BY GRINDING PRIOR TO PERFORMING GOUGING.*

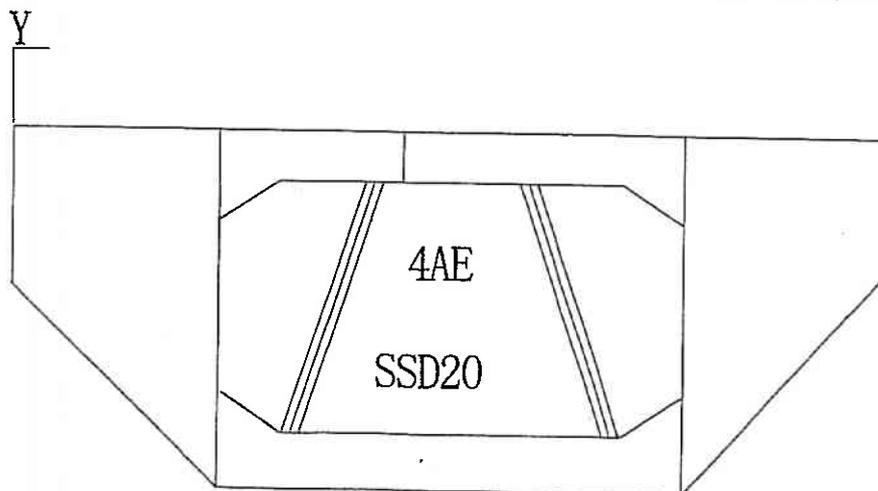
WELD NUMBER: SSD20-PP025-004/005

Two longitudinal cracks and Six transverse cracks were found by use of MT on SSD20-PP025-004

Six longitudinal cracks and eight transverse cracks were found by use of MT on SSD20-PP025-005

1. 火焰加热时, 水汽没有完全的去掉或者这个区域预热不够;
1. Moisture wasn't completely removed during drying operation (preheating) or the area wasn't preheated sufficiently.

1. QC and a Lead CWI shall be present, direct and supervise all grinding and welding operations during this repair to ensure the repair is per the disposition requirements

2. QC and a Lead CWI shall have an approved copy of the CWR in hand prior to the repair.
3. Remove paint ≥ 25 mm in all direction of HAZ prior to MT.
4. Remove cracks by grinding, repair area shall extend a minimum of 50mm beyond each end of single crack repairs, and 50mm beyond the outermost cracks for multiple crack repairs.

5. If base metal is damaged by grinding, the damaged area shall be ground clean prior to performing weld repair. If gap > 5 mm is found during or after grinding, a CJP weld is required in that location, and perform MT after performing grinding the defects away.

6. Prepare excavation in accordance with an approved repair WPS prior to welding.
7. Before this repair, Verify with VT and MT repair areas are defects free, and also MT shall be performed on the base metal laying abroad cracks to ensure that no cracks were propagated to the base metal. Separate CWR approval is needed if cracks are found in the base metal.

8. Preheat and weld according to the approved repair WPS.
9. Grind the repaired area flush with base metal or the adjacent weld.
10. Perform MT inspection to all repaired welds (along with an additional 50mm at each end of the weld repair) which include the near side and far side on the upper and bottom side of flange in the same area where the repair was performed according to additional NDT requirement stated in special provision 10-1.59 "inspection testing" note 3. Perform UT and MT inspection to CJP weld.
