Contract #: 04-0120F4  
 Cty: SF/ALA Rte: 80 PM: 13.2/13.9  
 File #: 69.25B

## QUALITY ASSURANCE -- NON-CONFORMANCE REPORT

**Report No:** NCR-000360

**Reference Description:** Base Metal Repair to Mis-Located Drill Holes

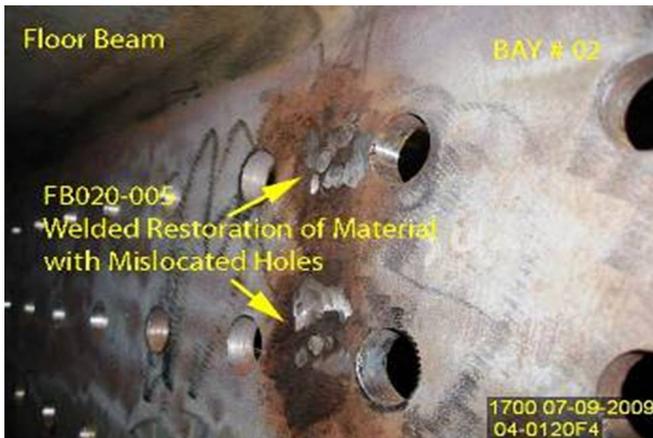
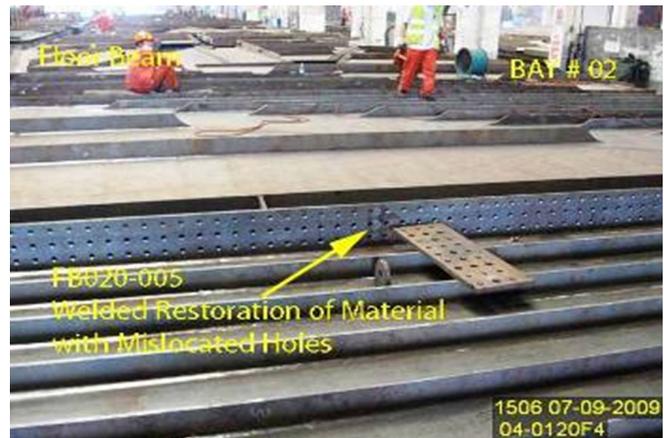
Caltrans Quality Assurance (QA) Inspector observed ZPMC personnel performing welded restoration of base material with mis-located drilled holes at five (5) locations. The member is identified as Floor Beam FB020-005. ZPMC QC did not provide an approved Welding Procedure Specification (WPS) or notify the Engineer of the above mentioned welding repair.

For further information, Please see the attached pictures below

**Reference Resolution:** ZPMC has been informed that this repair requires engineers approval as well as having the proper procedures in place at the worksite during repairs.

ZPMC has been informed that this repair requires engineers approval as well as having the proper procedures in place at the worksite during repairs. ZPMC will submit all repair documentation at a later date to close this NCR.

Repair according to B-CWR 618, and B-CWR 636.

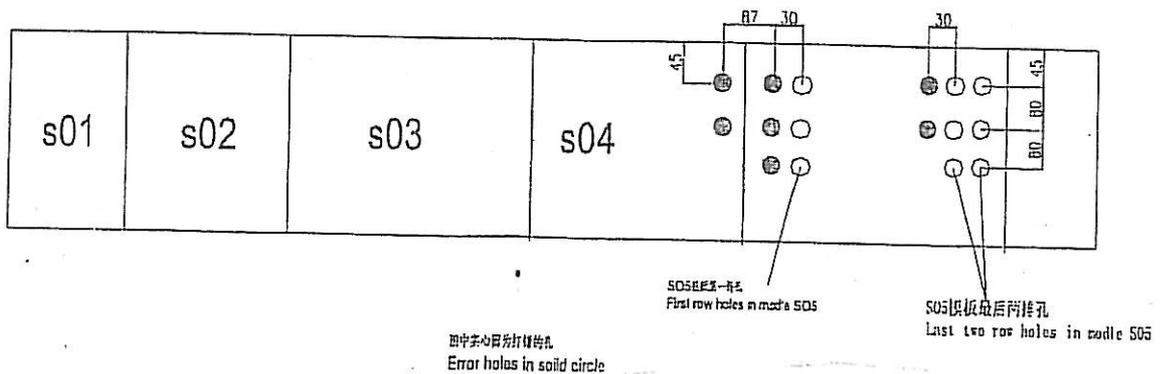
FL3 Floor beam fabricated by Li Zhenjie Work Team, it didn't review drawing requirement caused seven holes drilled error, drawing No.: FB020-005, and Work Team repair holes without approved CWR, the detail position sees the following draft.

- 1. 在钻孔时, 没有看清楚图纸要求;
  - 2. 模板的位置错误, 导致孔钻错.
- 1. Didn't review drawing requirement during drilling holes;
  - 2. The position of model was error caused holes position error.

- 6. 按照批准的WPS预热和焊接;
  - 7. 打磨返修区域与母材和临近焊缝平齐;
  - 8. 按照WPS程序进行VT,MT,UT检测;
  - 9. 对承受拉应力和反向应力的构件焊缝修补区域应按照AWS D1.5, 3.2.2.3上要求的UT和MT进行检测;
- 1. The Engineer shall be notified and present during this repair.

- 2. QC and a Lead CWI shall be present and direct all gouging, grinding and welding operations during this repair.
  - 3. QC and a Lead CWI shall have an approved copy of the CWR in hand prior to the repair.

- 4. QC and a Lead CWI shall direct the repair to ensure the repair is per the disposition requirements.
  - 5. Prepare the excavation according to the approved WPS details.

- 6. Perform preheating and welding in accordance with the approved WPS.
  - 7. Grind the repaired area flush to base metal or the adjacent weld.
  - 8. Perform VT, MT and UT inspections according to the approved WPS procedure.

- 9. Weld repairs are being performed on TM/SRM member per AWS D1.5, 3.2.2.3 UT and MT is required.

1. Review drawing carefully before drilling holes to understand drilling holes size;
2. Check drilling holes size by QC before drilling holes.

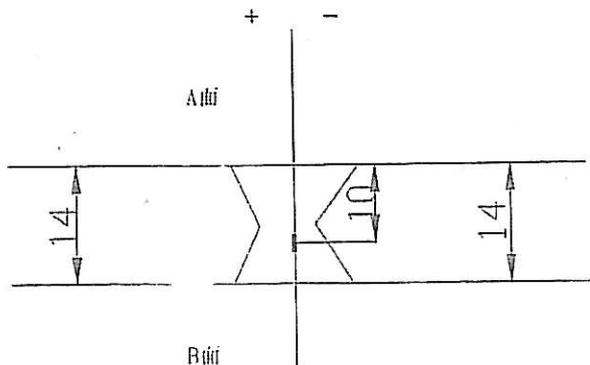
Two defect found by use of UT on the build-up No. X73E

1. 火焰加热时, 水汽没有完全的去掉或者这个区域预热不够;
1. Moisture wasn't completely removed during drying operation (preheating) or the area wasn't preheated sufficiently.

1. QA and CWI should be present to witness the repair.
  2. Elongate the hole by arc gouging, and grind smooth the surface. The elongated hole should conform to the joint detail in Repair WPS. Preheat before gouging according to relevant WPS.
  3. Perform VT and MT to ensure no defects exist.
  4. Add steel backing. Preheat and weld according to the repair WPS, weld stringers longitudinally along the elongated direction of the hole.
  5. Remove steel backing and back gouge the root pass, MT backing area prior to welding and complete the welding. *BACK GOUGER* *8-3-09*  
*IN ACCORDANCE W/ APPROVED WPS.*
  6. Grind the repair area flush with adjacent base metal.
  7. Cooling time shall conform to AWS D1.5 section 12.16.4 approved FCP.
  8. Check with VT, UT, MT after welding to the repair area.
- Note: ALL gouging, grinding and welding should be inspected by QC and Leader CWI.

1. QC shall verify sufficient preheat has been applied, to remove moisture, prior to welding.
