Contract #: 04-0120F4Cty: SF/ALA Rte: 80 PM: 13.2/13.9File #: 69.25B**QUALITY ASSURANCE -- NON-CONFORMANCE REPORT****Location:** Changxing Island, Shanghai, PRC**Report No:** NCR-000361**Prime Contractor:** American Bridge/Fluor Enterprises, a JV**Date:** 14-Jul-2009**Submitting Contractor:** Zhenhua Port Machinery Company, Ltd (ZPMC), Changxing Island**NCR #:** ZPMC-0335**Type of problem:**

**Reference Description:** Oversized Holes Drilled in LD**Description of Non-Conformance:**

**Job Name:** SAS Superstructure  
**Document No:** 05.03.06-000314

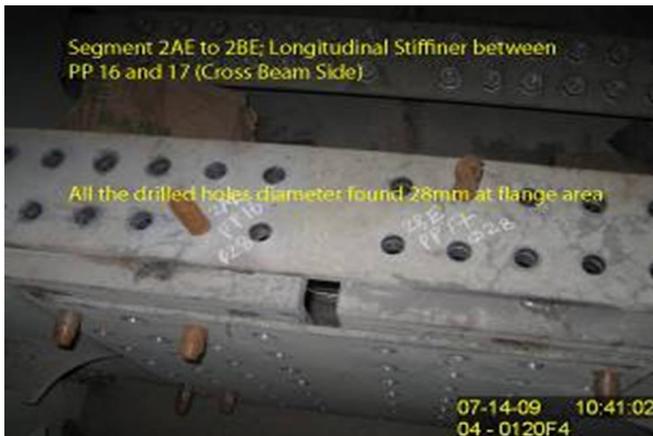
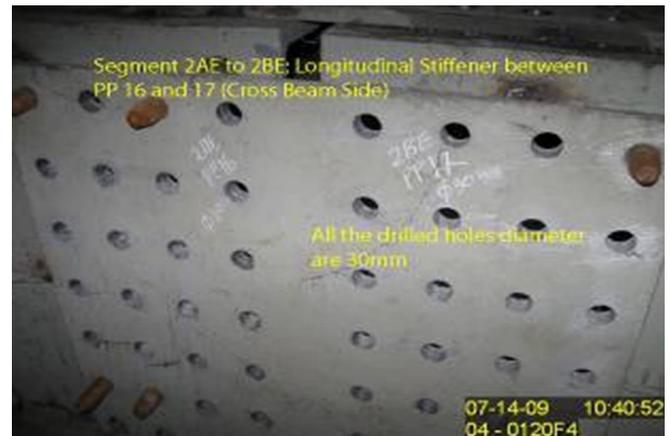
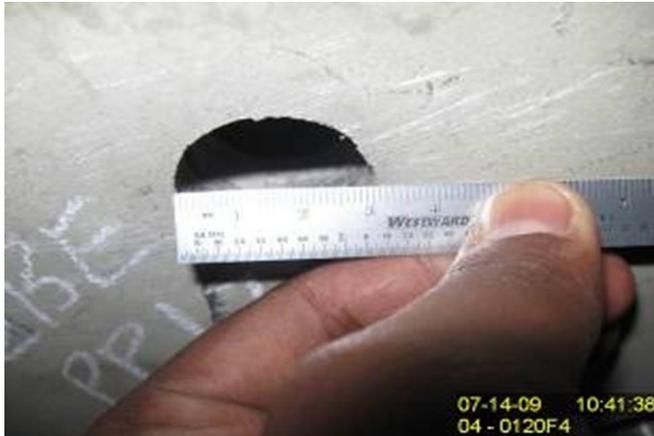
Caltrans Quality Assurance (QA) Inspector observed oversized holes drilled at the Longitudinal Stiffener (LD) for Segment 2AE to 2BE, between PP 16 and 17 (Cross Beam Side) in the web area. Holes drilled for M24 bolts are generally drilled with a 26mm diameter. The holes at this area were measured as being 28mm and 30mm diameter bolt holes.

Caltrans Standards Specifications July 1999: Steel Structure Section 55-3.14A, 'Bolt Holes': "The finished holes shall be cylindrical, perpendicular to the plane of the connection and shall be not more than 1.6 mm larger than the nominal diameter of the bolt."

ZPMC's proposal to use 27mm bolts in lieu of 24mm bolts is acceptable.

For this type of substitution it is also critical to check the center to center spacing on the bolts in question. In this instance the center to center spacing is 90mm and is greater than  $3 \times \text{DIA}$  and therefore acceptable.

ZPMC should revise shop drawing to indicate the location of this change.

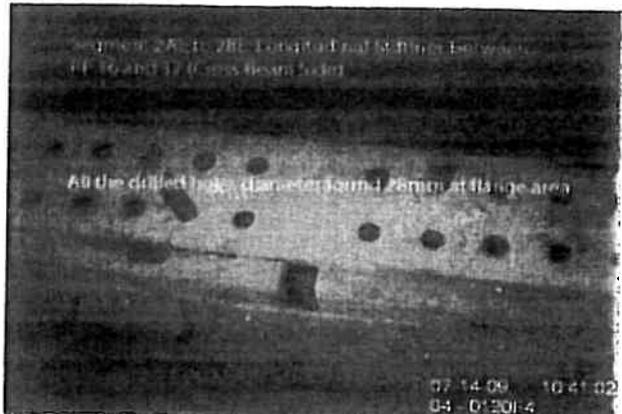
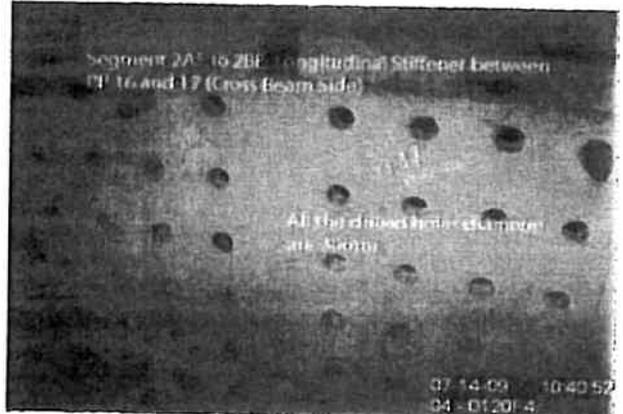
Caltrans Quality Assurance (QA) Inspector observed oversized holes drilled at the Longitudinal Stiffener (LD) for Segment 2AE to 2BE, between PP 16 and 17 (Cross Beam Side) in the web area. Holes drilled for M24 bolts are generally drilled with a 26mm diameter. The holes at this area were measured as being 28mm and 30mm diameter bolt holes.

Caltrans Standards Specifications July 1999: Steel Structure Section 55-3.14A, 'Bolt Holes': "The finished holes shall be cylindrical, perpendicular to the plane of the connection and shall be not more than 1.6 mm larger than the nominal diameter of the bolt."

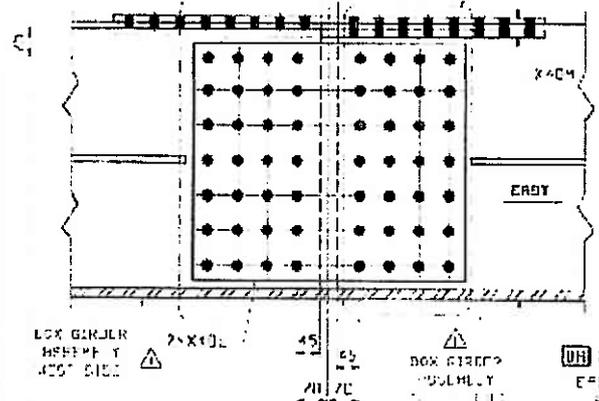
During fabrication, it is found all the holes in longitudinal shear PL at SEG2AE and SEG2BE splice are mistakenly drilled into 30mm while per shop drawings it shall be 27mm. There are 112 mistakenly oversized holes in total and edge distance is 45mm. ZPMC proposes to,

1. Leave the oversized holes "as built" and use M24 HSB on them. Then minimum edge distance ( $24 \times 1.75 = 42\text{mm}$ ) can be kept.
2. Leave the oversized holes "as built" and use M27 HSB on them.
