DEPARTMENT OF TRANSPORTATION
 DIVISION OF ENGINEERING SERVICES
 Office of Structural Materials
 Quality Assurance and Source Inspection

QUALITY ASSURANCE -- NON-CONFORMANCE REPORT

Location: Changxing Island **Report No:** NCR-000362
Prime Contractor: American Bridge/Fluor Enterprises, a JV **Date:** 08-Jul-2009
Submitting Contractor: Zhenhua Port Machinery Company, Ltd (ZPMC), Changxing Island **NCR #:** ZPMC-0336

Reference Description: Missed UT and MT indications

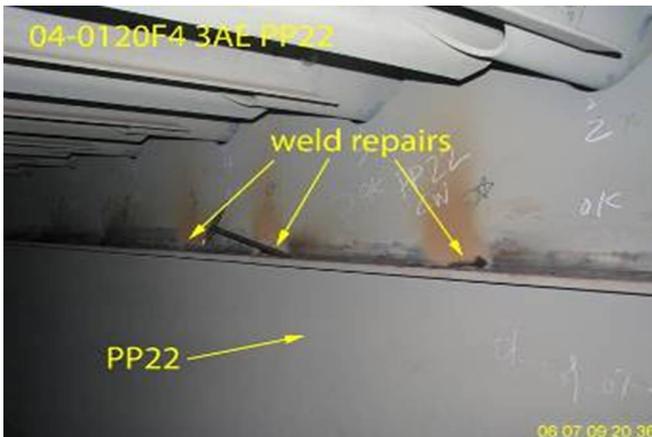
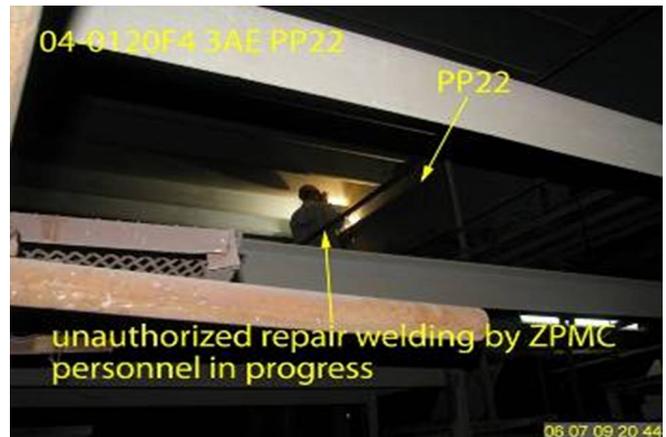
1. Caltrans Quality Assurance (QA) Inspector performed Magnetic Particle Testing (MT) on Weld Joint SEG015A-007 (Side Plate to Bottom Plate) and Longitudinal Diaphragm (LD) between Panel Point 22 and 23 located in Segment 3BW. QA Inspector also performed the MT on Panel Point 23 vertical surface area where the LD fits up. The QA Inspector observed several linear indications approximately 130mm in length. ZPMC MT Technician performed the MT testing at same area after and concurred with the QA Inspector findings.

2. Caltrans Quality Assurance (QA) Inspector performed Ultrasonic Testing (UT) verification on weld joint SEG015A-007 (Side Plate to Bottom Plate). The tested area was located between Panel Point 22 and 23 in Segment 3BW. QA Inspector discovered sixteen (16) class "A", "B" and "C" rejectable indication measuring approximately 480 mm in total in length. The weld seam that was inspected is approximately 4300mm in length.

The first linear discontinuity is located at 1100mm from Panel Point 23. The last measurable linearity discontinuity was located at 4270mm from Panel Point 23.

ABF has notified ZPMC of the missed MT indications and ZPMC has completed the necessary repairs. ABF has taken action by hiring several MT technicians to perform overchecks of several types of welds due to the amount of missed indications. ABF is also conducting an investigation of why ZPMC is experiencing cracking of welds. This investigation is being performed by both onsite ABF personnel as well as welding experts hired by ABF for this purpose. Recently CT has brought in their own welding consultant to discuss ABF findings and preventive actions. Preventive actions such as increased preheats have been discussed with ZPMC. When the investigation is completed, ABF will submit the findings to ZPMC and CT. ABF will continue to perform overchecks until we are sure this issue is corrected and preventive actions are implemented. ZPMC will submit the repair documents at a later date to close this NCR.

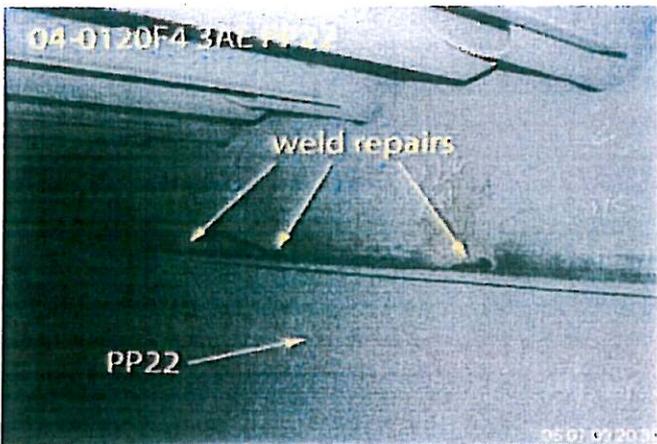
- Caltrans Quality Assurance (QA) Inspector performed Magnetic Particle Testing (MT) on Weld Joint SEG015A-007 (Side Plate to Bottom Plate) and Longitudinal Diaphragm (LD) between Panel Point 22 and 23 located in Segment 3BW. QA Inspector also performed the MT on Panel Point 23 vertical surface area where the LD fits up. The QA Inspector observed several linear indications approximately 130mm in length. ZPMC MT Technician performed the MT testing at same area after and concurred with the QA Inspector findings.

- Caltrans Quality Assurance (QA) Inspector performed Ultrasonic Testing (UT) verification on weld joint SEG015A-007 (Side Plate to Bottom Plate). The tested area was located between Panel Point 22 and 23 in Segment 3BW. QA Inspector discovered sixteen (16) class "A", "B" and "C" rejectable indication measuring approximately 480 mm in total in length. The weld seam that was inspected is approximately 4300mm in length.
 The first linear discontinuity is located at 1100mm from Panel Point 23. The last measurable linearity discontinuity was located at 4270mm from Panel Point 23.

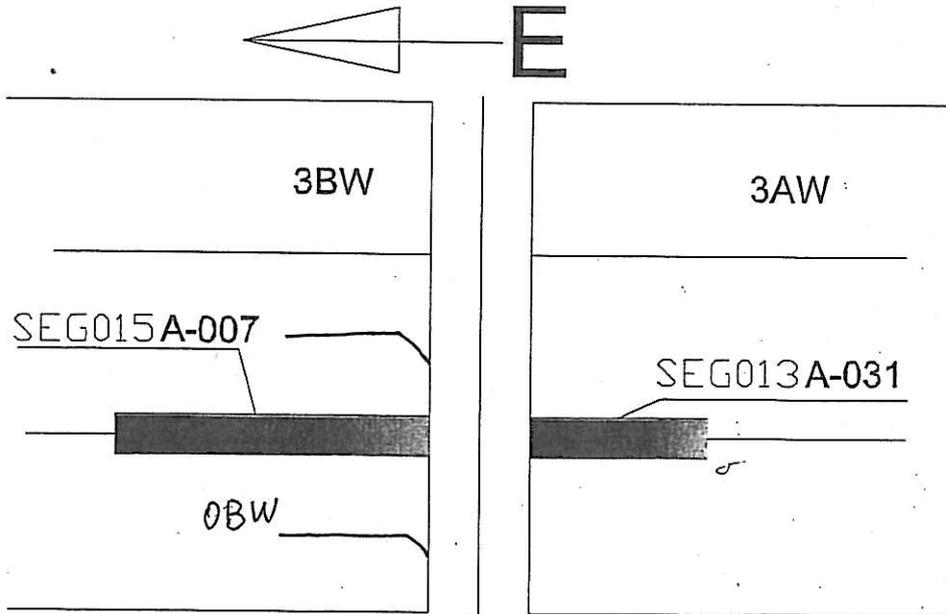
Draft of Welding Discontinuity:

经检查发现3AW与3BW北侧底板与斜底板拐角处对接缝错边最大10.5mm, 错边总长约5000mm. 详见下图, 其焊缝编号分别为SEG013A-031, SEG015A-007(现状态焊接已冲砂)

The misalignment was maximum 10.5mm at north bottom plate and side plate, 5000mm in length, relevant welds No.: SEG013A-031, SEG015A-007, and has finished welding and shading, the detail see the following draft.

焊接变形和制作误差。

Weld distortion and fabricate error.

1. Remove the welds between side plates and bottom plate at the splice. Preheat according to the WPS prior to gouging.
2. Adjust the misalignment and the straightness to meet the tolerance by outer force.
3. Prepare the excavation between side plate and bottom plate according to the relevant WPS.
4. Perform 100%VT and MT inspection to the groove to ensure no defects exist; ;
5. Preheat and weld according to the WPS.
6. Grind the weld flush to the adjacent weld or base metal.
7. Check the weld according to the shop drawings.
