Contract #: 04-0120F4Cty: SF/ALA Rte: 80 PM: 13.2/13.9File #: 69.25B**QUALITY ASSURANCE -- NON-CONFORMANCE REPORT****Location:** Chanxing Island, Shanghai, PRC**Report No:** NCR-000365**Prime Contractor:** American Bridge/Fluor Enterprises, a JV**Date:** 20-Jun-2009**Submitting Contractor:** Zhenhua Port Machinery Company, Ltd (ZPMC), Changxing Island**NCR #:** ZPMC-0339**Type of problem:**

Reference Description: Heat Straightening without Engineer's approval**Description of Non-Conformance:**

Job Name: SAS Superstructure

Subject: NCR No. ZPMC-0339

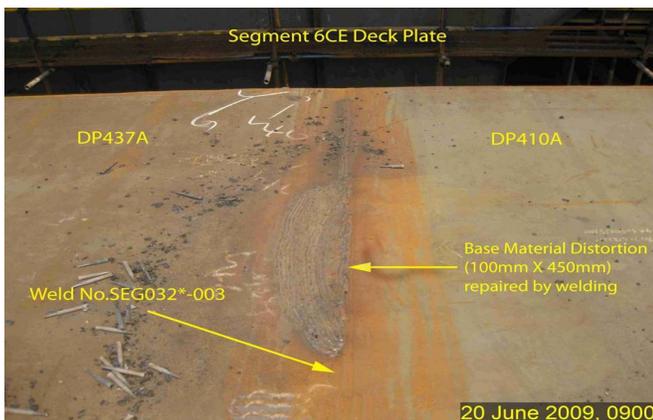
Caltrans Quality Assurance (QA) Inspector observed that a base material distortion repair was performed on Deck plate 437A in way of deck panel splice weld No. SEG032*-003. Approximately 100mm x 450mm of filler material was deposited around the splice weld. This base material distortion repair was performed without the approval of the Engineer.

Please provide documentation of the heat straightening performed and that the welds affected by the heat straightening are acceptable. The Department will review the Contractor's proposal to close Non-Conformance ZPMC-0339 at that time.

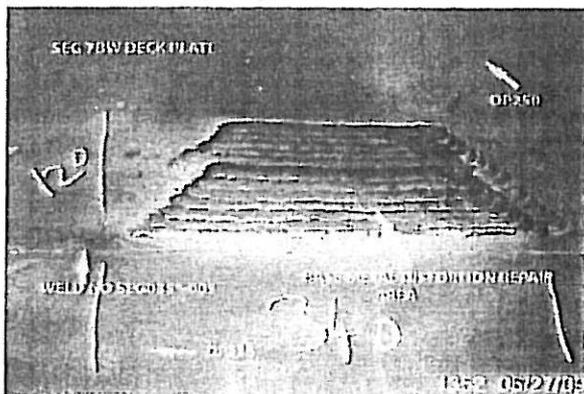
Caltrans Quality Assurance (QA) Inspector observed that a base metal distortion repair was performed on Deck plate 250 in way of deck panel splice weld No. SEG035*-005. Approximately 340mm x 120mm of FCAW filler material was deposited around the splice weld. This base metal distortion repair was performed without the approval of the Engineer.
