QUALITY ASSURANCE -- NON-CONFORMANCE REPORT

Report No: NCR-000366

Reference Description: Heat Straightening of BK2A

Job Name: SAS Superstructure

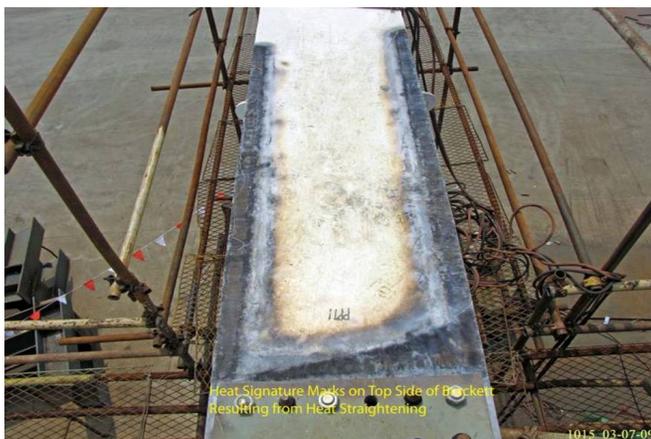
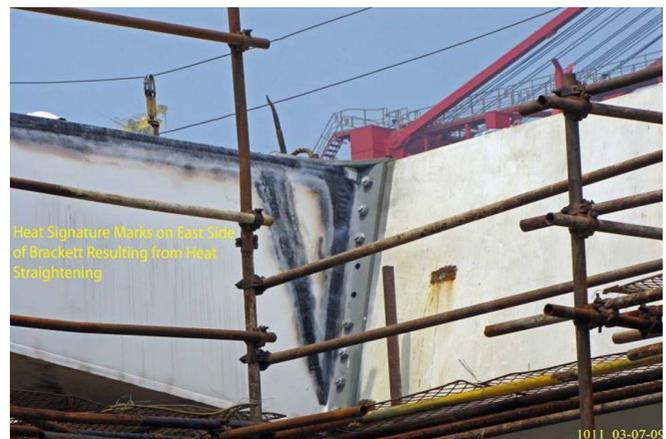
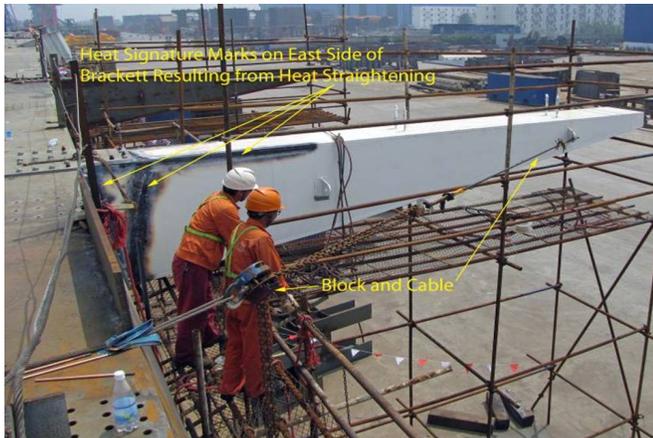
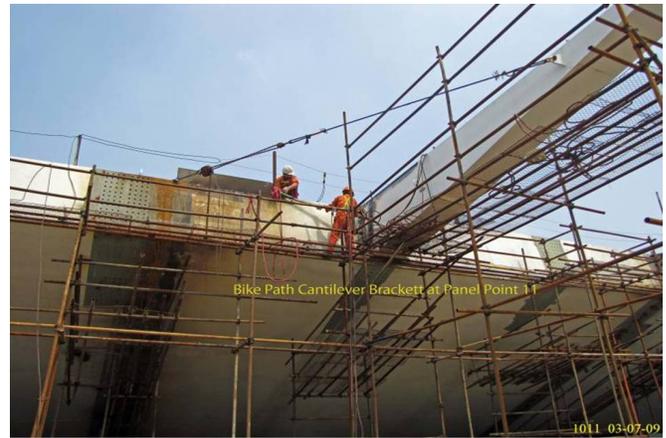
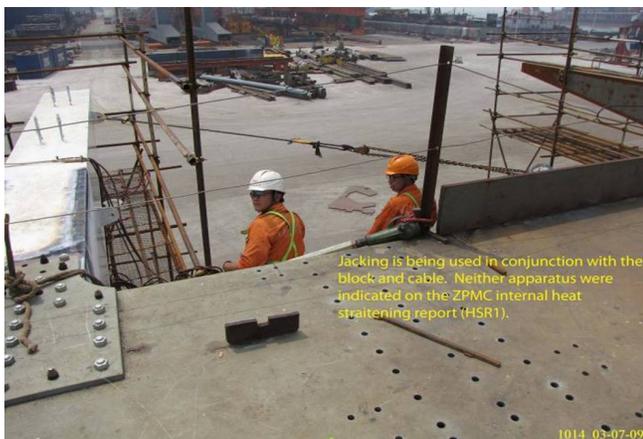
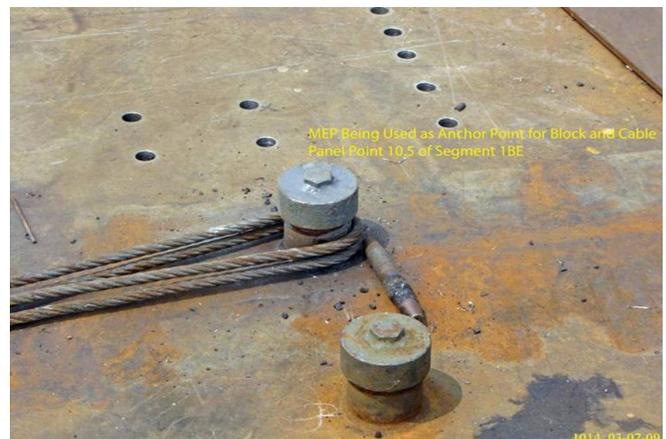
Quality Assurance Representative observed heat straightening operations being performed on the Bike Path Cantilever Brackett located at Panel Point 11 of Segment 1BE. ZPMC production personnel performing the work presented, when requested, ZPMC's internal Heat Straightening Record 1(B) 7055, which described a procedure that varied from the operations observed. The variations included the locations for the application of heat, the use of jacks and the use of a block and chain/cable to apply active pressure after heating. In addition, the anchor point of the block and chain/cable was observed to be the Mechanical Electrical Penetration (MEP) at Panel Point 10.5. The MEP was observed to be leaning toward the direction of the load while the cable was tensioned and after the load was released the MEP was measured to be 2mm out of plumb. The deck area immediately adjacent to the MEP and opposite the direction of load was observed to be slightly upset. This upset is visible but within tolerance of the specifications.

Reference Resolution: ZPMC violated several requirements regarding this NCR. The bike path bracket has since been reworked in compliance with the WQCP using the proper procedures. The MEP was replaced.

ZPMC violated several requirements regarding this NCR. The bike path bracket has since been reworked in compliance with the WQCP using the proper procedures. The MEP was replaced. ZPMC will submit the required documents at a later date for closure of this NCR.

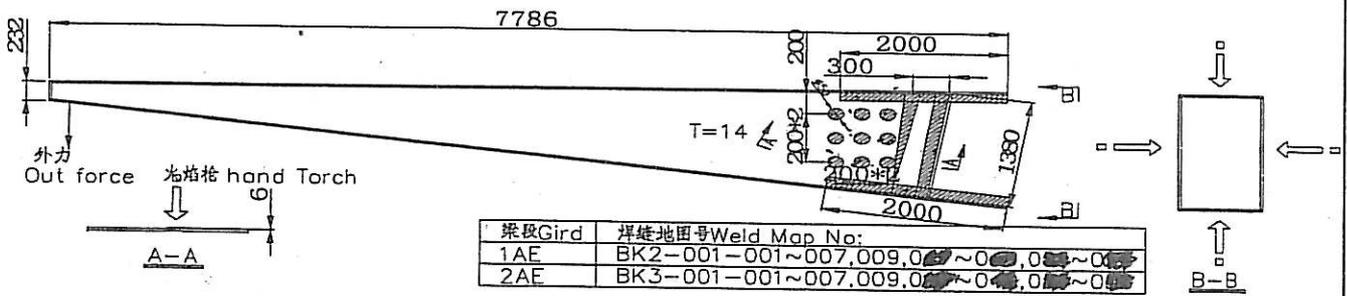
简图 Sketch

Welding distortion 焊接变形

注: 最大变形量约 6mm, 校火宽度 50~100mm.

NOTE: the max deformation is about 6mm, heat straightening the width is 50~100mm.

Flame Straightening by oxygen acetylene 运用氧乙炔进行校火

After finishing heat straightening, the weld of the heat area shall perform NDT according to the approved shop drawing 校火后, 根据图纸要求对热影响区域进行 NDT 检测。

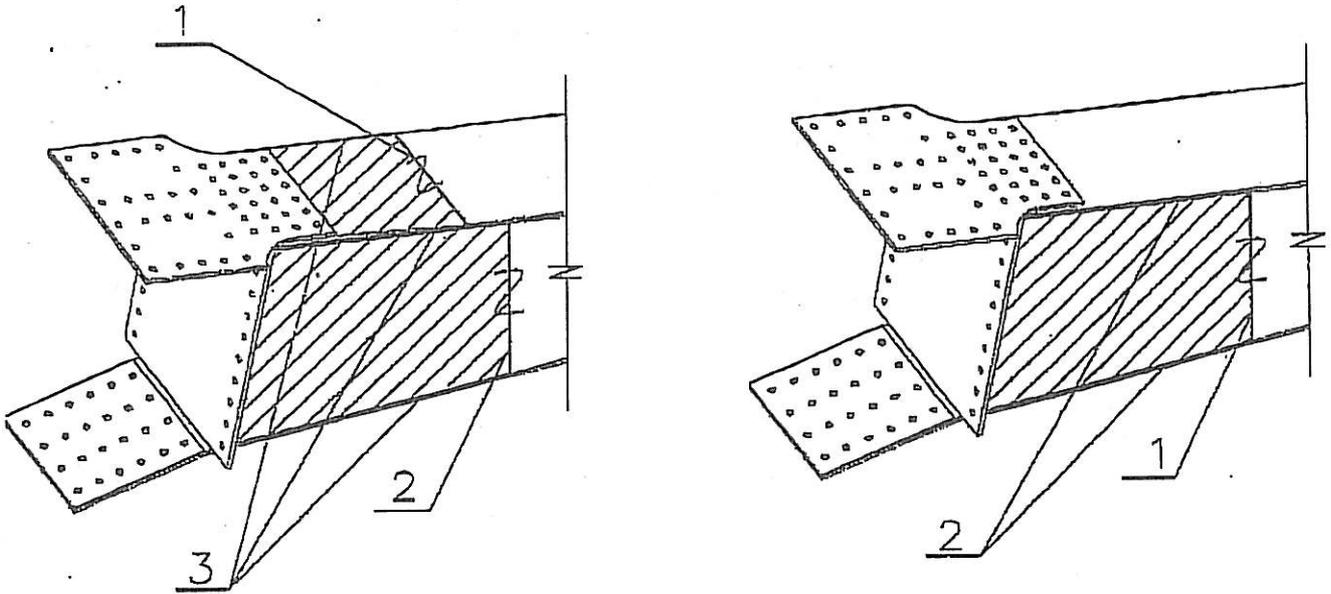
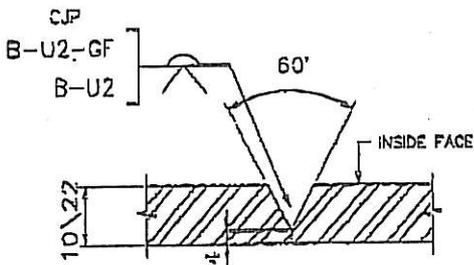
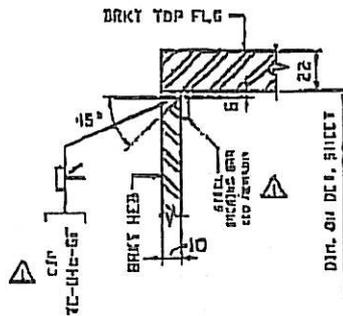
After the fabrication of bikepath cantilever beam, ZPMC finds that the flatness of deck & web will be difficult to adjust.
 Therefore, ZPMC proposes to introduce CJP splices in bikepath cantilever beam deck & web.
 See attached drawings for the proposed locations.
 For the welding sequence see the sketches below. The marked up top and web plates at BK2 & BK3 will be replaced.
 For the welding detail see the WD below. 100%UT and 100%MT will be performed on these welds.
