QUALITY ASSURANCE -- NON-CONFORMANCE REPORT

Location: Changxing Island **Report No:** NCR-000368
Prime Contractor: American Bridge/Fluor Enterprises, a JV **Date:** 19-Jun-2009
Submitting Contractor: Zhenhua Port Machinery Company, Ltd (ZPMC), Changxing Island **NCR #:** ZPMC-0342

Reference Description: Buttering of FB and SP of CB 5

Job Name: SAS Superstructure
Document No: 05.03.06-000321

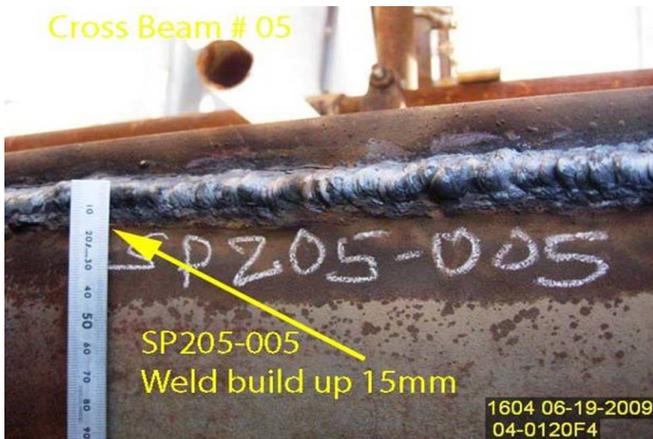
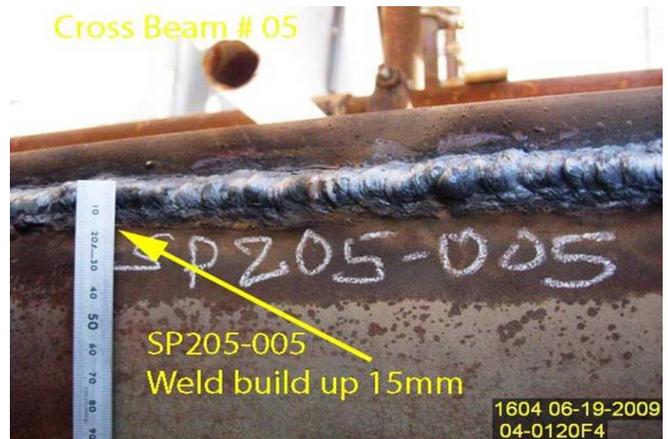
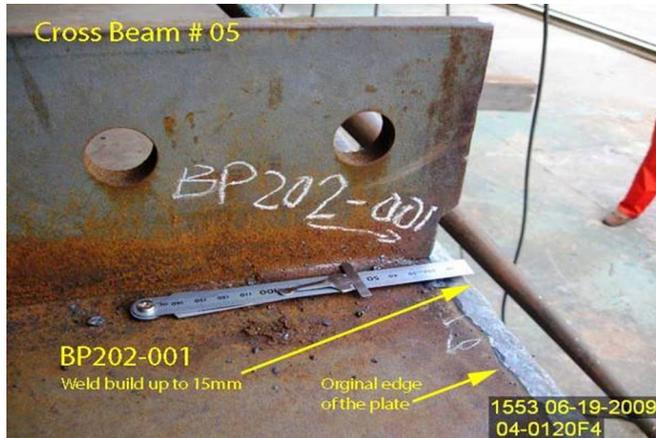
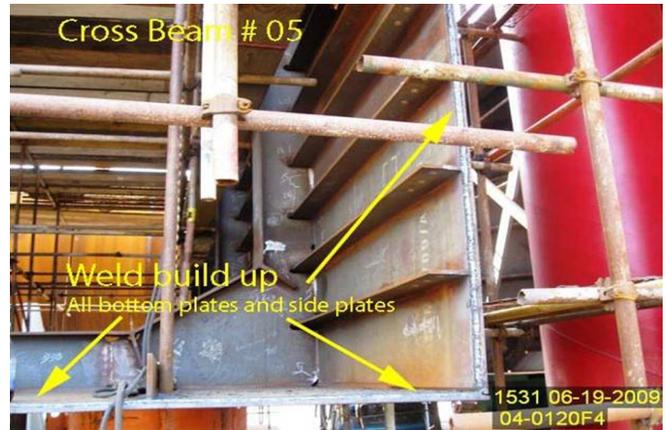
Caltrans Quality Assurance (QA) Inspector observed ZPMC personnel performing buttering on both SPCM and non SPCM portions of CB5 without an approved Critical Weld Repair. The members can be identified as the side plates and bottom plate for the Crossbeam (reference drawings CB202C, CB202D, & CB202F). Buttering was performed to correct dimensional issues with the member, and has been performed throughout the entire length of the bottom plate and both side plates. The amount of weld material deposited exceeds 1/4 of the thickness of the 12mm thick material. See attached photos:

AWS D1.5 2002, Section 12.17.2 (7) 'Noncritical Repair Welds': " Noncritical repair welds are generally welds to deposit additional weld beads or layers to compensate for insufficient weld size and to fill limited excavations to remove unacceptable edge or surface discontinuities, rollover, or undercut, including:.. (7) Deposition of weld metal up to 10 mm (3/8 inch) deep, or 1/4 the base-metal thickness, whichever is less, to correct for length or joint geometry."

Propose a resolution for the identified non-conformance with revised procedures to prevent future occurrences.,A response for the resolution of this issue is expected within 14 days.

Please provide documentation of the weld repairs that were performed and that the repairs were acceptable. The Department will review the Contractor's proposal to close Non-Conformance ZPMC-0342 at that time.

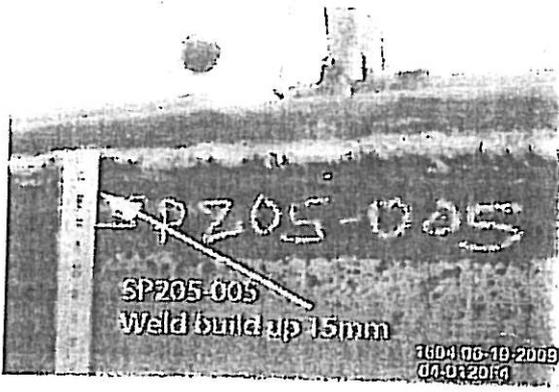
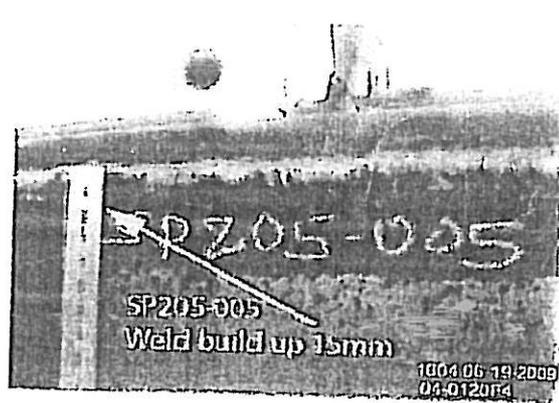
Caltrans Quality Assurance (QA) Inspector observed ZPMC personnel performing buttering on both SPCM and non SPCM portions of CB5 without an approved Critical Weld Repair. The members can be identified as the side plates and bottom plate for the Crossbeam (reference drawings CB202C, CB202D, & CB202F). Buttering was performed to correct dimensional issues with the member, and has been performed throughout the entire length of the bottom plate and both side plates. The amount of weld material deposited exceeds 1/4 of the thickness of the 12mm thick material. See attached photos:

AWS D1.5 2002, Section 12.17.2 (7) 'Noncritical Repair Welds': " Noncritical repair welds are generally welds to deposit additional weld beads or layers to compensate for insufficient weld size and to fill limited excavations to remove unacceptable edge or surface discontinuities, rollover, or undercut, including: (7) Deposition of weld metal up to 10 mm (3/8 inch) deep, or 1/4 the base-metal thickness, whichever is less, to correct for length or joint geometry."

Recommendation:
建议: 对堆焊区域进行 UT, MT 检测。 UT, MT inspect build up area.

Technical Justification for Use-As-Is/Repair: Attachment Non-attachment
 回用或返修的技术依据: 附件 对堆焊区域进行 UT, MT 检测, 并加强现场管理。 Perform UT, MT inspection to the repair area, and enhance site supervision and management.

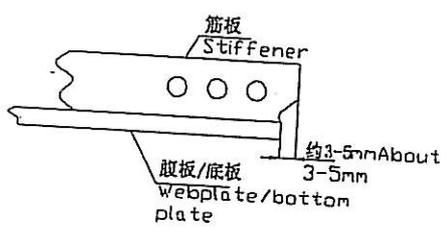
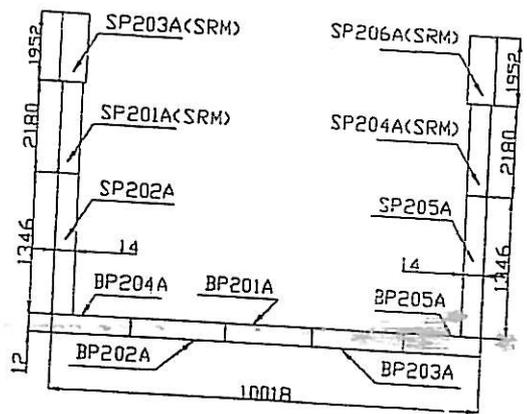
Draft of Welding Discontinuity:

注: 图中
SP202A, SP205A, BP201A, BP202A, BP203A, BP204A, BP205A
7块板单元为SPCM板
Remark: SP202A, SP205A,
BP201A, BP202A, BP203A, BP204A, BP205A
were SPCM component

Worker wasn't carefully during trimming allowance caused component was shorter than T-shape.

1. The Engineer shall be notified and present during this repair. Indicate repair procedure;
2. QC and a Lead CWI shall be present and direct all grinding and welding operations during this repair.
3. QC and a Lead CWI shall have an approved copy of the CWR in hand prior to the repair.
4. QC and a Lead CWI shall direct the repair to ensure the repair is per the disposition requirements.
5. Perform hardness testing at repair area and base metal laying above cracks, provide verbal and written notification to Engineer prior to performing hardness testing, and submit the testing result to Caltrans for review prior to repairing after testing.

1. Prepare excavation with relevant WPS.
2. VT to verify repair area is free of all defects.
3. Add steel backing at the back of groove according to AWS D1.5.3.13;
4. Preheat and weld according to the relevant WPS.
5. Gouge off the steel backing and grind the weld flush with base metal after welding;
6. Perform NDT inspection (VT, UT and MT) to the repaired welding according to the relevant requirement. UT and MT must be performed for SRM members in accordance with Section 3.2.2.3 of AWS D1.5 after repair.

1. Prepare excavation with relevant WPS.
2. VT to verify repair area is free of all defects.
3. Preheat and weld according to the relevant repaired WPS.
4. Grind the weld flush with base metal after welding;
5. Perform NDT inspection (MT) to the repaired welding according to the relevant requirement. UT and MT must be performed for SRM members in accordance with Section 3.2.2.3 of AWS D1.5 after repair.

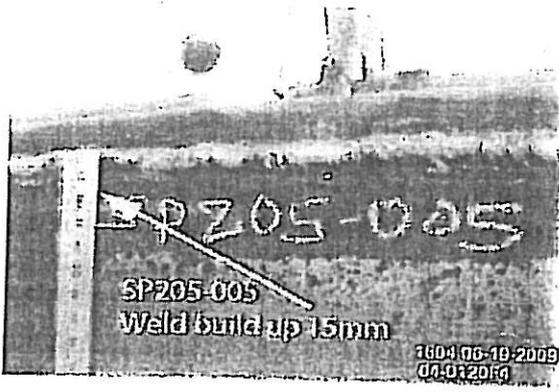
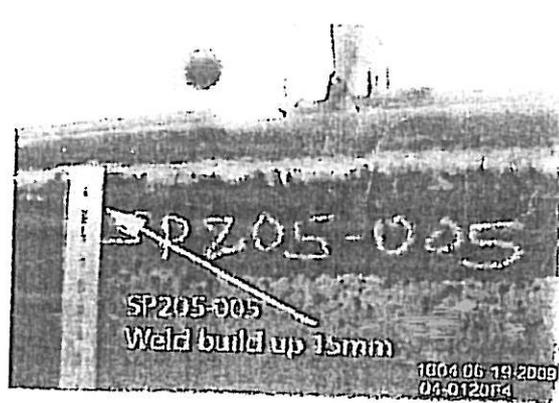
Caltrans Quality Assurance (QA) Inspector observed ZPMC personnel performing buttering on both SPCM and non SPCM portions of CB5 without an approved Critical Weld Repair. The members can be identified as the side plates and bottom plate for the Crossbeam (reference drawings CB202C, CB202D, & CB202F). Buttering was performed to correct dimensional issues with the member, and has been performed throughout the entire length of the bottom plate and both side plates. The amount of weld material deposited exceeds 1/4 of the thickness of the 12mm thick material. See attached photos:

AWS D1.5 2002, Section 12.17.2 (7) 'Noncritical Repair Welds': " Noncritical repair welds are generally welds to deposit additional weld beads or layers to compensate for insufficient weld size and to fill limited excavations to remove unacceptable edge or surface discontinuities, rollover, or undercut, including: (7) Deposition of weld metal up to 10 mm (3/8 inch) deep, or 1/4 the base-metal thickness, whichever is less, to correct for length or joint geometry."

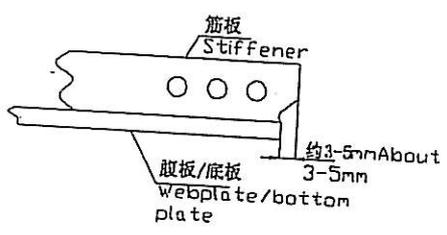
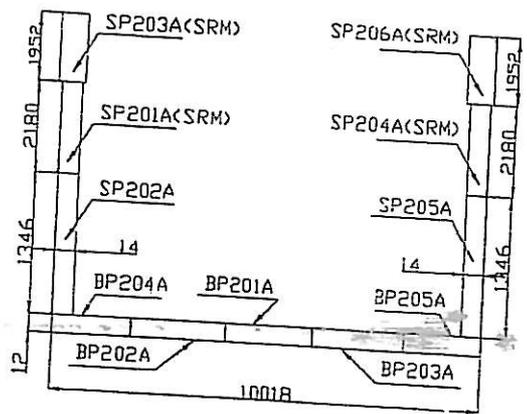
Draft of Welding Discontinuity:

注: 图中
 SP202A, SP205A, BP201A, BP202A, BP203A, BP204A, BP205A
 7块板单元为SPCM板
 Remark: SP202A, SP205A,
 BP201A, BP202A, BP203A, BP204A, BP205A
 were SPCM component

Worker wasn't carefully during trimming allowance caused component was shorter than T-shape.

1. The Engineer shall be notified and present during this repair. Indicate repair procedure;
2. QC and a Lead CWI shall be present and direct all grinding and welding operations during this repair.
3. QC and a Lead CWI shall have an approved copy of the CWR in hand prior to the repair.
4. QC and a Lead CWI shall direct the repair to ensure the repair is per the disposition requirements.
5. Perform hardness testing at repair area and base metal laying above cracks, provide verbal and written notification to Engineer prior to performing hardness testing, and submit the testing result to Caltrans for review prior to repairing after testing.

1. Prepare excavation with relevant WPS.
2. VT to verify repair area is free of all defects.
3. Add steel backing at the back of groove according to AWS D1.5.3.13;
4. Preheat and weld according to the relevant WPS.
5. Gouge off the steel backing and grind the weld flush with base metal after welding;
6. Perform NDT inspection (VT, UT and MT) to the repaired welding according to the relevant requirement. UT and MT must be performed for SRM members in accordance with Section 3.2.2.3 of AWS D1.5 after repair.

1. Prepare excavation with relevant WPS.
2. VT to verify repair area is free of all defects.
3. Preheat and weld according to the relevant repaired WPS.
4. Grind the weld flush with base metal after welding;
5. Perform NDT inspection (MT) to the repaired welding according to the relevant requirement. UT and MT must be performed for SRM members in accordance with Section 3.2.2.3 of AWS D1.5 after repair.
