Contract #: 04-0120F4
 Cty: SF/ALA Rte: 80 PM: 13.2/13.9
 File #: 69.25B

QUALITY ASSURANCE -- NON-CONFORMANCE REPORT

Report No: NCR-000371

Reference Description: Longitudinal Diaphragm & Deck Plate

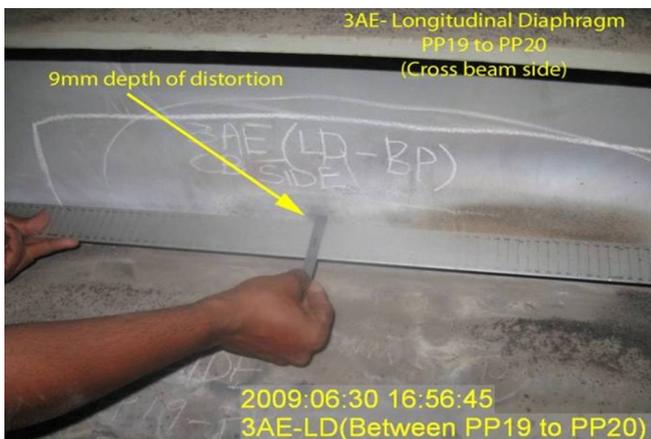
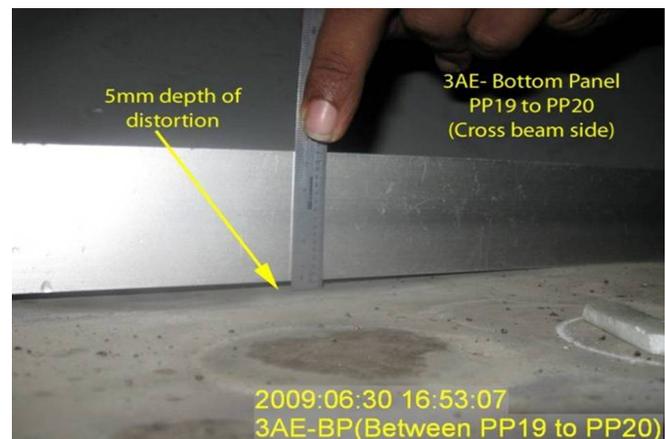
During in process visual inspection of the OBG Trial Assembly of Segment 3AE, Caltrans Quality Assurance (QA) Inspector discovered isolated distortion damage at Longitudinal Diaphragm and Bottom Plate between Panel Point 19 and 20 (Cross Beam Side). The distortion damage appears as a viable bulge in the Diaphragm and Bottom Plate at a location where an external support was positioned. The bulge appears to be related to heat straightening repairs. The heat straightening was performed without submitting a Heat Straightening Request to the Engineer. See the below photos for further information.

AWS D1.5 2002, Section 3.7.3: "Members distorted by welding shall be straightened by mechanical means or by carefully supervised application of a limited amount of localized heat as approved by the Engineer."

The proposed resolution is acceptable. The welds in question have been accepted by VT and MT as shown in the attached documents. The Department concurs that Non-Conformance ZPMC-0345 is closed.

With this letter of response, ZPMC requests closure for Caltrans **NCR-000371 (ZPMC-345)**. We agree what are submitted the FCN for the engineer approval that change one part of the LD in the middle to replace the distorted position, and also perform the round CJP weld per the WPS and drawing require, right now we provide the documentation to prove that the repair have been conducted and the weld were acceptable by NDT and visual inspection, by the way remind here that the corresponding item in the punchlist have been closed out by caltrans and ABF.

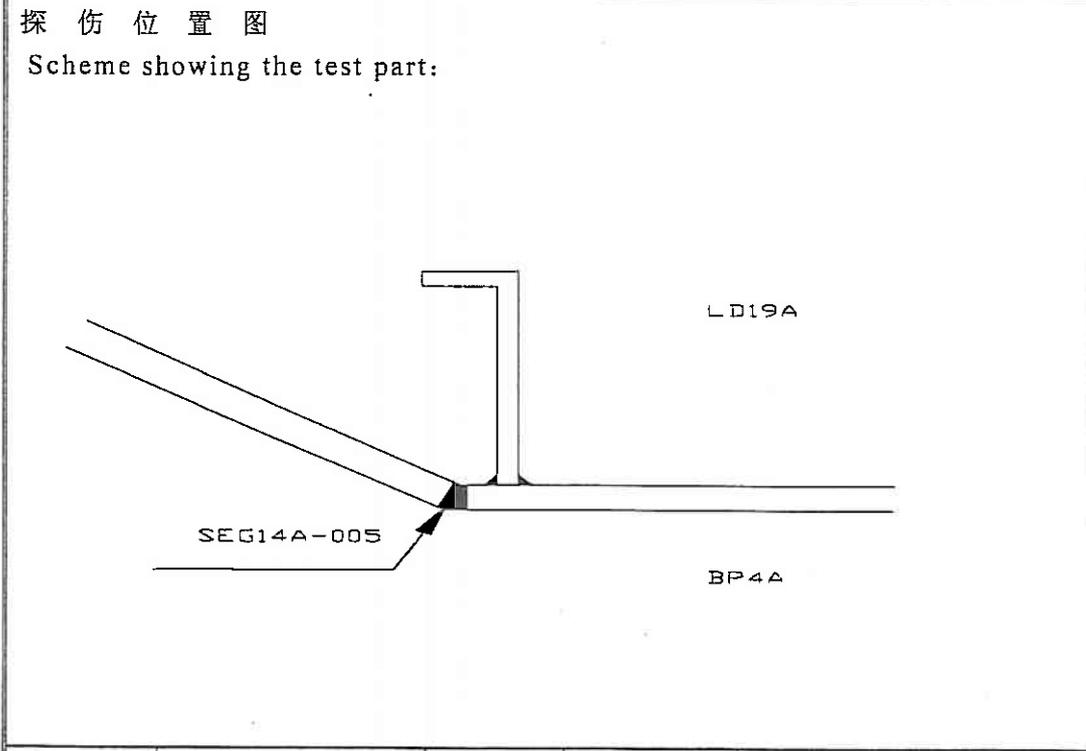
序号 No.	探伤编号 NDL No.	焊缝类型 Weld type	板厚/直径 thickness/diameter	焊工姓名 Welder name	焊工编号 Welder No.	结 论 Result	备注 remark
1	SEG14A-005	对接	22*20*900		220063 066571	✓	
2

WR/CWR 返修后
WR/CWR NO: B-wr-6492

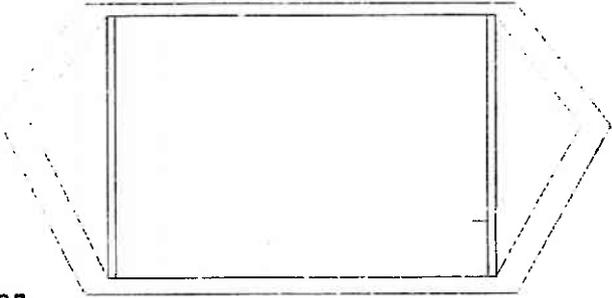
ZPMC		探伤申请表 APPLICATION FORM FOR NDT			产品名称 NAME OF PRODUCT 美国海湾大桥		
零部件图号 Drawing No	OBE3	探伤类别 Test type	100%UT	编号 No	ZP06--787		
零部件名称 Items	3AE	材料 Material	A709M-345	数量 Quantity			
序号 No.	探伤编号 NDT No.	焊缝类型 Weld type	板厚/直径 thickness/diameter	焊工姓名 Welder name	焊工编号 Welder No.	结论 Result	备注 remark
1	SEG014A-005	对接	20*20*1000		220063+066571	✓	
2							
3							
4							
5							
6							
7							
8							
9							
探伤位置图 Scheme showing the test part					备注:		
3AE联系案例
