Contract #: 04-0120F4Cty: SF/ALA Rte: 80 PM: 13.2/13.9File #: 69.25B**QUALITY ASSURANCE -- NON-CONFORMANCE REPORT****Location:** Changxing Island, Shanghai, P.R. China**Report No:** NCR-000373**Prime Contractor:** American Bridge/Fluor Enterprises, a JV**Date:** 06-Aug-2009**Submitting Contractor:** Zhenhua Port Machinery Company, Ltd (ZPMC), Changxing Island**NCR #:** ZPMC-0347**Type of problem:**

Reference Description: Undercut welds were accepted by QC at Crossbeam 2**Description of Non-Conformance:**

Job Name: SAS Superstructure

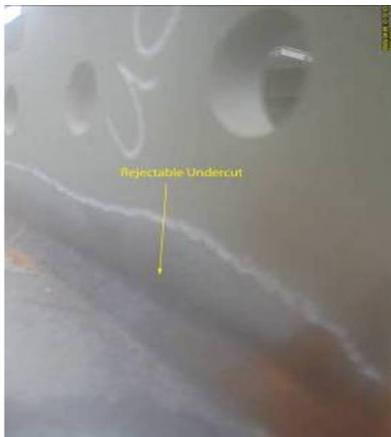
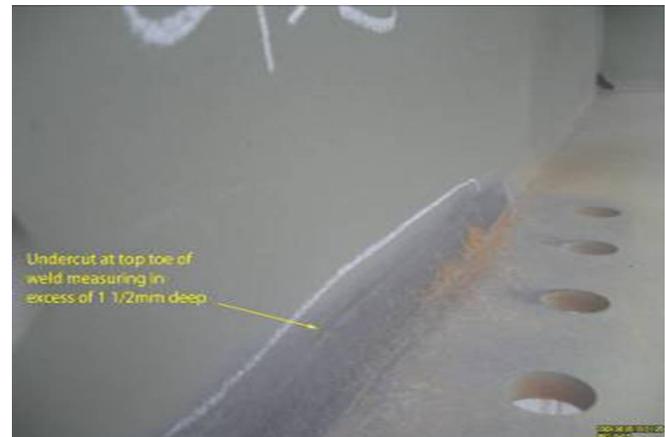
This Quality Assurance (QA) Inspector perform VT and MT inspection on holdback welds at the CB204A-004, 006, 010, 012, 016, 018, 023 and 024. Rejectable undercuts were found measuring up to a maximum of 1.75 mm deep in multiple (SPCM) Hold back areas. These welds are listed below. These welds were previously approved and accepted by ZPMC QC.

SP220A-1 To BP215A-1 (SP to BP Corner Joint With Fillet)
 SP220A-2 To BP215A-2 (SP to BP Corner Joint With Fillet)
 BP212A-1 To FB212A-1 (FB to BP Fillet weld)
 BP212A-2 To FB212A-2 (FB to BP Fillet weld)
 BP216A-1 To SP 217A-1 (SP to BP Corner Joint With Fillet)
 BP216A-2 To SP 218A-2 (SP to BP Corner Joint With Fillet)

AWS D1.5-2002 section 6.26.1.5: In Primary members, undercut shall be no more than 0.25 mm (0.01 in.) deep when the weld is transverse to tensile stress under any design loading condition. Undercut shall be no more than 1 mm (1/32) deep for all other cases.

Submit repair procedure to engineer for approval.

With this letter of response, ZPMC requests closure for Caltrans NCR-000373 (ZPMC-0347). We agree what describe in the non-conformance report, and have do the weld repair on the undercut areas, and then flush grinding on the fillet top to assure the profile reach the specification of 0.25mm undercut. By the way we have done the MT inspection on the related weld and providing the report as the attachment. Also we remind here that all of the repair process was witnessed by the CT inspector and accepted the final condition by each parties, the corresponding items in the punchlist have been closed out too.
