Contract #: 04-0120F4Cty: SF/ALA Rte: 80 PM: 13.2/13.9File #: 69.25B**QUALITY ASSURANCE -- NON-CONFORMANCE REPORT****Location:** Changxing Island, Shanghai, P.R. China**Report No:** NCR-000374**Prime Contractor:** American Bridge/Fluor Enterprises, a JV**Date:** 30-Jul-2009**Submitting Contractor:** Zhenhua Port Machinery Company, Ltd (ZPMC), Changxing Island**NCR #:** ZPMC-0348**Type of problem:**

Reference Description: Missed UT indications by QC on Traveler Rail Bracket TR1E**Description of Non-Conformance:**

Reference Description: Missed UT indications by QC on Traveler Rail Bracket TR1E

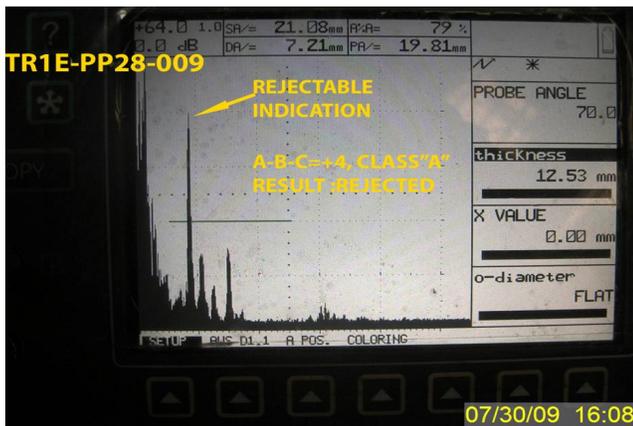
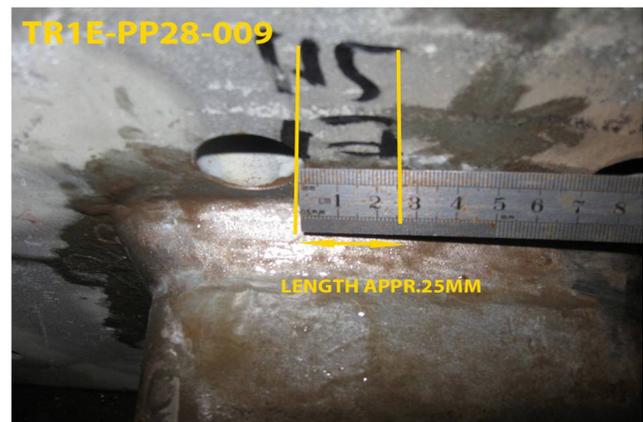
This Quality Assurance Inspector (QA) performed random verification of Ultrasonic Testing (UT) on weld joint identified as TR1E-PP28-009 for OBG Traveler Rail Bracket. This QA Inspector discovered one (1) class "A" rejectable indication measuring approximately 25 mm in length. This weld was previously tested and accepted by ZPMC QC UT technicians.

Submit weld repair to engineer for approval.

ABF has notified ZPMC of this nonconformance and instructed the same UT operator to recheck this weld. The UT operator verified the indication was an unacceptable Class "A" indication and has since marked the part for repair. ABF has discussed UT technique issues with ZPMC to prevent further nonconformances. ZPMC will submit repair reports at a later date to close this NCR.

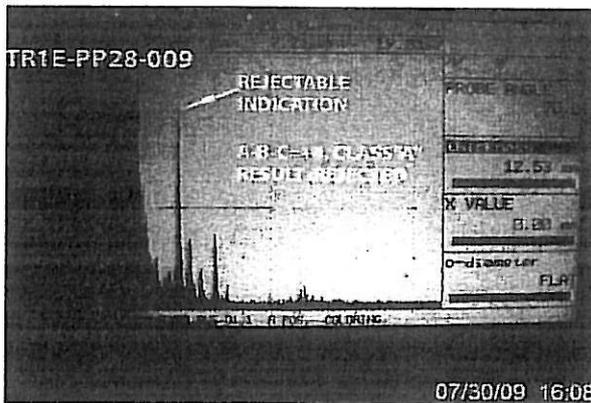
This Quality Assurance Inspector (QA) performed random verification of Ultrasonic Testing (UT) on weld joint identified as TR1E-PP28-009 for OBG Traveler Rail Bracket. This QA Inspector discovered one (1) class "A" rejectable indication measuring approximately 25 mm in length. This weld was previously tested and accepted by ZPMC QC UT technicians.

Submit weld repair to engineer for approval.

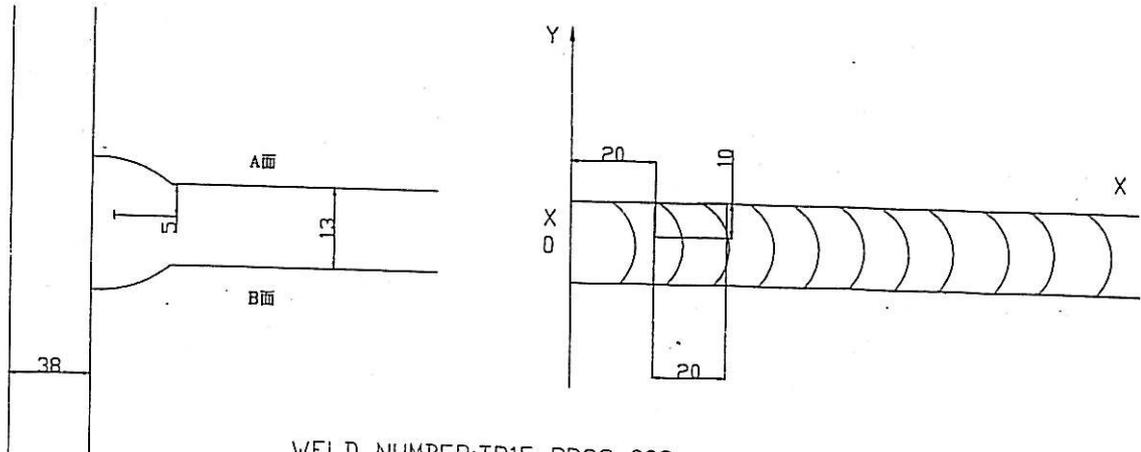
WELD NUMBER:TR1E-PP28-009

Rejected indication found by ultrasonic inspection is less than the maximum allowance aggregate length.

1. 焊道未及时处理干净。
1. Did not clear the weld pass completely in time.

1. 从缺陷距离端面较近一侧 ($D \leq 0.65T$, D 为缺陷深度, T 为板厚) 采用碳刨或打磨的方法去除焊缝缺陷;
 2. 参照返修焊接工艺规程 (WPS) 准备正确的接头型式, 预热和焊接;
 3. 焊前对修补区域进行VT检测保证缺陷完全被清除;
 4. 将修补区域打磨到与母材或邻近焊缝平齐;
 5. 根据批准的车间图纸检查焊缝.
-
1. Gouge or grind from nearer side from metal edge ($D \leq 0.65T$, " D " is depth of defects, " T " is thickness of metal) to remove all defects;
 2. Follow repair WPS for joint preparation, preheat, and weld deposit;
 3. Verify with VT no defects remain in the weld joint prior to welding;
 4. Grind the repaired area flush with base metal or the adjacent weld;
 5. Check the welds according to the working drawings.

1. Improve monitoring of welding and interpass cleaning.
