Contract #: 04-0120F4Cty: SF/ALA Rte: 80 PM: 13.2/13.9File #: 69.25B**QUALITY ASSURANCE -- NON-CONFORMANCE REPORT****Location:** Changxing Island, Shanghai, P.R. China**Report No:** NCR-000379**Prime Contractor:** American Bridge/Fluor Enterprises, a JV**Date:** 06-Aug-2009**Submitting Contractor:** Zhenhua Port Machinery Company, Ltd (ZPMC), Changxing Island**NCR #:** ZPMC-0353**Type of problem:**

Reference Description: Missed MT Indication in the base metal on CB6 Intermediate Diaphragm**Description of Non-Conformance:**

Job Name: SAS Superstructure

Subject: NCR No. ZPMC-0353

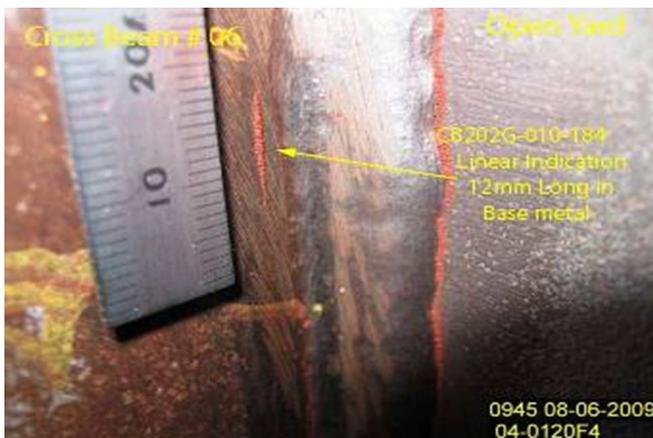
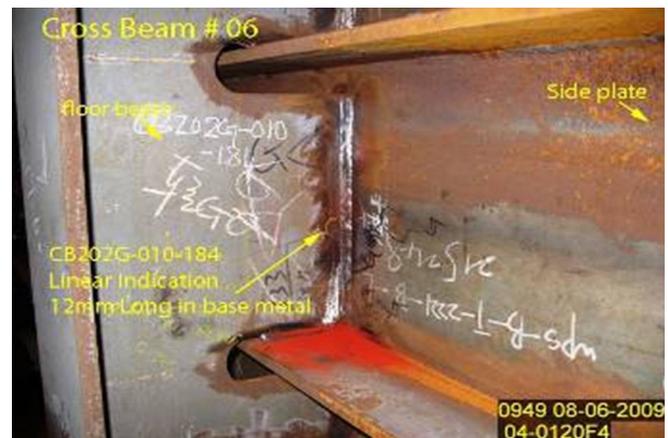
During random verification of Magnetic Particle Testing (MT) at OBG Cross Beam # 06 Intermediate Diaphragm. Caltrans Quality Assurance (QA) Inspector discovered a 12mm long linear indication in the base metal near the weld (CB202G-010-184). These areas were previously tested and accepted by ZPMC Quality Control MT Technician.

AWS D1.5 (02) Section 6.26.2 – “Welds that are subject to MT in addition to visual inspection shall have no cracks”

Submit weld repair to engineer for approval.

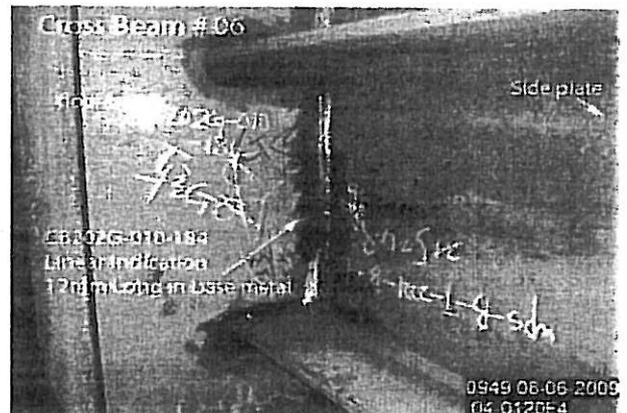
During random verification of Magnetic Particle Testing (MT) at OBG Cross Beam # 06 Intermediate Diaphragm. Caltrans Quality Assurance (QA) Inspector discovered a 12mm long linear indication in the base metal near the weld (CB202G-010-184). These areas were previously tested and accepted by ZPMC Quality Control MT Technician.

AWS D1.5 (02) Section 6.26.2 – “Welds that are subject to MT in addition to visual inspection shall have no cracks”

Submit weld repair to engineer for approval.

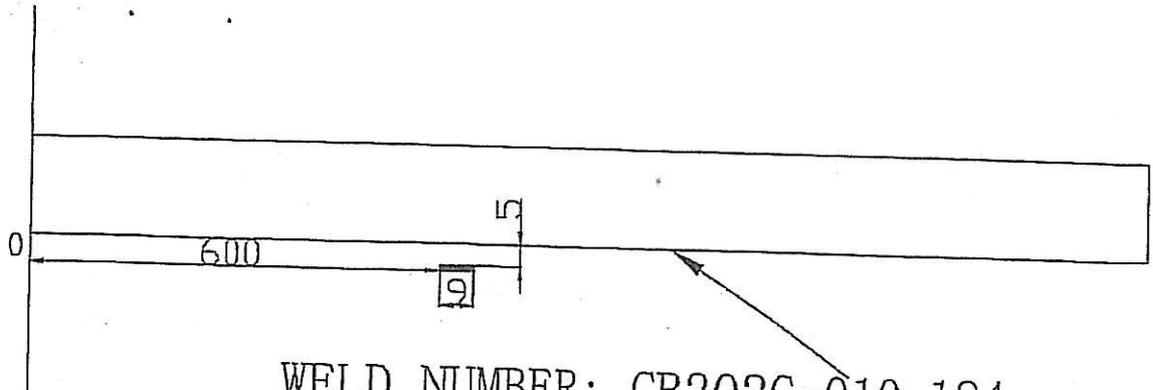
WELD NUMBER: CB202G-010-184

One longitudinal crack was found by use of MT on CB202G-010-184.

1. 火焰加热时, 水汽没有完全的去掉或者这个区域预热不够;
1. Moisture wasn't completely removed during drying operation (preheating) or the area wasn't preheated sufficiently.

1. QC and a Lead CWI shall be present, direct and supervise all grinding and welding operations during this repair to ensure the repair is per the disposition requirements.

2. QC and a Lead CWI shall have an approved copy of the CWR in hand prior to the repair.
 3. Remove paint ≥ 25 mm in all direction of HAZ prior to MT.
 4. Remove cracks by grinding. Repair area shall extend a minimum of 50mm beyond each end of single crack repairs.

5. Perform hardness testing at repair area and base metal laying abroad cracks, provide verbal and written notification to Engineer prior to performing hardness testing, and submit the testing result to Caltrans for review prior to repairing after testing.

6. Perform base metal repair work as follows if base metal damage protrudes into the surface more than 3mm.
 7. Prepare excavation in accordance with an approved repair WPS prior to welding.

8. Before this repair, Verify with VT and MT repair areas are defects free.
 9. Preheat and weld according to the approved repair WPS.
 10. Grind the repaired area flush with base metal or the adjacent weld.

11. Perform relevant NDT inspection to all repaired weld (along with an additional 50mm at each end of the weld repair) as well as the weld which is in the opposite position of the repaired welds according to shop drawing and additional NDT requirement stated in special provision 10-1.59 "inspection testing" note 3 after repair.
