## QUALITY ASSURANCE -- NON-CONFORMANCE REPORT

**Report No:** NCR-000380

**Reference Description:** Welding on wet material and with the absence of QC exceeding 30 minutes

**Job Name:** SAS Superstructure

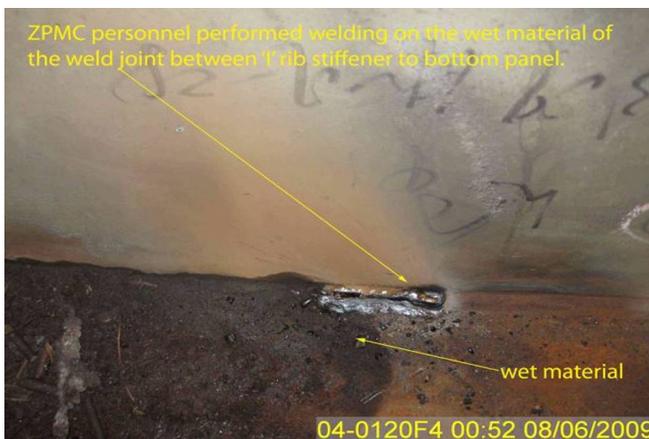
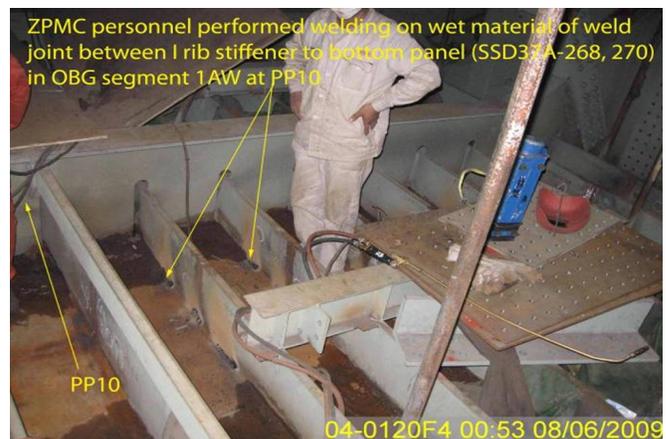
This Caltrans Quality Assurance (QA) Inspector observed the following on OBG Segment 1AW (SSD37A-268 and 270):

1. ZPMC welding personnel performing SMAW welding on weld joints SSD37A-268 and SSD37A-270 at OBG Segment 1AW near PP10, "I-rib" stiffener to bottom panel while the base material was wet.
2. On August 6, 2009 between the hours of 00:10 and 01:15 during the welding of joints SSD37A-268 and SSD37A-270 at OBG Segment 1AW near PP10, no ZPMC Quality Control (QC) CWI Inspection personnel were present to monitor this welding.

1. AWS D1.5 2002 section 3, paragraph 3.1.3 "Welding shall not be done when the surfaces are wet or exposed to rain. AWS D1.5 2002 section 3, paragraph 3.2.1 "Surfaces to be welded and surfaces adjacent to a weld shall also be free from moisture that would prevent proper welding.
2. Special Provisions 8-3.01, "QC inspections shall be provided to ensure continuous inspection when any welding is being performed. Continuous inspection, as a minimum, shall include (1) having QC Inspectors

Submit weld repair for engineers approval. This is an ongoing problem.

ABF has notified ZPMC QA supervisors regarding this NCR who in turn have discussed this with the welders in trial assembly. This weld will be inspected a minimum 48 hours after welding by MT. ZPMC will submit the required inspection documentation at a later date to close this NCR.
