Contract #: 04-0120F4Cty: SF/ALA Rte: 80 PM: 13.2/13.9File #: 69.25B**QUALITY ASSURANCE -- NON-CONFORMANCE REPORT****Location:** Changxing Island, Shanghai, P.R. China**Report No:** NCR-000381**Prime Contractor:** American Bridge/Fluor Enterprises, a JV**Date:** 06-Aug-2009**Submitting Contractor:** Zhenhua Port Machinery Company, Ltd (ZPMC), Changxing Island**NCR #:** ZPMC-0355**Type of problem:****Welding****Concrete****Other****Welding****Curing****Procedural****Bridge No:** 34-0006**Joint fit-up****Coating****Other****Component:** OBG Cantilever Box Bracket**Procedural****Procedural****Description:****Reference Description:** Missed MT Transverse Indication by QC on Bikepath Cantilever Box Bracket**Description of Non-Conformance:**

QUALITY ASSURANCE -- NON-CONFORMANCE REPORT

NON-CONFORMANCE REPORT TRANSMITTAL

Reference Description: Missed MT Transverse Indication by QC on Bikepath Cantilever Box Bracket

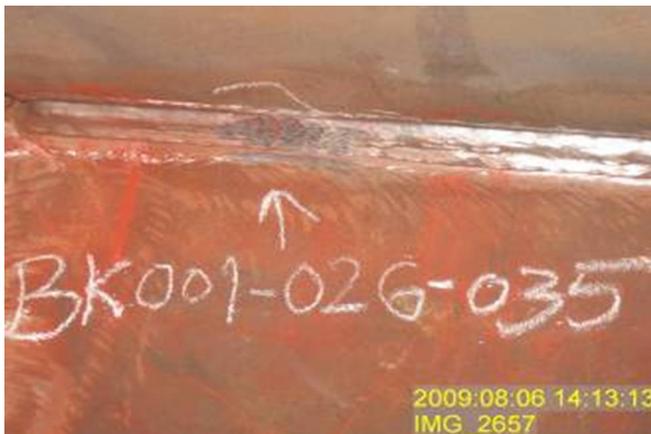
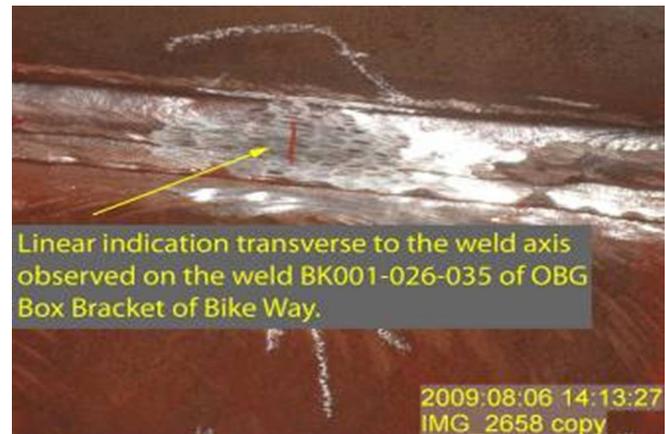
During random verification Magnetic Particle Testing (MT) of OBG Cantilever Box Bracket of Bike Path weld BK001-026-035 located in ZPMC Shop Bay 5. Caltrans Quality Assurance (QA) Inspector discovered a transverse linear indication approximately 10~12mm in length. This area had been previously tested and accepted by ZPMC NDT personnel.

AWS D1.5 (02) Section 6.26.2 – “Welds that are subject to MT in addition to visual inspection shall have no cracks.”

Submit repair procedure to engineer for approval.

Repair weld in question and perform required NDT.

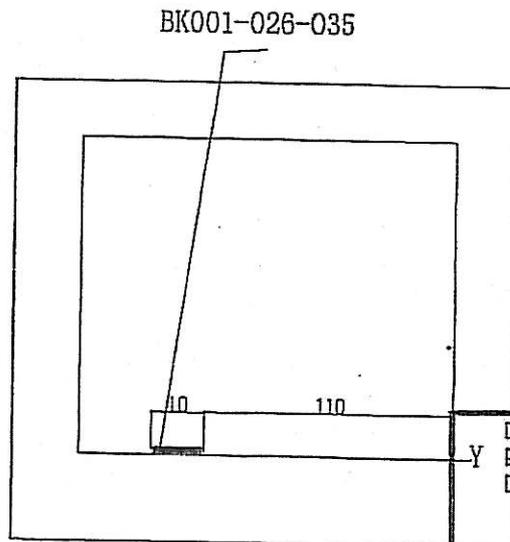
Draft of Welding Discontinuity:

We found one transverse crack on the BK001-026-035

1. 火焰加热时, 水汽没有完全的去掉或者这个区域预热不够;
1. Moisture wasn't completely removed during drying operation (preheating) or the area wasn't preheated sufficiently.

1. QC and a Lead CWI shall be present, direct and supervise all grinding and welding operations during this repair to ensure the repair is per the disposition requirements

2. QC and a Lead CWI shall have an approved copy of the CWR in hand prior to the repair.
3. Remove paint ≥ 25 mm in all direction of HAZ prior to MT.
4. Remove cracks by grinding, repair area shall extend a minimum of 50mm beyond each end of single crack repairs, and 50mm beyond the outermost cracks for multiple crack repairs.

5. Perform hardness testing across the transverse crack. Notify the Engineer prior to performing hardness testing, and submit hardness test results prior to performing repair work.

6. Prepare excavation in accordance with an approved repair WPS prior to welding.
7. Before this repair, Verify with VT and MT repair areas are defects free;

8. Preheat and weld according to the approved repair WPS.
9. Grind the repaired area flush with base metal or the adjacent weld;
10. Perform NDT in accordance with approved Contract Drawings, and perform additional NDT in accordance with Section 10-1.59 of the Special Provisions 'Steel Structures', subsection 'Inspection & Testing' Note 3.
