Contract #: 04-0120F4Cty: SF/ALA Rte: 80 PM: 13.2/13.9File #: 69.25B**QUALITY ASSURANCE -- NON-CONFORMANCE REPORT****Location:** Changxing Island, Shanghai, P.R. China**Report No:** NCR-000382**Prime Contractor:** American Bridge/Fluor Enterprises, a JV**Date:** 10-Aug-2009**Submitting Contractor:** Zhenhua Port Machinery Company, Ltd (ZPMC), Changxing Island**NCR #:** ZPMC-0356**Type of problem:**

**Reference Description:** Improper handling and support on welded base panel**Description of Non-Conformance:**

**Job Name:** SAS Superstructure

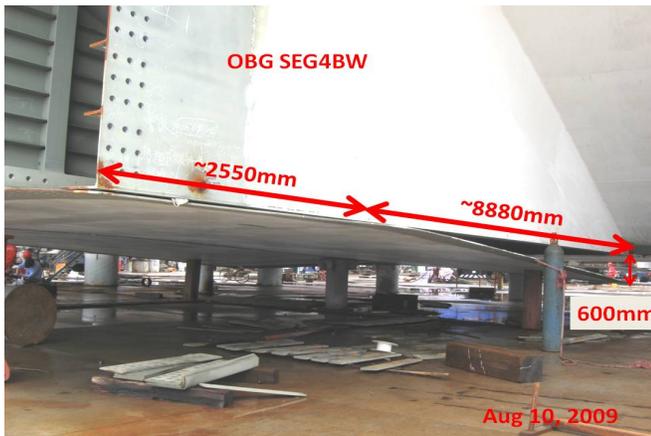
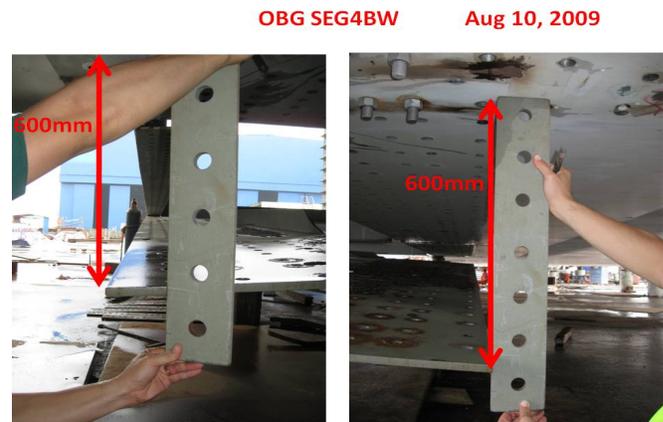
Caltrans Quality Assurance Inspector (QA) observed that the contractor has neglected to keep the fillet welded joint of the internal intermediate diaphragm with SPCM Cross Beam bottom plate (BP-25A) in close contact to prevent distortion or bending on OBG Segment 4BW. The maximum deflection at the end of the plate measured 600mm over a distance of 8880mm. The plate has been in this position and condition for at least 36 hours.

1. Standard Specifications Section 55-3.05 "Surfaces of bearing and base plates and other metal surfaces that are to come in contact with each other or with ground concrete surfaces or with asbestos sheet packing shall be flat to within one millimeter tolerance in 305 mm and to within 2 mm tolerance overall. Surfaces of bearing and base plates and other metal bearing surfaces that are to come into contact with preformed fabric pads, elastomeric bearing pads or Portland cement mortar shall be flat to within 3 mm tolerance in 305 mm and to within 5 mm overall. Steel slabs where not in contact with other metal bearing surfaces may be heat straightened in lieu of machining at the option of the Contractor, provided the above tolerances are met.

2. Standard Specifications Section 55-3.09 "Finished members shall be true to line and free from twists, bends and open joints.

Submit repair plan to engineer for approval.

**Reference Resolution:** ZPMC QA has notified their production department to adjust storage areas as necessary. As for the X-Beam plate, ZPMC will adjust the supporting practices and re-MT the affected welds.

**Reference Resolution:** ZPMC has completed NDT of the welds affected by this NCR and found them acceptable. ZPMC requests closure of this NCR.
