Contract #: 04-0120F4Cty: SF/ALA Rte: 80 PM: 13.2/13.9File #: 69.25B**QUALITY ASSURANCE -- NON-CONFORMANCE REPORT****Location:** Changxing Island, Shanghai, PRC**Report No:** NCR-000384**Prime Contractor:** American Bridge/Fluor Enterprises, a JV**Date:** 14-Aug-2009**Submitting Contractor:** Zhenhua Port Machinery Company, Ltd (ZPMC), Changxing Island**NCR #:** ZPMC-0358**Type of problem:****Welding****Concrete****Other****Welding****Curing****Procedural****Bridge No:** 34-0006**Joint fit-up****Coating****Other****Component:** North Tower**Procedural****Procedural****Description:** North Tower, Lift 1, Diaphragm to Fit Lug weld**Reference Description:** Missed MT indication on North Tower, Lift 1, Skin E, 38m Diaphragm to Fit Lug weld**Description of Non-Conformance:**

**Subject:** NCR No. ZPMC-0358

**Reference Description:** Missed Indication (MT) / North Shaft Lift 1 / Fit Lug Weld

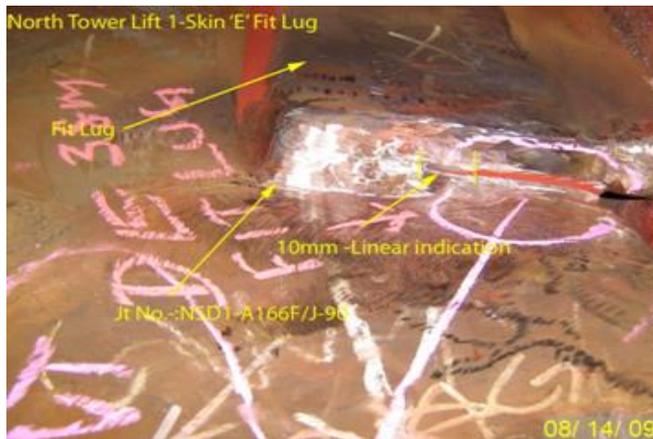
During Magnetic Particle Testing (MT) of North Tower Lift 1, Skin E, 38m Diaphragm to Fit Lug weld, designated as NSD1-A166F/J-90, QA discovered a 10mm long linear indication. This weld was previously tested and accepted by ZPMC MT Technicians.

AWS D1.5 (02) Section 6.26.2 – “Welds that are subject to MT in addition to visual inspection shall have no cracks.”

Propose a resolution for the identified non-conformance including documentation that the deficiency has been brought into compliance with the contract requirements. Additionally address the probable causes for the indication and any actions that will be taken to limit future occurrences.

In addition to the material/workmanship non-conformance, propose a resolution that addresses the failure of Quality Control to identify the linear indication during magnetic particle testing of the weld. Provide documentation of the steps taken by the Quality Control Manager to prevent future occurrences.

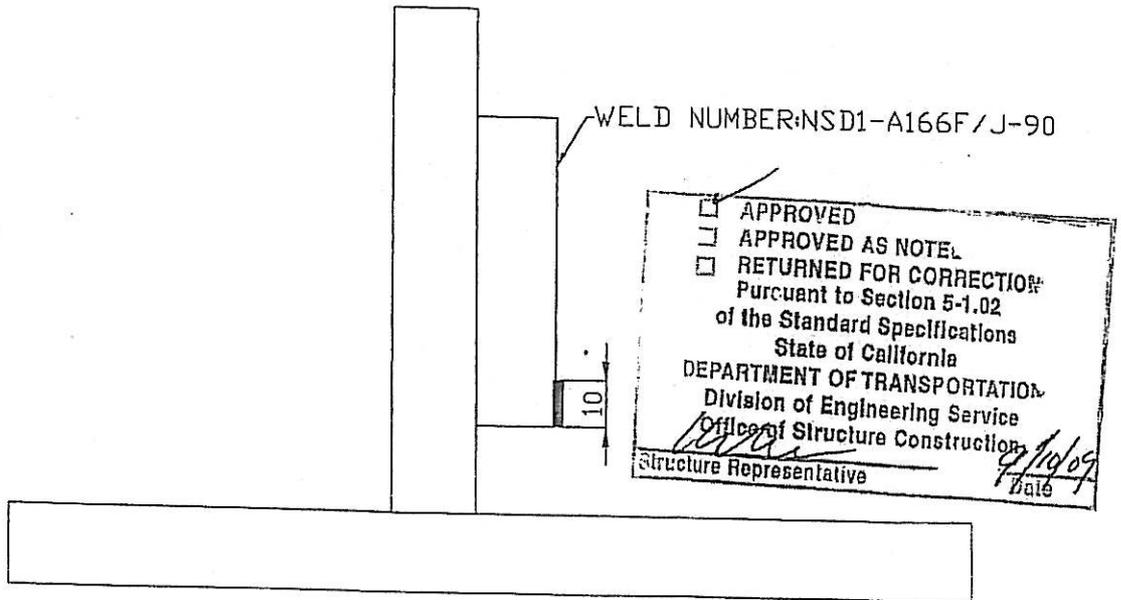
Draft of Welding Discontinuity:

One line indication was found by use of MT on NSD1-A166F/J-90.

1. 火焰加热时, 水汽没有完全的去掉或者这个区域预热不够;
1. Moisture wasn't completely removed during drying operation (preheating) or the area wasn't preheated sufficiently.

1. QC shall monitor and direct the welder and the grinder doing the repair operation.
2. Preheat before gouging; the temperature shall be at least 65°C.
3. Gouge the weld to remove identified defects.
4. Joint details shall refer to the approved WPS repair.
5. Grind the gouged areas to a smooth and shiny surface.
6. Verify with VT and MT to ensure no defects remain in the weld joint prior to welding.
7. QC shall monitor all welding passes being deposited.
8. QC shall ensure all slag has been removed prior the deposition of next pass.
9. Preheat and maintain interpass temperature control in accordance with the WPS.
10. Blend the weld repaired areas into the adjacent weld or base metal by grinding.
11. Perform VT, MT and UT NDT inspection to the repaired areas.

1. QC shall verify sufficient preheat has been applied, to remove moisture, prior to welding.
