Contract #: 04-0120F4Cty: SF/ALA Rte: 80 PM: 13.2/13.9File #: 69.25B**QUALITY ASSURANCE -- NON-CONFORMANCE REPORT****Location:** Changxing Island, Shanghai, PRC**Report No:** NCR-000385**Prime Contractor:** American Bridge/Fluor Enterprises, a JV**Date:** 27-Aug-2009**Submitting Contractor:** Zhenhua Port Machinery Company, Ltd (ZPMC), Changxing Island**NCR #:** ZPMC-0359**Type of problem:**

Reference Description: Missed MT Indications on West Tower, Lift 1, 28m Fit Lug welds**Description of Non-Conformance:**

Dear: Mr. Charles Kanapicki
Job Name: SAS Superstructure

Subject: NCR No. ZPMC-0359

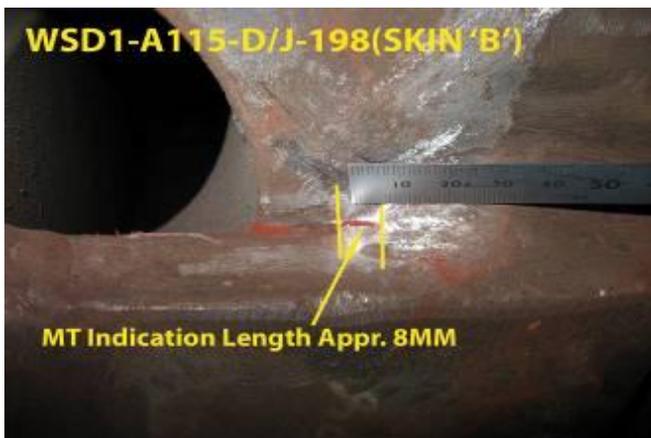
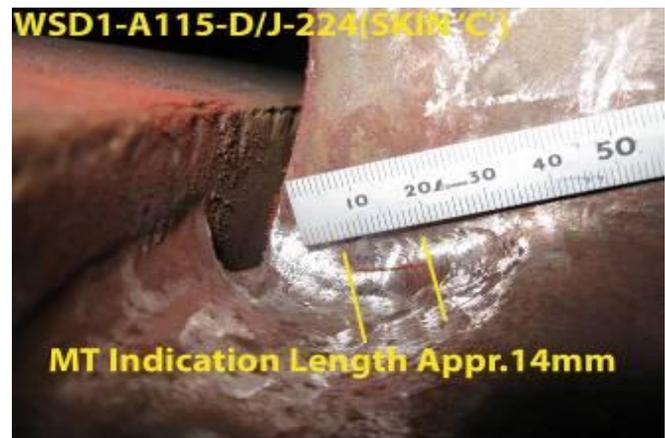
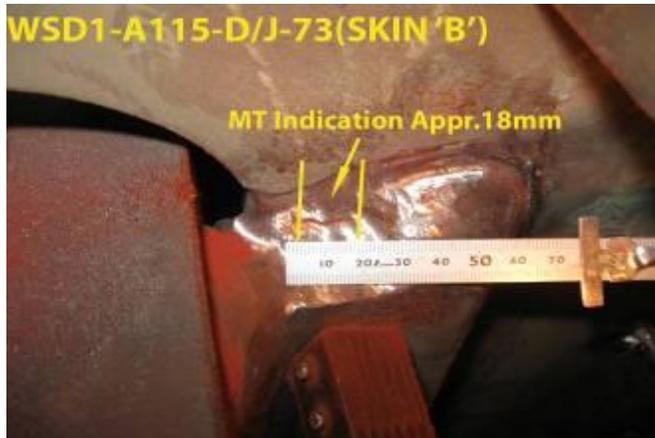
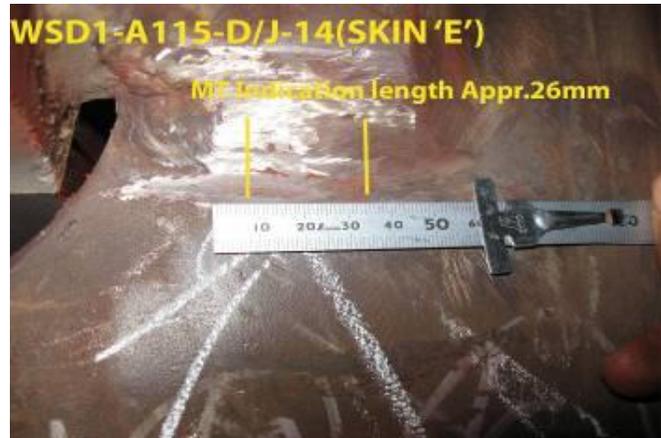
During Magnetic Particle Testing (MT) of weld joints WSD1-A115-D/J-14, 73, 60, 165, 198, 222 and 224 at West Tower, 28m Diaphragm Fit Lugs, QA discovered seven (7) rejectable linear indications measuring approximately 8 to 26 mm in length. These welds were previously tested and accepted by ZPMC QC MT technicians.

AWS D1.5 (02) Section 6.26.2 – “Welds that are subject to MT in addition to visual inspection shall have no cracks.”

Propose a resolution for the identified non-conformance including documentation that the deficiencies have been brought into compliance with the contract requirements. Additionally address the probable causes for the indications and any actions that will be taken to limit future occurrences.

In addition to the material/workmanship non-conformance, propose a resolution that addresses the failure of Quality Control to identify the linear indications during magnetic particle testing of the welds. Provide documentation of the steps taken by the Quality Control Manager to prevent future occurrences.

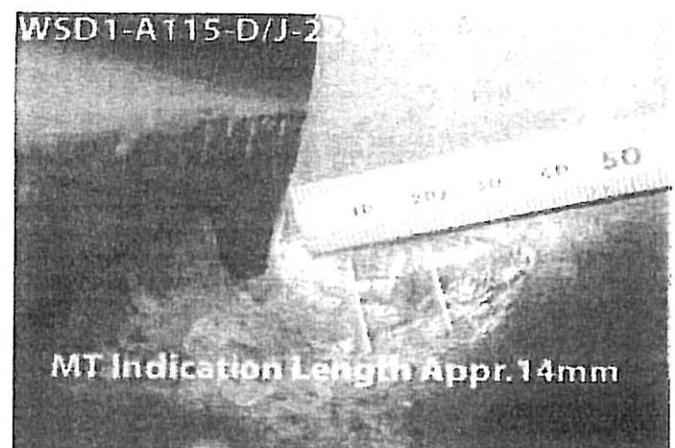
During Magnetic Particle Testing (MT) of weld joints WSD1-A115-D/J-14, 73, 60, 165, 198, 222 and 224 at West Tower, 28m Diaphragm Fit Lugs, QA discovered seven (7) rejectable linear indications measuring approximately 8 to 26 mm in length. These welds were previously tested and accepted by ZPMC QC MT technicians.

AWS D1.5 (02) Section 6.26.2 – “Welds that are subject to MT in addition to visual inspection shall have no cracks.”

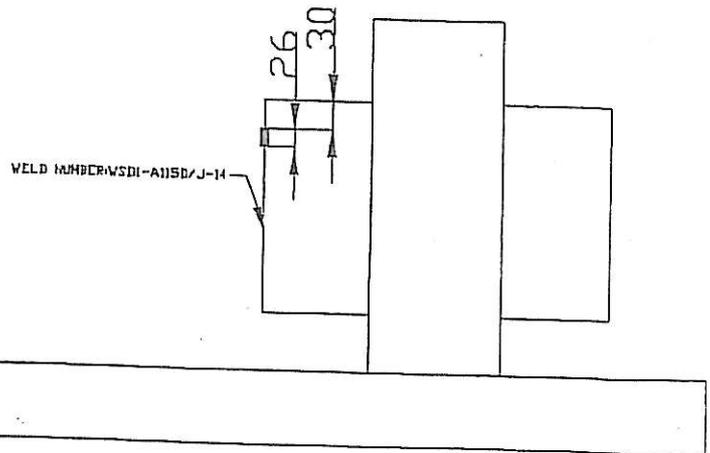
Draft of Welding Discontinuity:

One longitudinal crack was found by use of MT on WSD1-A115D/J-14.

1. 焊缝的位置比较狭窄, 碳刨时, 不能准确的将缺陷刨出.
 2. 打磨工在打磨时, 不够仔细, 没有将所有的缺陷去除.
1. The access space was quite narrow resulting in making it difficult to arc-gouge the defects effectively.
 2. The grinder was not observant during the grinding operation resulting in the indications not being completely removed.

1. QC shall monitor and direct the welder and the grinder doing the repair operation.
 2. Preheat before gouging; the temperature shall be at least 65°C.

3. Gouge the weld to remove identified defects.
 4. Joint details shall refer to the approved WPS repair.
 5. Grind the gouged areas to a smooth and shiny surface.

6. Verify with VT and MT to ensure no defects remain in the weld joint prior to welding.
 7. QC shall monitor all welding passes being deposited.
 8. QC shall ensure all slag has been removed prior the deposition of next pass.

9. Preheat and maintain interpass temperature control in accordance with the WPS.
 10. Blend the weld repaired areas into the adjacent weld or base metal by grinding.

11. Perform VT, MT and UT NDT inspection to the repaired areas.
1. 在返修过程中, QC 应该监控和指导焊工和打磨工;
 2. 碳刨之前必须先进行预热, 温度不低于 65° C;
 3. 碳刨去除缺陷;
 4. 缺陷被完全消除后, 必须准备一个正确的接头型式, 具体接头型式请参见对应的修补焊接工艺规程(WPS);

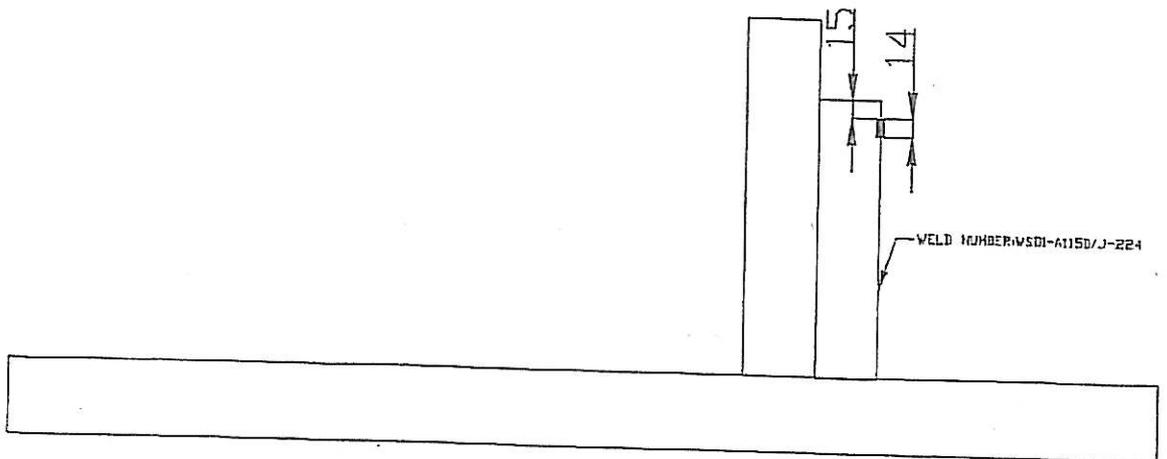
Draft of Welding Discontinuity:

One longitudinal crack was found by use of MT on WSD1-A115D/J-224.

1. 焊缝的位置比较狭窄, 碳刨时, 不能准确的将缺陷刨出.
 2. 打磨工在打磨时, 不够仔细, 没有将所有的缺陷去除.
-
1. The access space was quite narrow resulting in making it difficult to arc-gouge the defects effectively.
 2. The grinder was not observant during the grinding operation resulting in the indications not being completely removed.

1. QC shall monitor and direct the welder and the grinder doing the repair operation.
 2. Preheat before gouging; the temperature shall be at least 65°C.

3. Gouge the weld to remove identified defects.
 4. Joint details shall refer to the approved WPS repair.
 5. Grind the gouged areas to a smooth and shiny surface.

6. Verify with VT and MT to ensure no defects remain in the weld joint prior to welding.
 7. QC shall monitor all welding passes being deposited.
 8. QC shall ensure all slag has been removed prior the deposition of next pass.

9. Preheat and maintain Interpass temperature control in accordance with the WPS.
 10. Blend the weld repaired areas into the adjacent weld or base metal by grinding.

11. Perform VT, MT and UT NDT inspection to the repaired areas.
-
1. 在返修过程中, QC 应该监控和指导焊工和打磨工;
 2. 碳刨之前必须先进行预热, 温度不低于 65° C;
 3. 碳刨去除缺陷;
 4. 缺陷被完全消除后, 必须准备一个正确的接头型式, 具体接头型式请参见对应的修补焊接工艺规程(WPS);

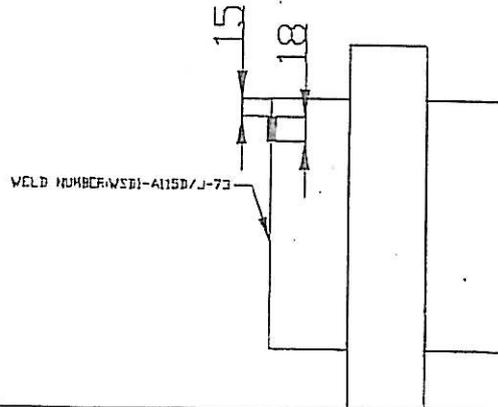
焊缝返修位置示意图:
Draft of Welding Discontinuity:

One longitudinal crack was found by use of MT on WSD1-A115DJJ-73.

1. 焊缝的位置比较狭窄, 碳刨时, 不能准确的将缺陷刨出.
 2. 打磨工在打磨时, 不够仔细, 没有将所有的缺陷去除.
1. The access space was quite narrow resulting in making it difficult to arc-gouge the defects effectively.
 2. The grinder was not observant during the grinding operation resulting in the indications not being completely removed.

1. QC shall monitor and direct the welder and the grinder doing the repair operation.
 2. Preheat before gouging; the temperature shall be at least 65°C.

3. Gouge the weld to remove identified defects.
 4. Joint details shall refer to the approved WPS repair.
 5. Grind the gouged areas to a smooth and shiny surface.

6. Verify with VT and MT to ensure no defects remain in the weld joint prior to welding.
 7. QC shall monitor all welding passes being deposited.
 8. QC shall ensure all slag has been removed prior the deposition of next pass.

9. Preheat and maintain interpass temperature control in accordance with the WPS.
 10. Blend the weld repaired areas into the adjacent weld or base metal by grinding.

11. Perform VT, MT and UT NDT inspection to the repaired areas.
1. 在返修过程中, QC 应该监控和指导焊工和打磨工;
 2. 碳刨之前必须先进行预热, 温度不低于 65° C;
 3. 碳刨去除缺陷;
 4. 缺陷被完全消除后, 必须准备一个正确的接头型式, 具体接头型式请参见对应的修补焊接工艺规程(WPS);

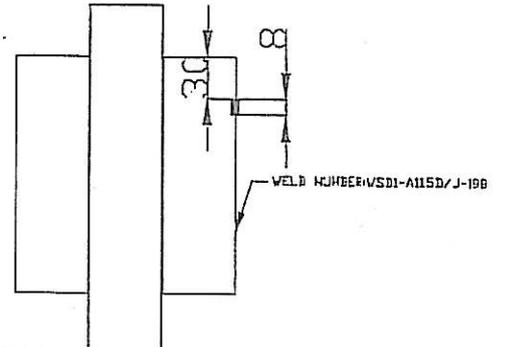
Draft of Welding Discontinuity:

One longitudinal crack was found by use of MT on WSD1-A115D/J-198.

1. 焊缝的位置比较狭窄, 碳刨时, 不能准确的将缺陷刨出.
 2. 打磨工在打磨时, 不够仔细, 没有将所有的缺陷去除.
-
1. The access space was quite narrow resulting in making it difficult to arc-gouge the defects effectively.
 2. The grinder was not observant during the grinding operation resulting in the indications not being completely removed.

1. QC shall monitor and direct the welder and the grinder doing the repair operation.
 2. Preheat before gouging; the temperature shall be at least 65°C.

3. Gouge the weld to remove identified defects.
 4. Joint details shall refer to the approved WPS repair.
 5. Grind the gouged areas to a smooth and shiny surface.

6. Verify with VT and MT to ensure no defects remain in the weld joint prior to welding.
 7. QC shall monitor all welding passes being deposited.
 8. QC shall ensure all slag has been removed prior the deposition of next pass.

9. Preheat and maintain interpass temperature control in accordance with the WPS.
 10. Blend the weld repaired areas into the adjacent weld or base metal by grinding.

11. Perform VT, MT and UT NDT inspection to the repaired areas.
-
1. 在返修过程中, QC 应该监控和指导焊工和打磨工;
 2. 碳刨之前必须先进行预热, 温度不低于 65°C;
 3. 碳刨去除缺陷;
 4. 缺陷被完全消除后, 必须准备一个正确的接头型式, 具体接头型式请参见对应的修补焊接工艺规程(WPS);
