Contract #: 04-0120F4
 Cty: SF/ALA Rte: 80 PM: 13.2/13.9
 File #: 69.25B

QUALITY ASSURANCE -- NON-CONFORMANCE REPORT

Report No: NCR-000386

Reference Description: Excessive DFTs, Non-uniform Paint Surface, Lift L4E

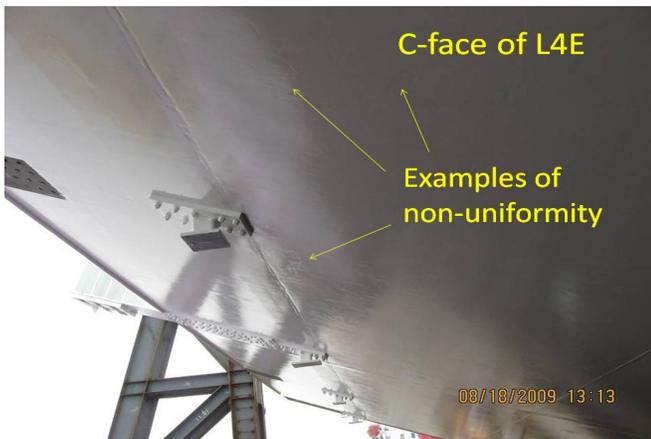
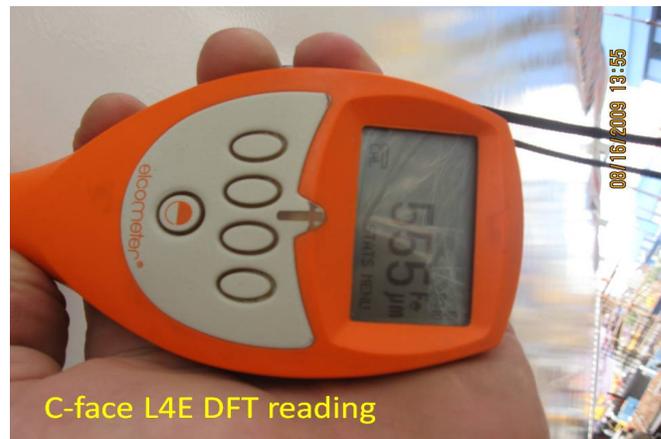
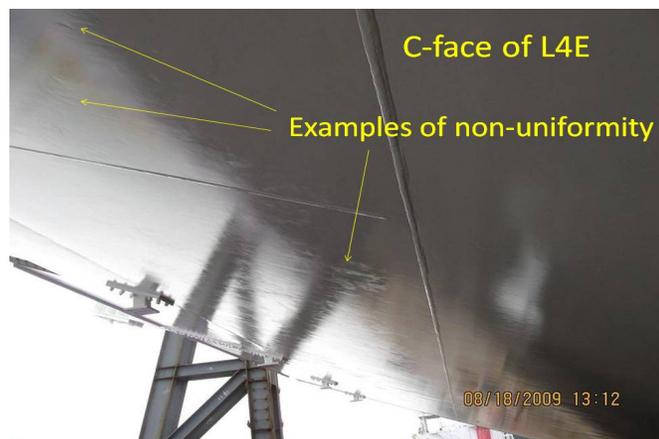
The exterior coating of Lift L4E is unsatisfactory per contract requirements. The dry film thickness (DFT) readings at multiple areas exceed the Special Provisions requirement of 325 μ m and also exceed the maximum allowable spot value of 390 μ m (per SSPC PA2). The painted surface does not possess a uniform appearance. Numerous scabs, scars, and cupped areas from previous applications of the paint system are visible through the most recent application of topcoat. These paint-based blemishes and the general areas where thin DFTs are adjacent to excessively thick DFTs distort the surface finish, resulting in non-uniformity.

Special Provisions: Section 10-1.69 Clean and Paint Structural Steel: Finish Paint: “The total dry film thickness of all applications of inorganic zinc and finish coat paint shall be not less than 200 μ m nor more than 325 μ m.”

Caltrans Standard Specifications, 1999, Section 59-1.03: “Runs, sags, thin and excessively thick areas in the paint film, skips and holidays, or areas of non uniform appearance shall be considered as evidence that the work is unsatisfactory, and the Contractor may be required to blast clean the areas and reapply the paint.”

Submit a repair plan indicating method to spray an even finish coat.

Reblast and repaint surface.

Entire surface was reblasted/repainted and is acceptable per contract requirements.
