Contract #: 04-0120F4Cty: SF/ALA Rte: 80 PM: 13.2/13.9File #: 69.25B**QUALITY ASSURANCE -- NON-CONFORMANCE REPORT****Location:** Changxing Island, Shanghai, P.R. China**Report No:** NCR-000389**Prime Contractor:** American Bridge/Fluor Enterprises, a JV**Date:** 24-Aug-2009**Submitting Contractor:** Zhenhua Port Machinery Company, Ltd (ZPMC), Changxing Island**NCR #:** ZPMC-0363**Type of problem:**

Reference Description: Missed UT indications by QC on 1AW/1BW Segment Transverse Splice**Description of Non-Conformance:**

QUALITY ASSURANCE -- NON-CONFORMANCE REPORT

Job Name: SAS Superstructure

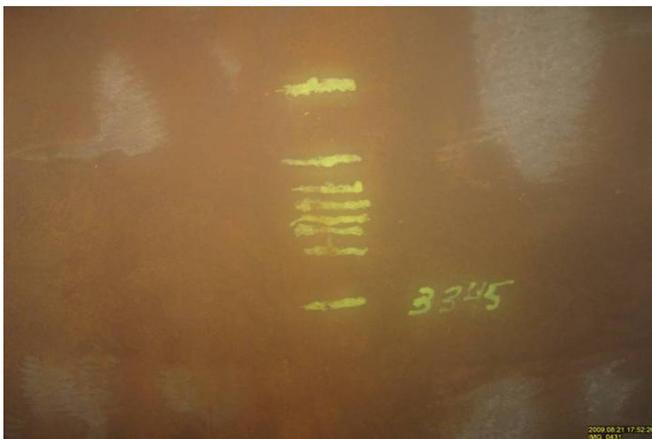
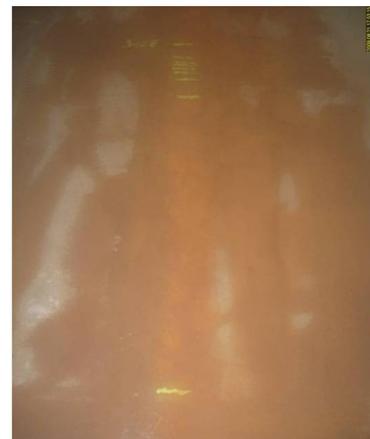
This Quality Assurance (QA) Inspector performed Ultrasonic Testing (UT) of Segment Assembly Transverse Splice Weld #OBW1A-007. QA Inspector discovered UT indications that did not meet the minimum acceptance criteria of AWS D1.5-2002, Table 6.3. A total of nine (9) transverse indications were discovered in the weld mentioned above. The indications were detected utilizing scanning pattern "E" or scanning pattern "D" as described in AWS D1.5, Figure 6.7 on areas where the weld surface condition permitted scanning on top of the weld. These welds have been 100% UT tested and accepted by ZPMC Quality Control (QC).

AWS D1.5/2002 Table 6.3

Submit a repair procedure to the engineer for approval.
Note: Missed indications after 100% UT testing by ZPMC welding inspectors is frequent.

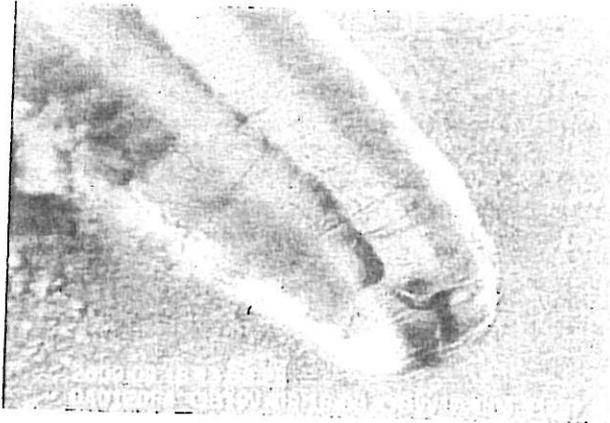
The Quality Assurance (QA) Inspector observed on Sept 18, 2009 and Sept 19, 2009 three (3) visual Transverse Linear Indications in the repair gouges of weld OBWJA-004 (1AAW to 1AW Side Panel Splice at the crossbeam side). The indications were located and documented at Y locations of 5842mm, 6165mm and 6520mm respectively. These visual Transverse Indications were measured from the weld of the Bottom Panel to Side Panel progressing toward the Edge Panel. Subsequently, ZPMC QC performed MT and confirmed that these are transverse indications. This weld joint had been previously tested and accepted by ZPMC QC NDT department. Please see attached NCR No. ZPMC-411 for details.

AWS D1.5 (02) Section 6.26.1.1 "The weld shall have no cracks"

Propose a resolution for the identified recurring non-conformance which constitutes a systematic problem on both materials/workmanship and quality control issues with revised procedures to remedy the defected work and to prevent future occurrences. A response for the resolution of this issue is expected within 14 days.

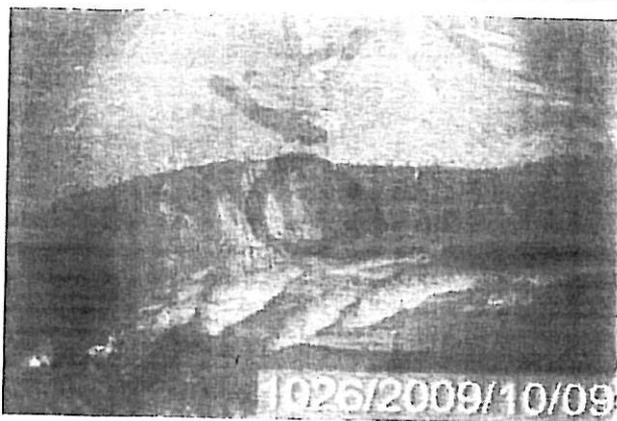
During a random visual inspection of repair work located at 1AW to 1BW side panel segment transverse splice weld OBW1A-007, the Caltrans Quality Assurance (QA) Inspector observed ZPMC workers performing repair excavations at two (2) separate areas along this weld splice. The QA Inspector performed Magnetic Particle testing (MT) at the excavated areas that had been previously tested and accepted by ZPMC MT technician. This QA inspector observed seven (7) Transverse Cracks present in the 2 excavation areas. The submitted critical weld repair procedure (CWR) for this location has not been approved by the Engineer prior to the repair work being started. The Y locations, length of excavated area and number of Transverse Cracks are as followed:

AWS D1.5-2002 Section 3,7,2,4 Crack in Weld or Base Metal; The extent of the crack shall be ascertained by the use of MT, PT, or other equally positive means; the metal shall be removed for the full length of the crack plus 50mm [2"] beyond the end of each crack and re-welded.

Submit a repair procedure for the approval of the engineer. Do not start weld repair until the CWR has been approved by the engineer. Missed MT indications have become a chronic problem. Provide training and tests to verify MT technician competency.

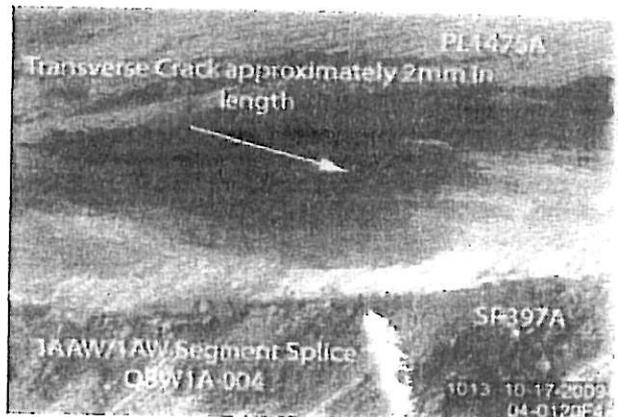
During random visual inspection the QA Inspector performed Magnetic Particle Testing (MT) of an Ultrasonic Testing (UT) reject excavation in the segment CJP Side Plate splice (OBW1A-004), cross beam side joining SP397A (1AW) and PL1475A (1AAW). During this verification the QA Inspector discovered three (3) Transverse Cracks in the excavation. One (1) 2 mm crack was located at Y location 1945mm and two (2) 1mm cracks at Y location 2785mm from the cross beam side Edge Plate.

AWS D1.5-2002 Section 3,7,2,4 Crack in Weld or Base Metal; The extent of the crack shall be ascertained by the use of MT, PT, or other equally positive means; the metal shall be removed for the full length of the crack plus 50mm [2"] beyond the end of each crack and re-welded.

Submit a repair procedure to the engineer for approval.
