QUALITY ASSURANCE -- NON-CONFORMANCE REPORT

Report No: NCR-000391

Welding	Concrete	Other	
Welding	Curing	Procedural	Bridge No: 34-0006
Joint fit-up	Coating	Other	Component: OBG Floorbeam in Segment 10CE
Procedural	Procedural	Description: Floorbeam FL3 Location (FB020-005)

Reference Description: Repair work deviated from the Mis-drilled repair hole procedure and CWR

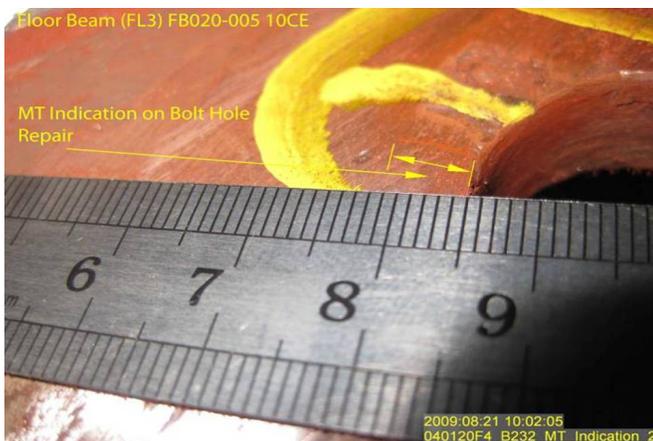
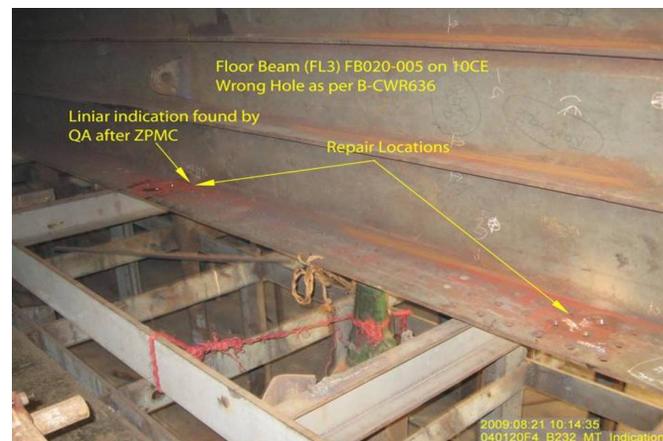
During random verification Magnetic Particle Testing (MT) of the mis-drilled hole repair area on OBG Floor Beam FB020-005 (FL3) on 10CE, Caltrans Quality Assurance (QA) Inspector discovered one (1) linear indication after ZPMC performed MT inspection. Furthermore, QA inspector received notification for inspection after the repair area has been drilled; therefore, proper Ultrasonic Testing (UT) cannot be performed by the QA inspector. This is a deviation from the procedures stated in the Critical Weld Repair B-CWR636 because: 1) VT, UT, and MT need to be performed after the repair; 2) Using plug weld for the mis-drilled hole repair instead of the described WPS; 3) There is an MT indication next to the newly drilled hole.

AWS D1.5 (02) Section 6.26.2 – “Welds that are subject to MT in addition to visual inspection shall have no

Submit weld repair for the engineer's approval.
Note: Missed indications by ZPMC QC are a continuing problem.

- ZPMC has issued internal NCR.
- The MT indication was removed by slight grinding.
- After grinding, MT was performed and accepted.
- UT for base metal is not required to be verified by CT.

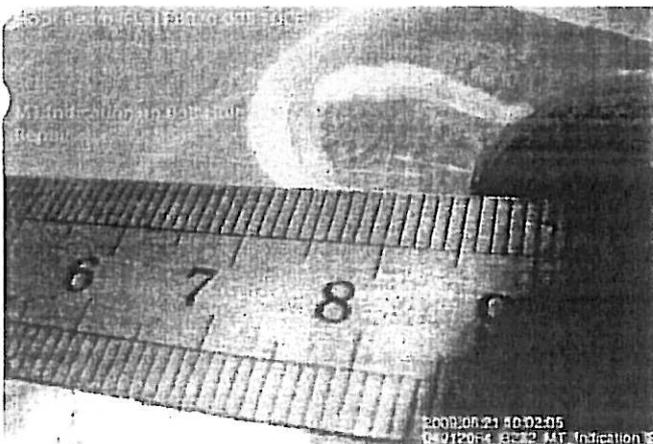
During random verification Magnetic Particle Testing (MT) of the mis-drilled hole repair area on OBG Floor Beam FB020-005 (FL3) on 10CE, Caltrans Quality Assurance (QA) Inspector discovered one (1) linear indication after ZPMC performed MT inspection. Furthermore, QA inspector received notification for inspection after the repair area has been drilled; therefore, proper Ultrasonic Testing (UT) cannot be performed by the QA inspector. This is a deviation from the procedures stated in the Critical Weld Repair B-CWR636 because: 1) VT, UT, and MT need to be performed after the repair; 2) Using plug weld for the mis-drilled hole repair instead of the described WPS; 3) There is an MT indication next to the newly drilled hole.

AWS D1.5 (02) Section 6.26.2 – “Welds that are subject to MT in addition to visual inspection shall have no

Remove indication by grinding.

Indication was removed by grinding. Magnetic Particle Testing was performed to verify the indication was removed completely.
