Contract #: 04-0120F4Cty: SF/ALA Rte: 80 PM: 13.2/13.9File #: 69.25B**QUALITY ASSURANCE -- NON-CONFORMANCE REPORT****Location:** Changxing Island, Shanghai, P.R. China**Report No:** NCR-000392**Prime Contractor:** American Bridge/Fluor Enterprises, a JV**Date:** 17-Aug-2009**Submitting Contractor:** Zhenhua Port Machinery Company, Ltd (ZPMC), Changxing Island**NCR #:** ZPMC-0366**Type of problem:****Welding****Concrete****Other****Welding****Curing****Procedural****Bridge No:** 34-0006**Joint fit-up****Coating****Other****Component:** OBG Segment 6AE Side Panel Repair**Procedural****Procedural****Description:****Reference Description:** Unacceptable Base metal repair on OBG side panel**Description of Non-Conformance:**

Job Name: SAS Superstructure

Subject: NCR No. ZPMC-0366

Reference Description: Unacceptable Base metal repair on OBG side panel

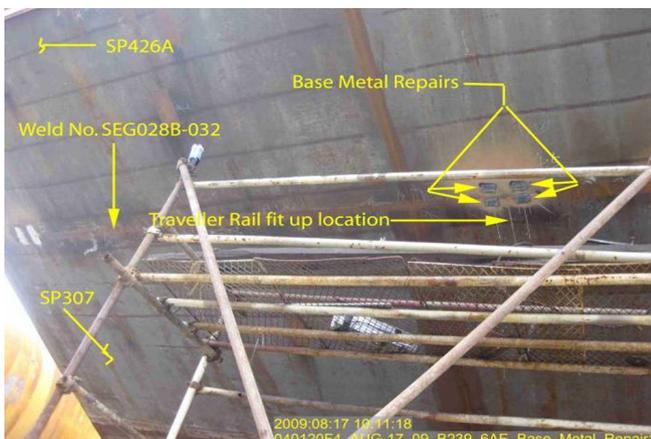
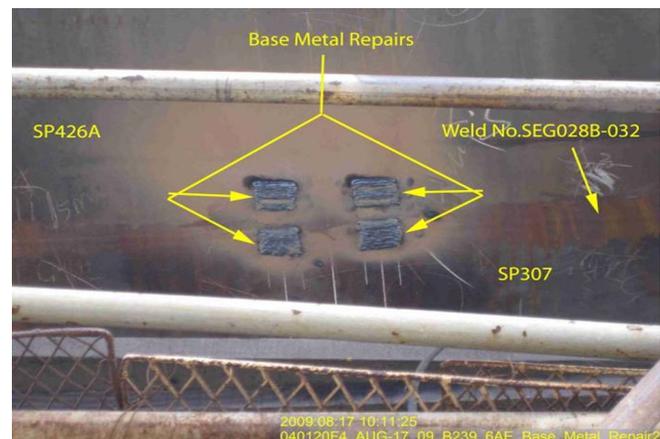
This Quality Assurance (QA) Inspector observed the in-process welding of a base metal repair being performed on side plate SP307 and SP426A adjacent to side plate splice weld No. SEG028B-032 on OBG Segment 6AE. Approximately four areas of 75mm x 75mm of filler material were deposited into four locations, in and around the splice weld to rectify the fit up of the traveler rail bolt attachments by building up the surface thickness to compensate the gap at the faying surface. These additional welds are not in the approved shop drawings or weld map. This is an unacceptable base metal repair and was performed without the approval of the Engineer.

AWS D1.5 2002-Section 3.7.4.- "Prior approval of the engineer shall be obtained for repairs to base metal (other than those required by 3.2), repair of major or delayed cracks, repairs to ESW and EGW welds with internal defects, or for a revised design to compensate for defects."

Submit repair procedure to the engineer for approval.

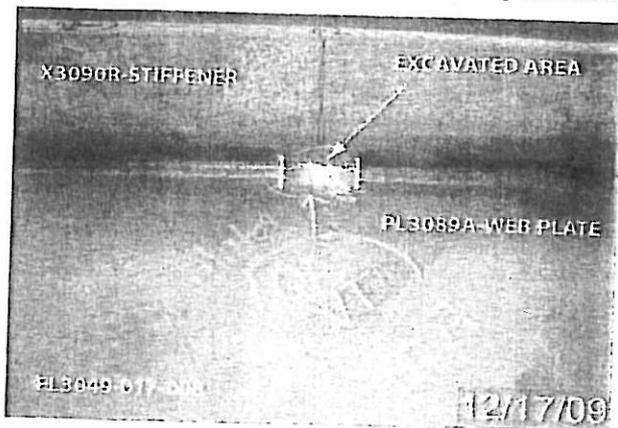
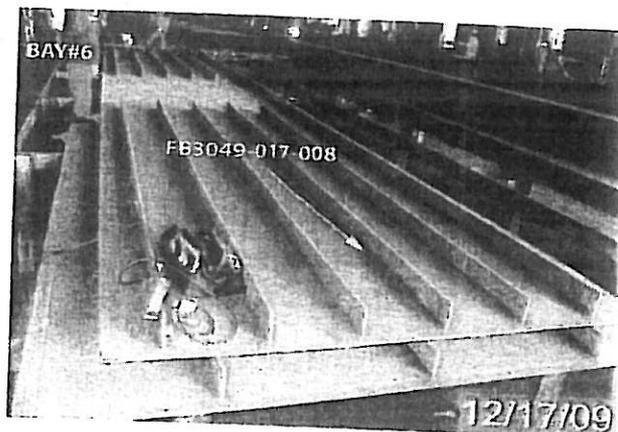
During a random in-process visual verification prior to performing Magnetic Particle Testing (MT) on a Floor Beam (FB) for Crossbeam CB17 located at Bay # 6, the Caltrans Quality Assurance (QA) Inspector observed a fillet weld that had been excavated approximately 50 mm in length and 6 mm in depth. The contractor (ZPMC) offered a formal NDT Inspection Notification Sheet, acknowledging the weld was complete and that ZPMC MT technicians had tested and accepted 100% MT on this FB. Additional information identifying the non-conformance is listed below.

- The Floor Beam is identified as FB3049-017-008.
- The fillet weld connects the FB Web Plate (PL3089A) to FB Stiffener (X3090R).
- The fillet weld size is 6 mm in size per the approved contract drawings.
- The NDT Inspection Notification Sheet request number was identified as: 004835

Submit a repair procedure to the engineer for approval. A response for the resolution of this issue is expected within 7 days.

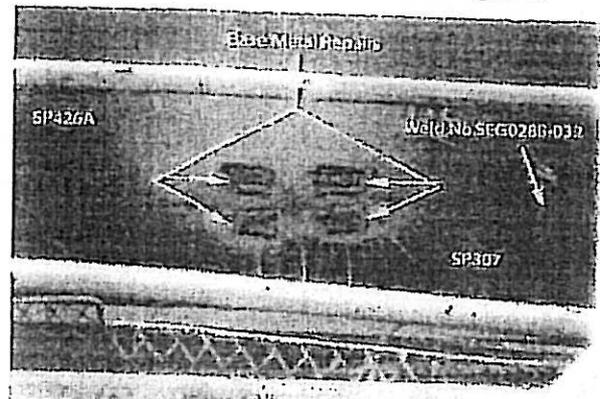
This Quality Assurance (QA) Inspector observed the in-process welding of a base metal repair being performed on side plate SP307 and SP426A adjacent to side plate splice weld No. SEG028B-032 on OBG Segment 6AE. Approximately four areas of 75mm x 75mm of filler material were deposited into four locations, in and around the splice weld to rectify the fit up of the traveler rail bolt attachments by building up the surface thickness to compensate the gap at the faying surface. These additional welds are not in the approved shop drawings or weld map. This is an unacceptable base metal repair and was performed without the approval of the Engineer.

AWS D1.5 2002-Section 3.7.4.- "Prior approval of the engineer shall be obtained for repairs to base metal (other than those required by 3.2), repair of major or delayed cracks, repairs to ESW and EGW welds with internal defects, or for a revised design to compensate for defects."

Submit repair procedure to the engineer for approval.

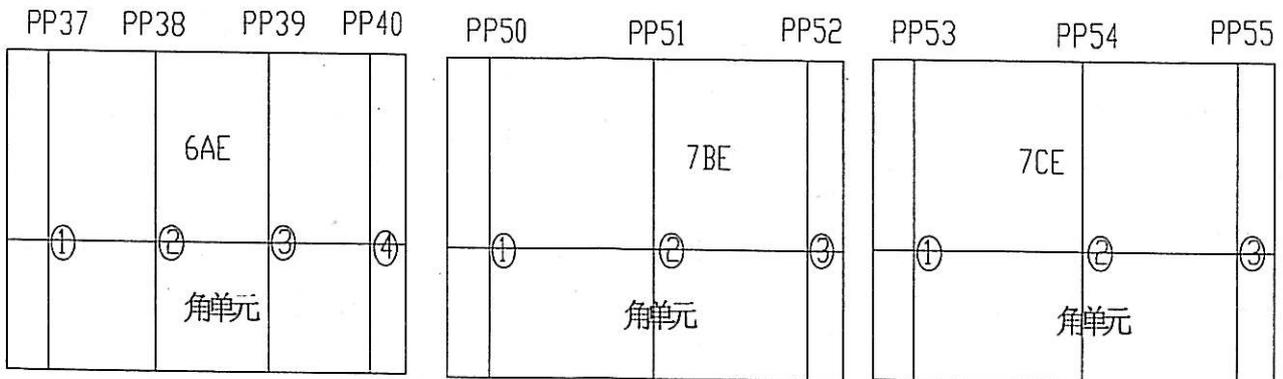
Draft of welding discontinuity:

According to inspection report 1075# disposition, it shall build up 6AE/7BE/7CE relevant position to ensure flatness, see the following draft.

Weld distortion and fabricate error.

1. 按照焊接返修工艺规程 (WPS) 打磨缺陷区域;
 2. 对该区域作100%MT检查, 确保缺陷全部去除;
 3. 根据批准的焊接返修工艺规程 (WPS) 进行预热及焊接;
 4. 将焊接区域打磨至与母材平齐;
 5. 对修补区域进行VT与MT检测;
-
1. Remove all the defects according to the approved repair WPS by means of grinding.
 2. Verify with MT and VT no defects remain in the repair area prior to weld;
 3. Preheat and weld according to the relevant WPS.
 4. Grind the weld flush with base metal after welding.
 5. Perform VT and MT inspection of the repaired area.
