Contract #: 04-0120F4
 Cty: SF/ALA Rte: 80 PM: 13.2/13.9
 File #: 69.25B

QUALITY ASSURANCE -- NON-CONFORMANCE REPORT

Reference Description: Missed MT transverse indication by QC on OBG Floorbeam 24

Job Name: SAS Superstructure

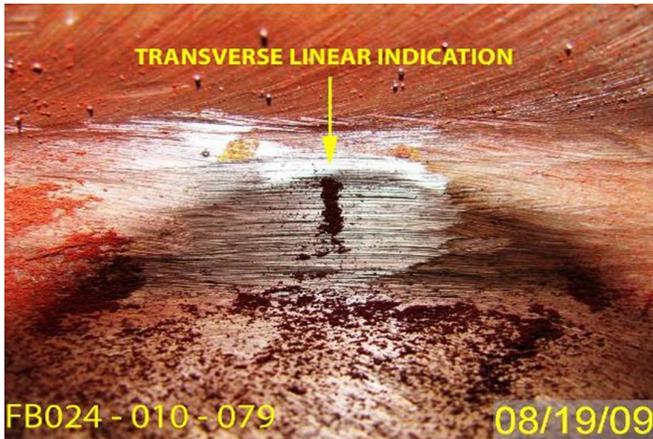
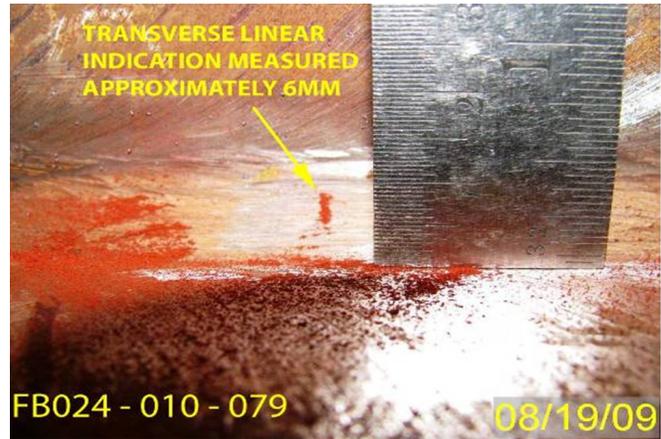
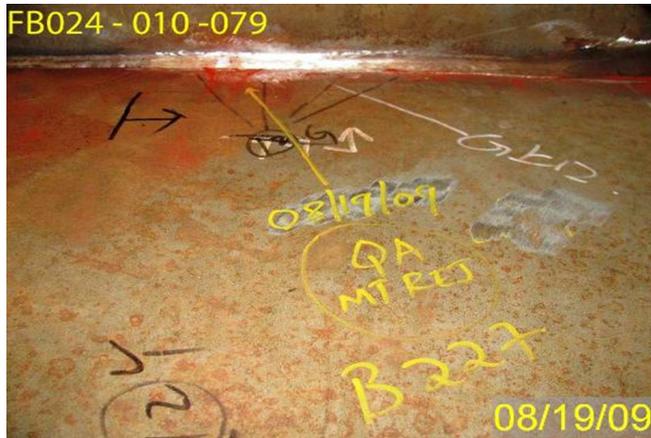
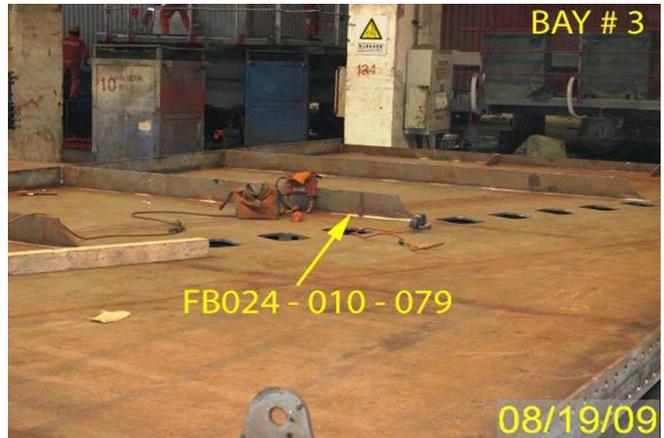
During random verification Magnetic Particle Testing (MT) for the OBG Floor Beam at Bay # 3, this Caltrans Quality Assurance Inspector (QA) observed one (1) transverse linear indication approximately 6mm in length in the weld metal on FB024-010-079. This area has been previously tested and accepted by ZPMC MT Technician.

AWS D1.5 (02) Section 6.26.2 – “Welds that are subject to MT in addition to visual inspection shall have no cracks.

Submit a repair procedure to the engineer for approval.
Note: Missing MT indications by ZPMC QC is an on going problem.

Reference Resolution: The indication was removed with grinding. ZPMC is submitting NDT documents to show that the weld is acceptable.
