QUALITY ASSURANCE -- NON-CONFORMANCE REPORT

Report No: NCR-000394

Component: Segment Splice Weld Joint 1AAE/1AE at LD

Reference Description: Welding without applying proper preheating as required by the WPS

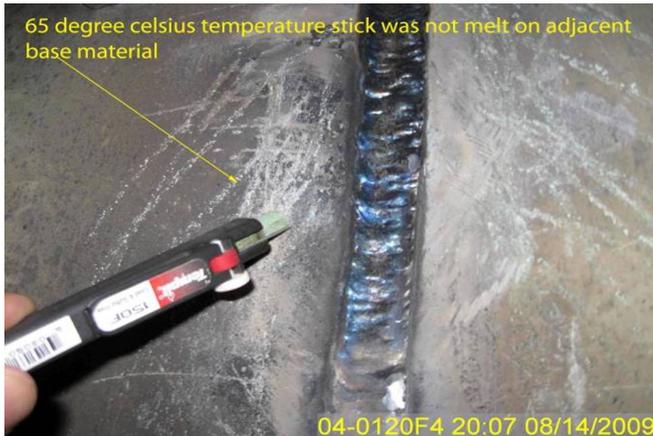
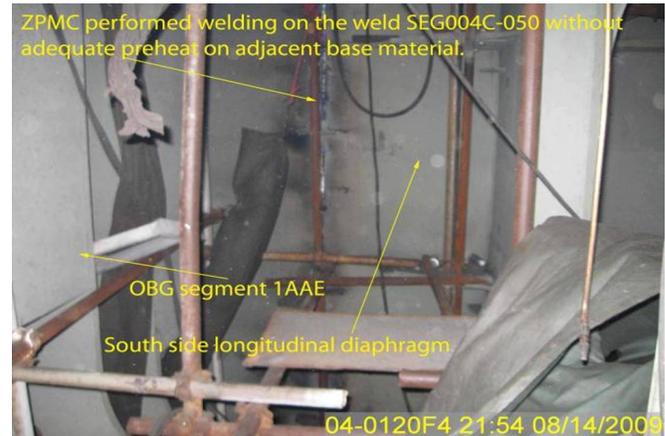
During the random visual inspection this Caltrans Quality Assurance Inspector (QA) observed ZPMC personnel performing Flux Core Arc Welding (FCAW) on the weld SEG004C-050, south side longitudinal diaphragm transverse segment splice weld joint of 1AAE to 1AE, without adequate preheating of the adjacent base material. This QA Inspector observed a 65 degree Celsius Tempstick did not melt when applied to the adjacent base material.

Welding Procedure Specification WPS-B-T-2233-B-U3-F, minimum preheat temperature required is 65 degree Celsius.

ZPMC production personnel did not apply the correct amount of pre-heat nor did they monitor the interpass temperature. ABF has advised ZPMC QA supervision to instruct the QC personnel to strictly monitor the pre-heat and interpass conditions as not meeting these requirements is directly related to welds being rejected for linear type indications. As for the specific welds related to this NCR, ZPMC will perform the necessary NDT inspections and submit the required documentation at a later date for closure of this NCR.

ZPMC has submitted documentation of NDT which shows the weld is acceptable despite the lower preheat temperature of the base metal. The documentation is available on the electronic database. ZPMC requests closure of the NCR.
