Contract #: 04-0120F4Cty: SF/ALA Rte: 80 PM: 13.2/13.9File #: 69.25B**QUALITY ASSURANCE -- NON-CONFORMANCE REPORT****Location:** Changxing Island, Shanghai, P.R. China**Report No:** NCR-000395**Prime Contractor:** American Bridge/Fluor Enterprises, a JV**Date:** 13-Aug-2009**Submitting Contractor:** Zhenhua Port Machinery Company, Ltd (ZPMC), Changxing Island**NCR #:** ZPMC-0369**Type of problem:****Welding****Concrete****Other****Welding****Curing****Procedural****Bridge No:** 34-0006**Joint fit-up****Coating****Other****Component:** OBG Bottom Plate BP026**Procedural****Procedural****Description:****Reference Description:** Missed MT Indications by QC on OBG Bottom Panel BP26**Description of Non-Conformance:**

Job Name: SAS Superstructure

Subject: NCR No. ZPMC-0369

Reference Description: Missed MT Indications by QC on OBG Bottom Panel BP26

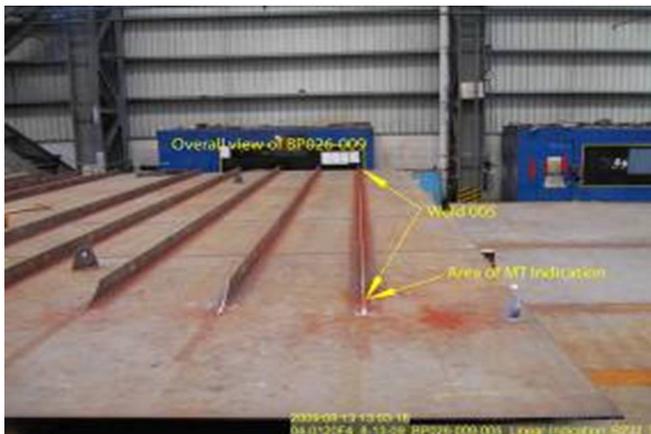
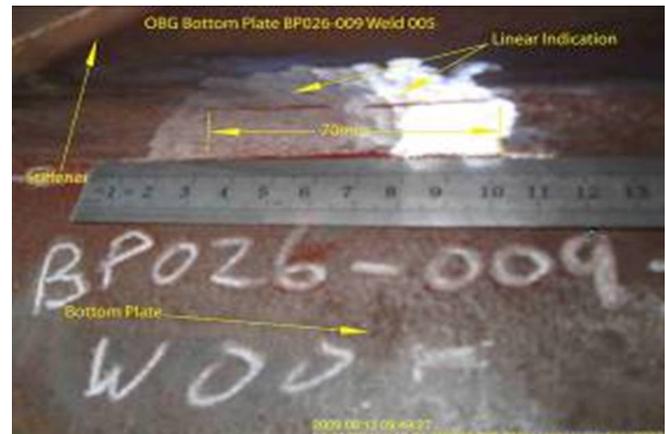
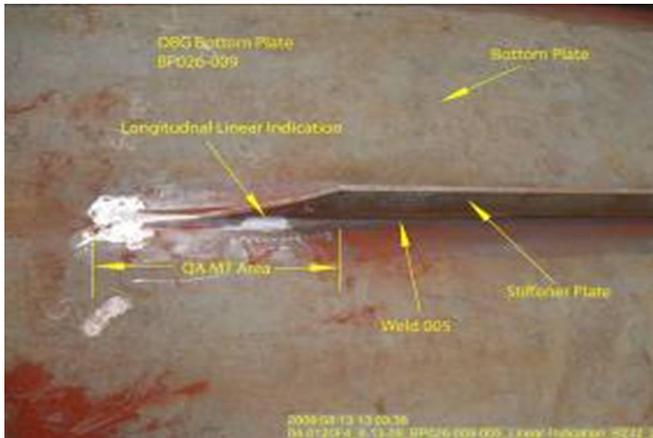
During random verification Magnetic Particle Testing (MT) of OBG Bottom Plate BP026-009 weld Number 005, Caltrans Quality Assurance (QA) Inspector discovered one (1) longitudinal linear indication 70 mm in length in the first 1 meter of inspection. This indication was discovered after ZPMC QC's 100 percent MT inspection.

AWS D1.5 (02) Section 6.26.2 – “Welds that are subject to MT in addition to visual inspection shall have no cracks”

Subit repair procedure for the engineer's approval
Note: Finding MT indications after ZPMC QC has completed MT inspection is a normal occurrence.

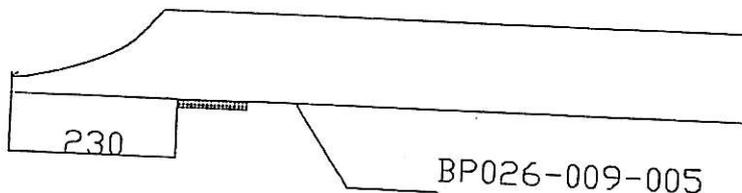
Draft of Welding Discontinuity:

The crack was found on weld (BP026-009-005) after view inspection, 70mm in length.

1. 火焰加热时, 水汽没有完全的去掉或者这个区域预热不够;
1. Moisture wasn't completely removed during drying operation (preheating) or the area wasn't preheated sufficiently.

1. QC and a Lead CWI shall be present, direct and supervise all grinding and welding operations during this repair to ensure the repair is per the disposition requirements

2. QC and a Lead CWI shall have an approved copy of the CWR in hand prior to the repair.
3. Remove paint ≥ 25 mm in all direction of HAZ prior to MT.
4. Remove cracks by grinding, repair area shall extend a minimum of 50mm beyond each end of single crack repairs;

5. If base metal is damaged by grinding, the damaged area shall be ground clean prior to performing weld repair. If gap > 5 mm is found during or after grinding, a separate CWR to make the weld joint a CJP is required in that location, and perform MT after performing grinding the defects away, if CJP joint is required, separate CWR approval is required.

6. Prepare excavation in accordance with an approved repair WPS prior to welding.
7. Before this repair, Verify with VT and MT repair areas are defects free;

8. Perform MT on the weld metal adjacent to the repair area to ensure that crack did not propagate into base metal. If crack is discovered in base metal, approval of a separate CWR is required before continuing with repair work.

9. Preheat and weld according to the approved repair WPS.
10. Grind the repaired area flush with base metal or the adjacent weld.
11. Perform NDT in accordance weld contract plans & adjacent NDT weld note 3 inspections and test. (along with an additional 50mm at each end of the weld repair) which include the near side and far side on the upper Perform UT and MT inspection to CJP weld.
