**QUALITY ASSURANCE -- NON-CONFORMANCE REPORT**

**Location:** Changxing Island, Shanghai, PRC**Report No:** NCR-000398**Prime Contractor:** American Bridge/Fluor Enterprises, a JV**Date:** 04-Sep-2009**Submitting Contractor:** Zhenhua Port Machinery Company, Ltd (ZPMC), Changxing Island**NCR #:** ZPMC-0372**Type of problem:****Welding****Concrete****Other****Welding****Curing****Procedural****Bridge No:** 34-0006**Joint fit-up****Coating****Other****Component:** West Tower**Procedural****Procedural****Description:** Missed MT indications on West Tower, Lift 1**Reference Description:** Missed MT indications on West Tower, Lift 1 discovered during additional NDT review**Description of Non-Conformance:**

<b>To:</b>	AMERICAN BRIDGE/FLUOR, A JV 375 BURMA ROAD OAKLAND CA 95607	<b>Date:</b>	05-Sep-2009
<b>Dear:</b>	Mr. Charles Kanapicki	<b>Contract No:</b>	04-0120F4 04-SF-80-13.2 / 13.9
<b>Attention:</b>	Mr. Thomas Nilsson    Project/Fabrication Manager	<b>Job Name:</b>	SAS Superstructure
<b>Subject:</b>	NCR No. ZPMC-0372	<b>Document No:</b>	05.03.06-000361

**Reference Description:** Missed Indications (MT) / West Shaft Lift 1 / Partial Weld Over-Check Transverse & Longitudinal Indicat

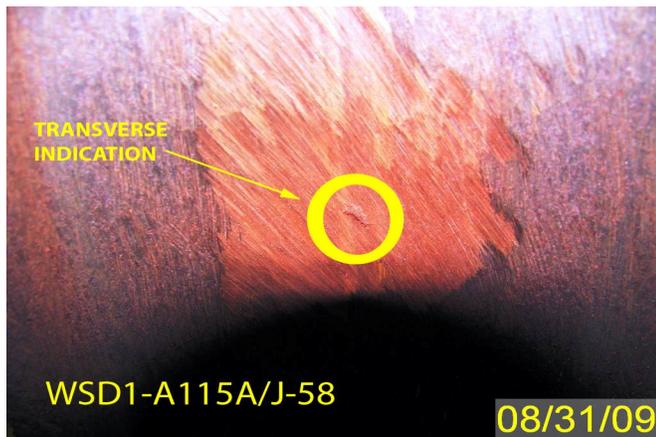
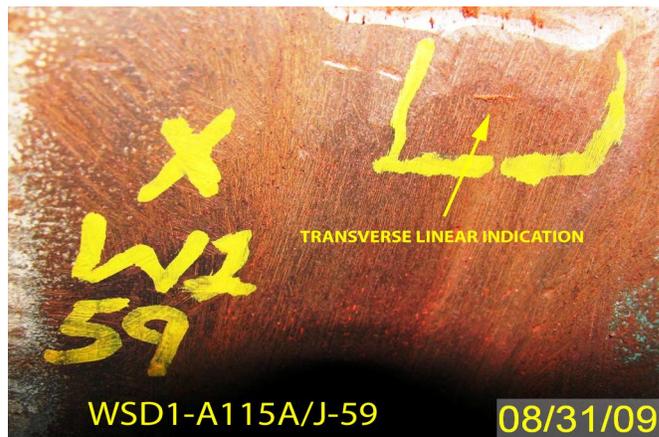
During additional (weld over-check) Magnetic Particle Testing (MT) of accessible welds at the 43 & 47.6 meter diaphragm elevations of West Tower, Lift 1, QA discovered transverse and longitudinal linear indications at the following welds. These welds were previously tested and accepted by ZPMC Quality Control personnel.

WSD1-A115A/J-44 - 2 - Transverse Linear Indication  
 WSD1-A115A/J-58 - 1 - Transverse Linear Indication  
 WSD1-A115A/J-59 - 1 - Transverse Linear Indication  
 WSD1-A115A/J-65 - 1 - Transverse Linear Indication  
 WSD1-A115A/J-67 - 1 - Transverse Linear Indication  
 WSD1-A115A/J-72 - 1 - Transverse Linear Indication  
 WSD1-A115A/J-99 - 1 - Transverse Linear Indication  
 WSD1-A115A/J-114 - 5 - Transverse Linear Indication  
 WSD1-A115H/J-179 - 2 - Transverse Linear Indication  
 WSD1-A115H/J-192 - 3 - Transverse Linear Indication  
 WSD1-A115H/J-227 - 2 - Transverse Linear Indication  
 WSD1-A115H/J-211 - 1 - Transverse Linear Indication  
 WSD1-A115H/J-214 - 1 - Transverse Linear Indication  
 WSD1-A115H/J-220 - 1 - Transverse Linear Indication  
 WSD1-A115H/J-196 - 3 - Transverse Linear Indication  
 WSD1-A115H/J-177/178 - 1 - Transverse Linear Indication  
 WSD1-SA49A/D-27A/B - 4 - Transverse Linear Indication

WSD1-A115H/J-76 - 2 - Longitudinal Linear Indication

WSD1-A115H/J-165 - 1 - Longitudinal Linear Indication  
WSD1-A115H/J-170 - 1 - Longitudinal Linear Indication  
WSD1-A115H/J-186 - 1 - Longitudinal Linear Indication  
WSD1-A115H/J-191 - 1 - Longitudinal Linear Indication  
WSD1-A115H/J-199 - 2 - Longitudinal Linear Indication  
WSD1-A115H/J-203/204 - 1 - Longitudinal Linear Indication  
WSD1-A115H/J-207/208 - 1 - Longitudinal Linear Indication  
WSD1-A115H/J-199 - 1 - Longitudinal Linear Indication  
WSD1-A115H/J-136 - 1 - Longitudinal Linear Indication  
WSD1-A115H/J-135 - 1 - Longitudinal Linear Indication  
WSD1-A115H/J-137 - 1 - Longitudinal Linear Indication  
WSD1-A115H/J-137 - 1 - Longitudinal Linear Indication  
WSD1-A115H/J-54 - 1 - Longitudinal Linear Indication  
WSD1-SA39G/K-18/19 - 1 - Longitudinal Linear Indication  
WSD1-SA39G/K-37/38 - 1 - Longitudinal Linear Indication

Propose a resolution for this systematic non-conformance that addresses the failure of Quality Control to identify the linear indications during magnetic particle testing of the welds. In addition to the welds identified during the limited over-check performed by CT, address how ABF/ZPMC intends to verify that additional indications have not been overlooked throughout the shaft. Provide documentation of steps/actions taken to ensure additional indications have not been overlooked. Address the steps/actions taken by the Quality Control Manager to prevent future occurrences.

In addition to the Quality Control non-conformance, address the material/workmanship for the identified non-conformance including documentation that the identified deficiencies have been brought into compliance with the contract requirements and that additional deficiencies identified by ABF/ZPMC have been remedied. Address the probable causes for the indications and the actions that will be taken to limit future occurrences.
